PAULLINA MUNICIPAL AIRPORT
PAVEMENT MANAGEMENT REPORT

Prepared By:
Applied Pavement Technology, Inc.

November 2003

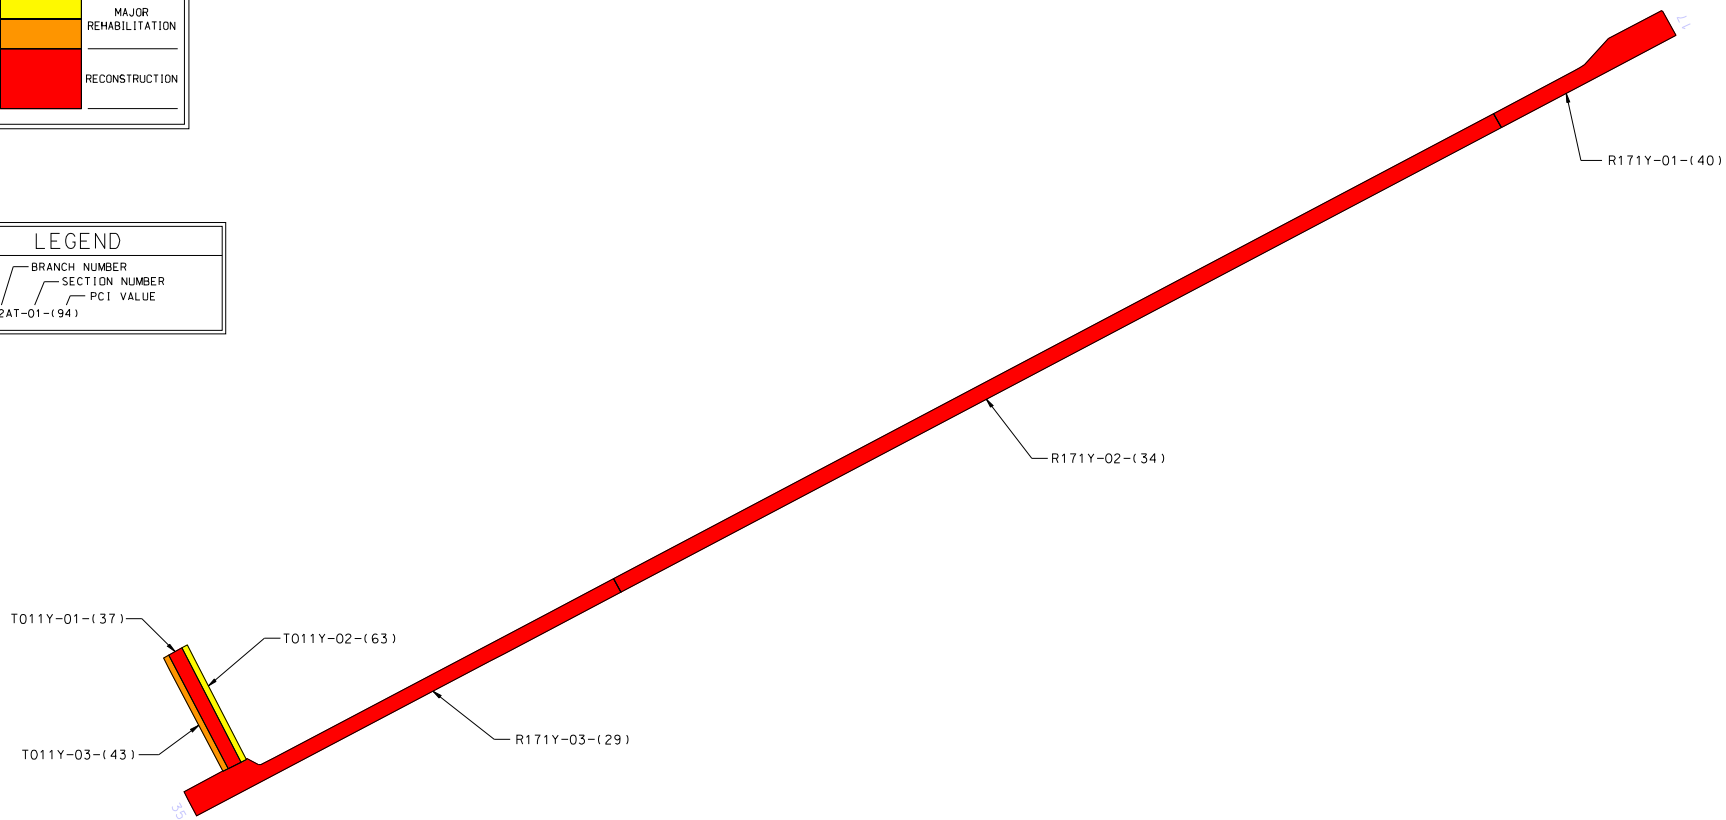
PAVEMENT CONDITION INDEX MAP

The pavements at Paullina Municipal Airport were inspected on November 20, 2003. The 2003 area-weighted condition of Paullina Municipal Airport is 34, with conditions ranging from 29 to 63 (on a scale of 0 [failed] to 100 [excellent]).

Paullina Municipal Airport								
Branch[1]	**Section**	**Surface Type** [2]	**Section Area, sf**	**LCD** [3]	**2003 PCI**	**% Distress Due To:**		**Distress Types**
						Load [4]	**Climate or Durability** [5]	
R171Y	01	AC	9,240	6/30/1991	40	54	46	Longitudinal and transverse cracking, rutting, alligator cracking
R171Y	02	AC	46,760	6/30/1993	34	60	39	Longitudinal and transverse cracking, weathering, rutting, alligator cracking, swelling
R171Y	03	AC	22,400	6/30/1991	29	59	41	Rutting, longitudinal and transverse cracking, weathering, alligator cracking
T011Y	01	AC	4,730	6/30/1991	37	15	85	Alligator cracking, longitudinal and transverse cracking, weathering
T011Y	02	AAC	2,150	6/30/1993	63	0	100	Longitudinal and transverse cracking, weathering
T011Y	03	AAC	2,150	6/30/1993	43	45	55	Weathering, alligator cracking, longitudinal and transverse cracking

Year	Branch[1]	Section	Type of Repair[2]	Estimated Cost[3]
2004	R171Y	01	Major Rehabilitation	$55,440
		02	Major Rehabilitation	$280,560
		03	Major Rehabilitation	$134,400
	T011Y	01	Major Rehabilitation	$28,380
		02	Localized Maintenance	$25
		03	Major Rehabilitation	$6,665
