ROCKWELL CITY MUNICIPAL AIRPORT PAVEMENT MANAGEMENT REPORT

Prepared By:
Applied Pavement Technology, Inc.

December 2010

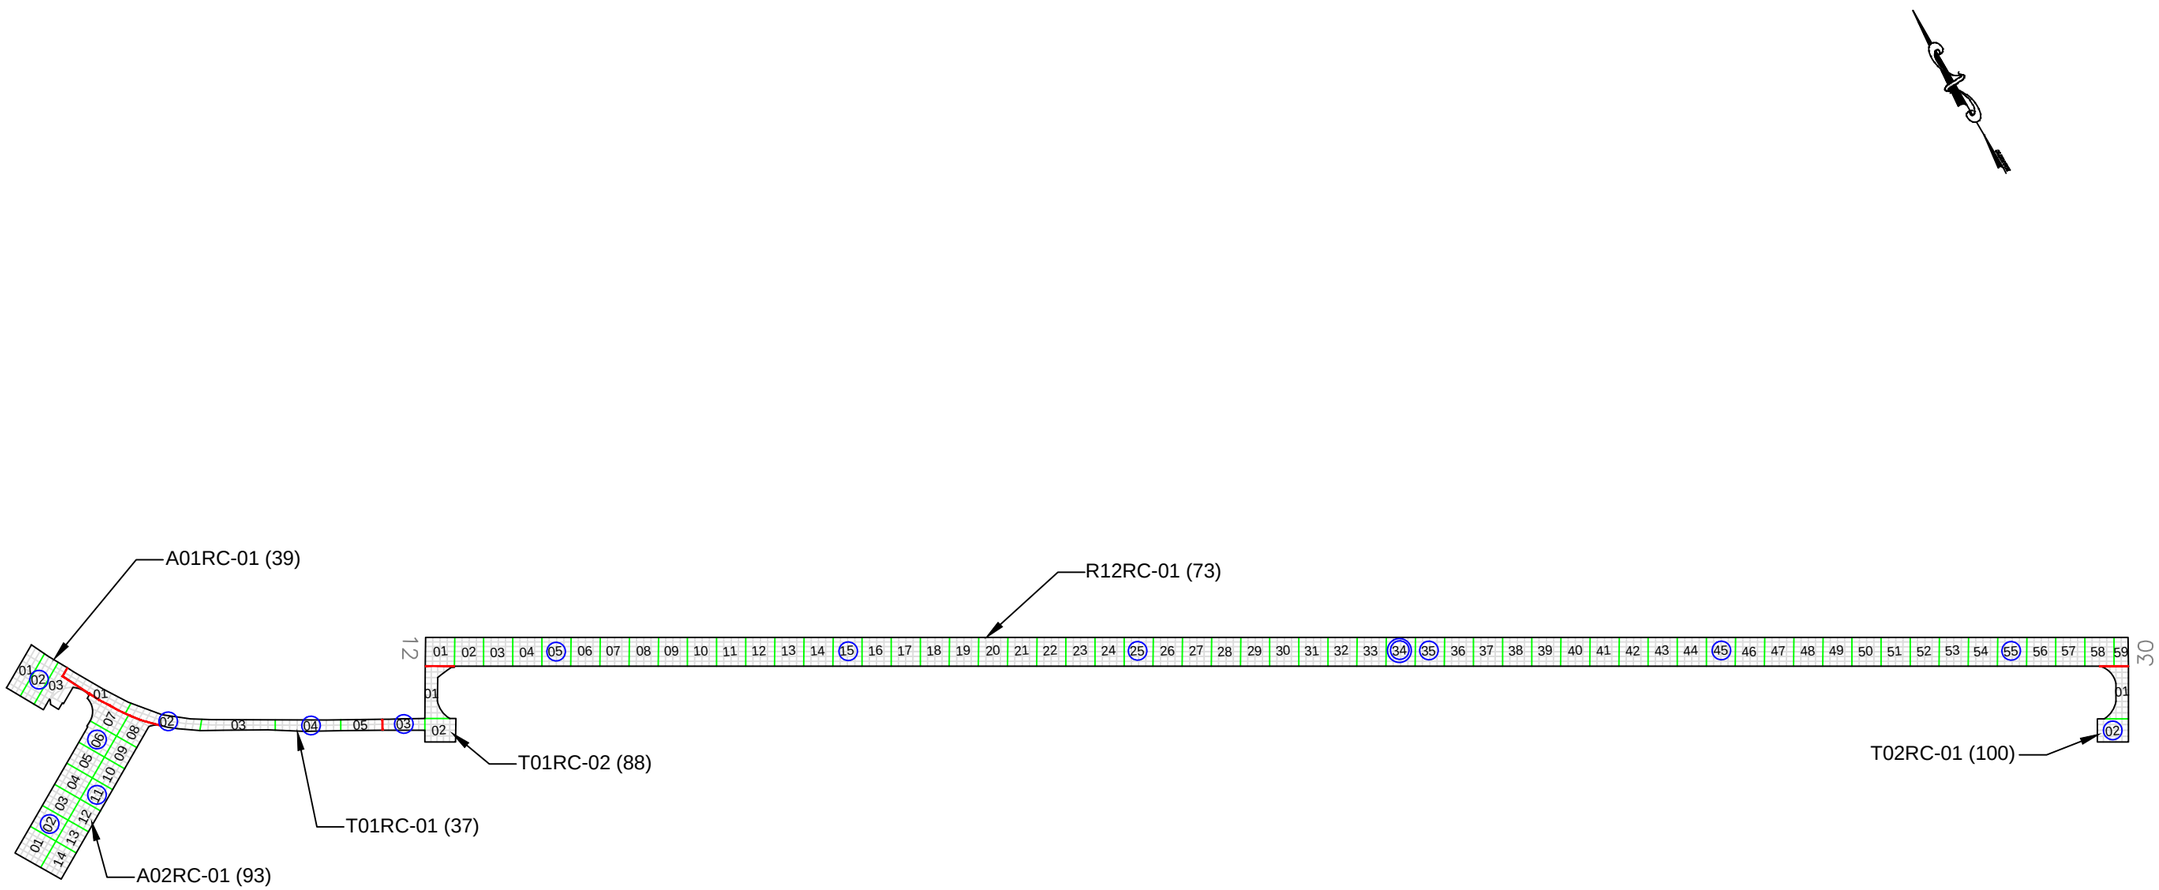
FIGURE 3. NETWORK DEFINITION MAP.

Runway 12-30 is comprised of one section. Section 01 is in satisfactory condition with medium- and high-severity joint seal damage and low- and medium-severity linear cracking recorded throughout. Small amounts of medium-severity corner breaks; low-, medium-, and high-severity joint spalling; and low- and medium-severity corner spalling were observed. In addition, isolated quantities of medium- and high-severity shattered slabs were identified.

Taxiway 01 connects the apron area with the runway and consists of two sections. Section 01, located adjacent to the apron area, is in failed condition with medium- and high-severity joint seal damage recorded throughout. Additionally, significant quantities of low- and medium-severity linear cracking and shattered slabs were identified. Small quantities of medium-severity corner breaks and low-severity faulting were also noted. Section 02, located adjacent to the runway, was recently reconstructed and is in good condition with small amounts of low-severity linear cracking and corner breaking observed.

Taxiway 02, located adjacent to the Runway 30 approach, was recently constructed. Section 01 is in excellent condition with no distresses identified during the inspection.

Apron 01 is located north of Taxiway 01 and consists of one section. Section 01 is in failed condition with high-severity joint seal damage identified. Additionally, significant quantities of medium-severity linear cracking, medium-severity shattered slabs, and high-severity joint spalling were noted.

Apron 02 is defined by one section located east of Taxiway 01. Section 01 is in good condition with low-severity joint seal damage recorded throughout. In addition, small quantities of low-severity large patching, linear cracking, and faulting were observed.

Year	Branch[1]	Section[1]	Type of Repair[2]	Estimated Cost[3]
2011	A01RC	01	Major Rehabilitation	$165,784
	T01RC	01	Major Rehabilitation	$237,022
			Total:	**$402,806**

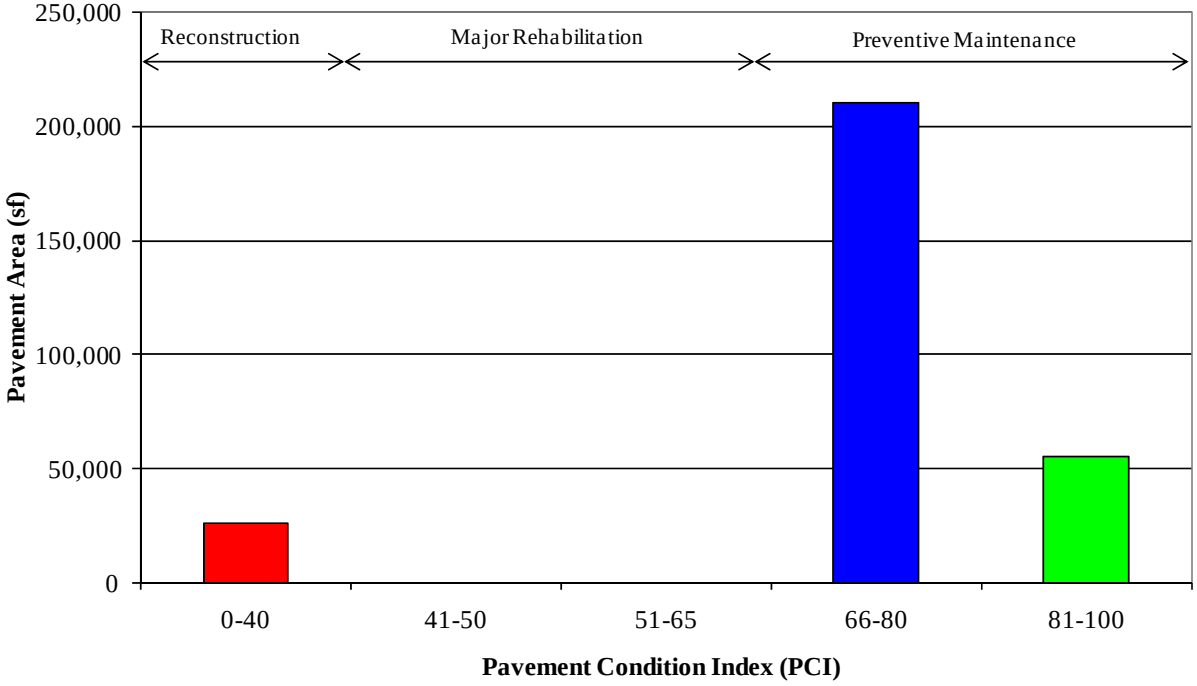
Figure 6. Overall condition.

The pavements at Rockwell City Municipal Airport were inspected on September 18, 2010. The 2010 area-weighted condition of Rockwell City Municipal Airport is 74, with conditions ranging from 37 to 100 (on a scale of 0 [failed] to 100 [excellent]). During the previous pavement inspection in 2006, the area-weighted PCI of the airport was 73.
