WINTERSET – MADISON COUNTY AIRPORT PAVEMENT MANAGEMENT REPORT

Prepared For:
Iowa Department of Transportation
Office of Aviation

Prepared By:
Applied Pavement Technology, Inc.

January 2007

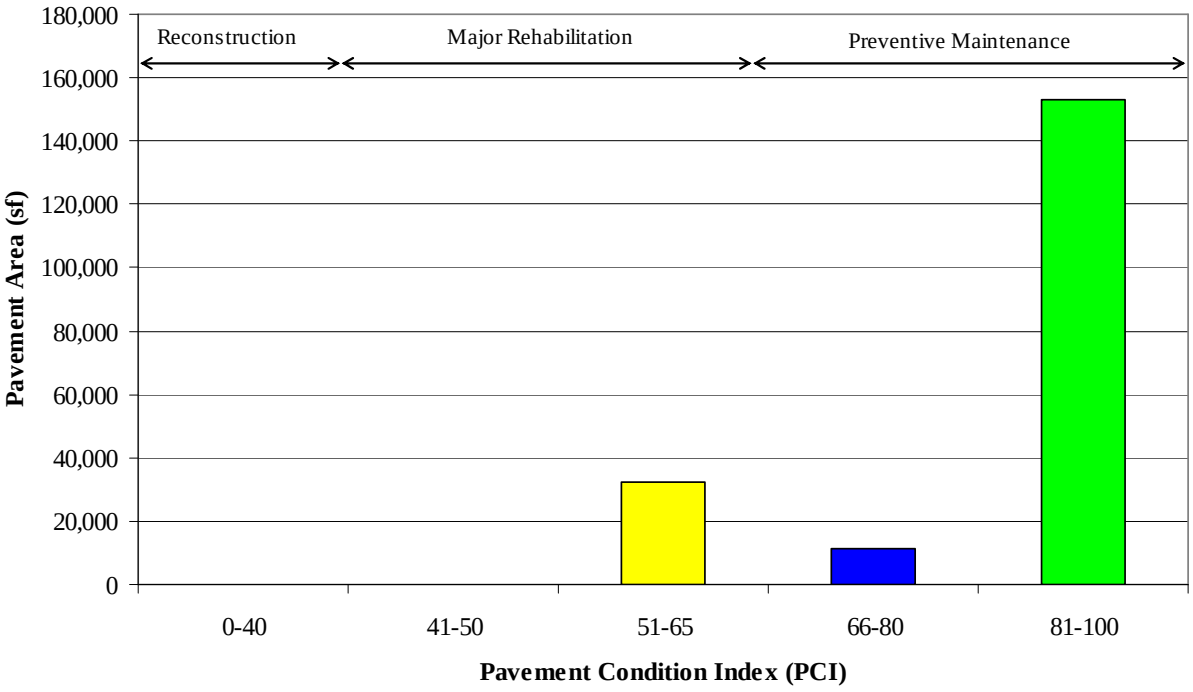
Figure 6. Overall condition.

The pavements at Winterset – Madison County Airport were inspected on September 11, 2006. The 2006 area-weighted condition of Winterset – Madison County Airport is 90, with conditions ranging from 53 to 100 (on a scale of 0 [failed] to 100 [excellent]). In 2003 the area-weighted PCI of the airport was 66.

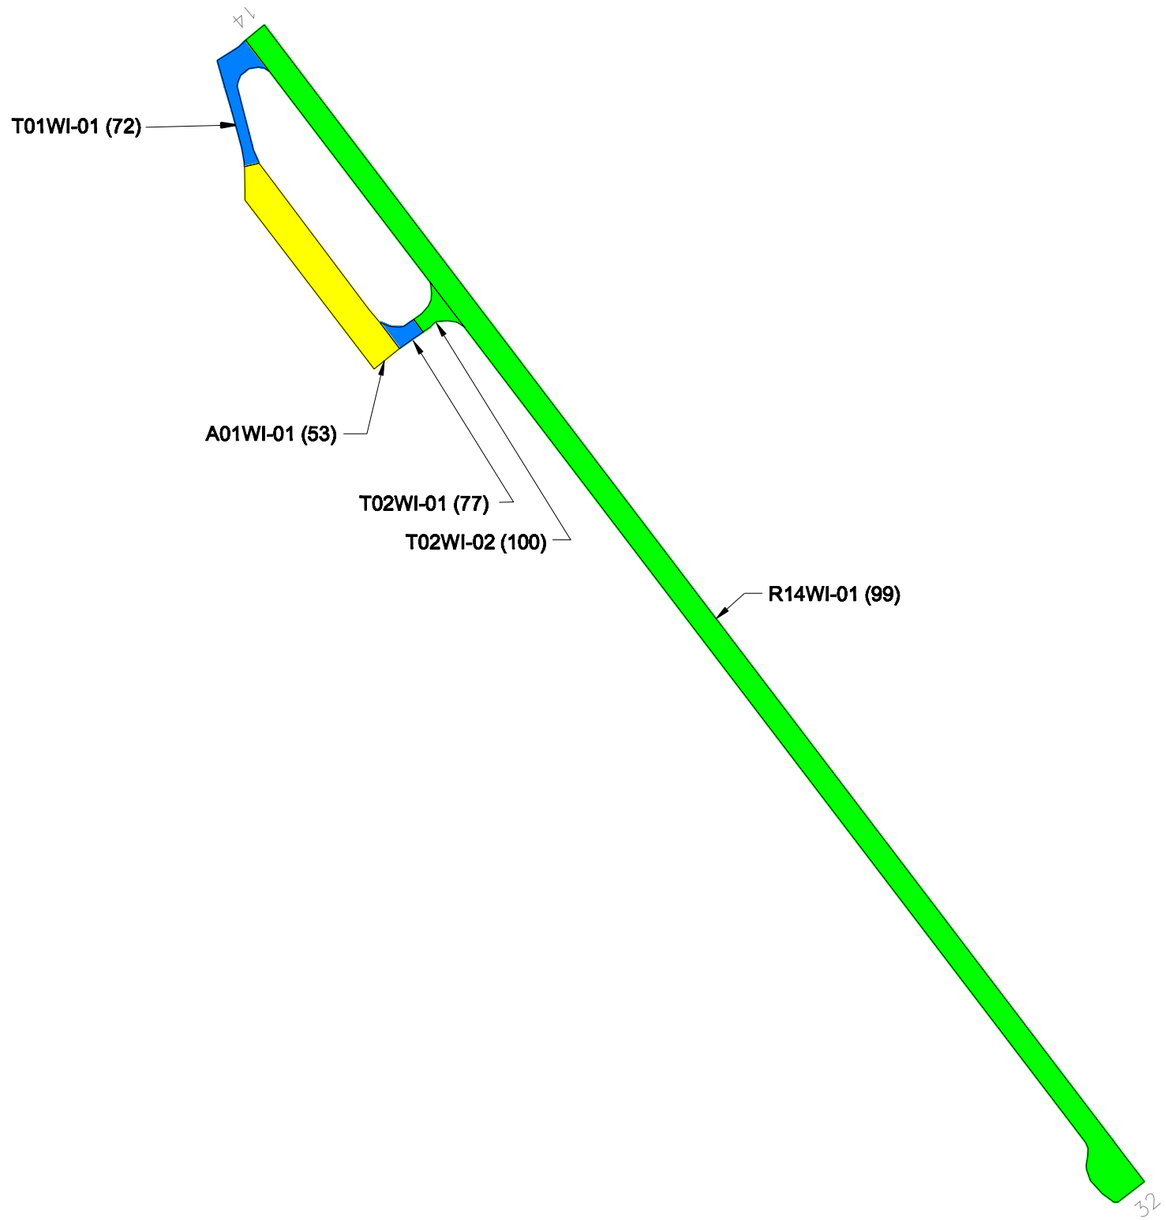
PAGE TITLE: Pavement Condition Index Map

Figures 6 and 7 provide graphs summarizing the overall condition of the pavements at the Winterset – Madison County Airport. Figure 8 is a map that displays the condition of the pavements evaluated. Table 1 summarizes the results of the pavement evaluation. Appendix C presents photographs taken during the PCI inspection, and Appendix D contains detailed information on the distresses observed during the visual survey. Appendix E includes detailed
