ALBIA MUNICIPAL AIRPORT
PAVEMENT MANAGEMENT REPORT

Prepared By:
Applied Pavement Technology, Inc.

December 2011

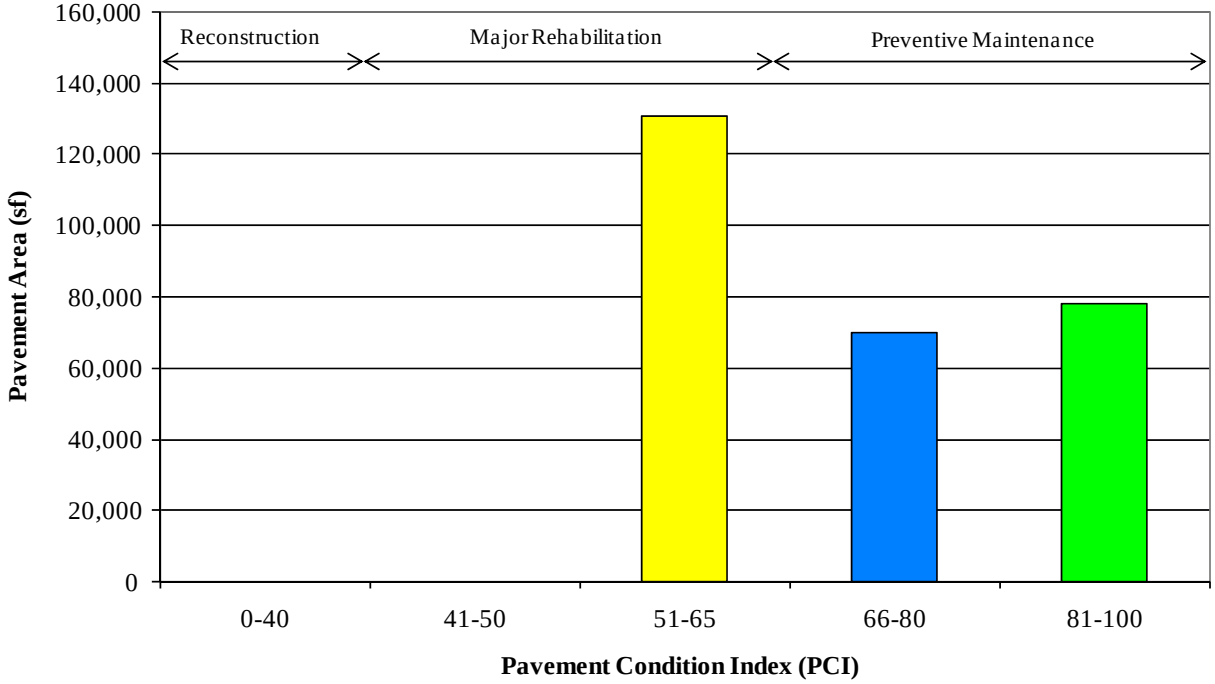
Figure 6. Overall condition.

The pavements at Albia Municipal Airport were inspected on September 9, 2011. The 2011 area-weighted condition of Albia Municipal Airport is 73, with conditions ranging from 63 to 100 (on a scale of 0 [failed] to 100 [excellent]). During the previous pavement inspection in 2008, the area-weighted PCI of the airport was 77.

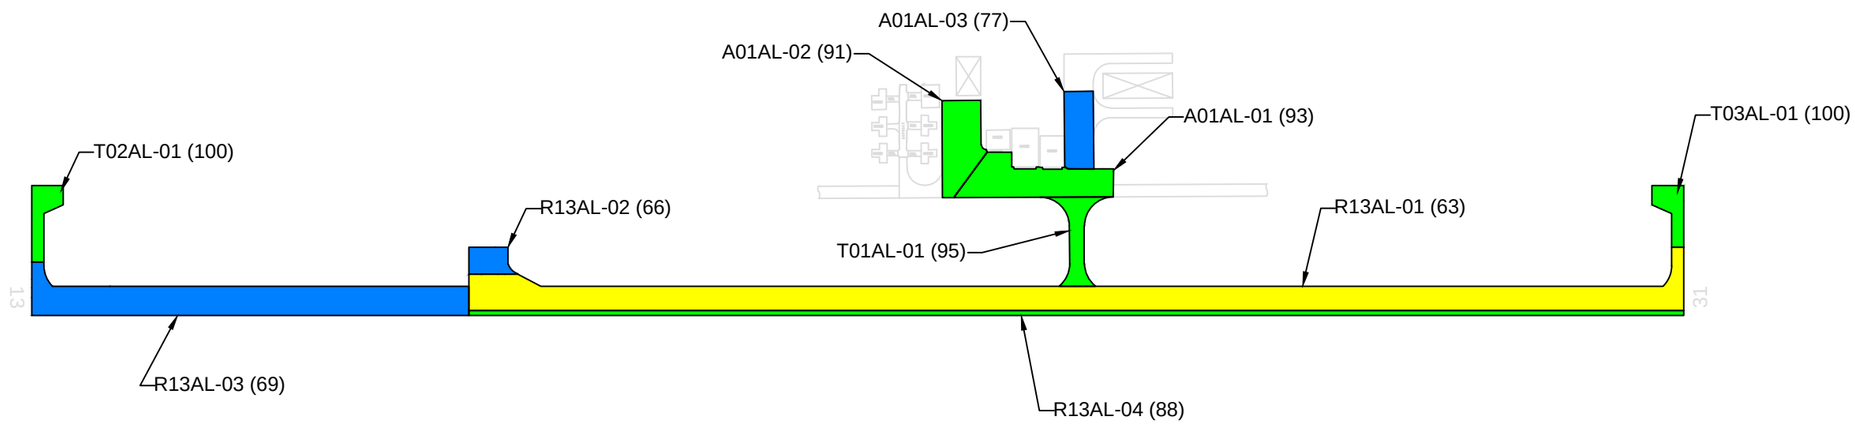
FIGURE 8. PCI MAP.

Runway 13-31 is defined by four sections. Section 01, which comprises the majority of the runway, is in fair condition with moderate quantities of low-severity longitudinal and transverse (L&T) cracking recorded. Small amounts of medium-severity L&T cracking were also observed. Most of the low-severity cracking was sealed, and the medium-severity cracking was recorded where secondary cracking had developed. Extensive amounts of low-severity raveling and weathering and small quantities of low-severity patching were also noted throughout. Section 02, a mid-runway turnaround, is in satisfactory condition with small amounts of low-severity, unsealed L&T cracking and low-severity patching observed along with extensive amounts of low-severity raveling and weathering. Section 03 is the extension located at the Runway 13 approach. This section is in satisfactory condition with low-severity L&T cracking and raveling and weathering recorded. The majority of the low-severity cracking was sealed. Section 04, the southwest edge of the runway, is in good condition with isolated quantities of low-severity, both sealed and unsealed, L&T cracking recorded along with small amounts of low-severity patching.

Taxiway 01 connects the apron area with Runway 13-31 and is in excellent condition with small amounts of low-severity, sealed L&T cracking identified.

Taxiways 02 and 03 were recently constructed and are both in excellent condition with no distresses observed at the time of inspection.

The apron area (Apron 01) is defined by three sections. Sections 01 and 02 are both in good condition with small amounts of low-severity, mostly sealed L&T cracking. Isolated quantities of oil/fuel damage, low-severity depression, and medium-severity raveling and weathering were also noted in Section 02. Section 03 is in satisfactory condition with moderate amounts of low-severity depression and small amounts of low-severity rutting and alligator cracking observed.

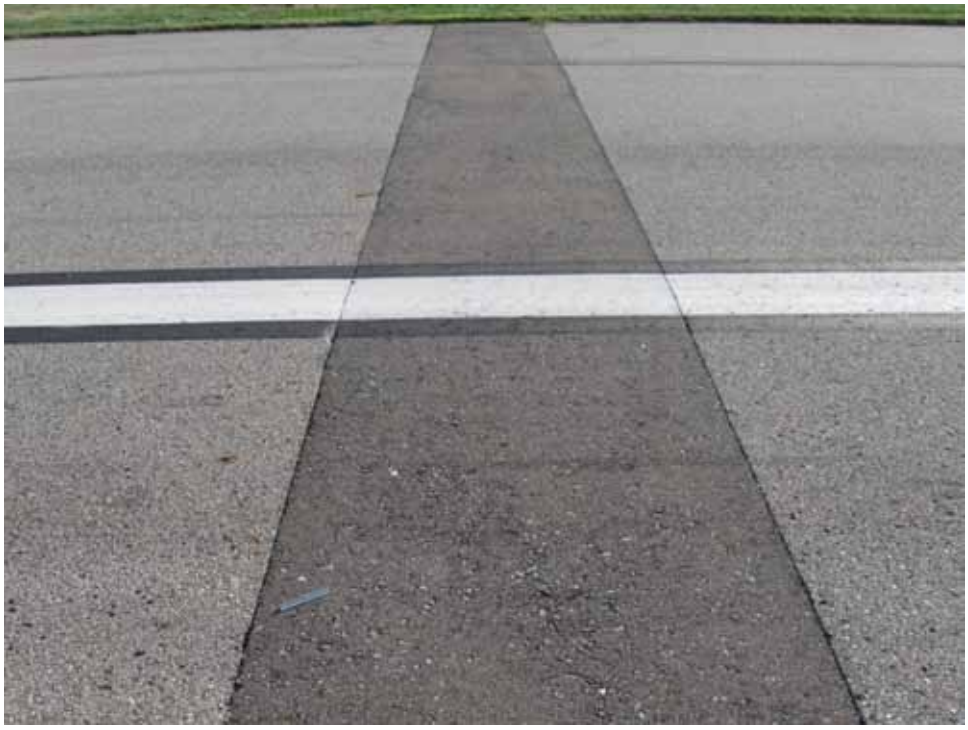
R13AL-01. Longitudinal and Transverse Cracking (Sample Unit #25).
