BLOOMFIELD MUNICIPAL AIRPORT PAVEMENT MANAGEMENT REPORT

Prepared By:
Applied Pavement Technology, Inc.

December 2011

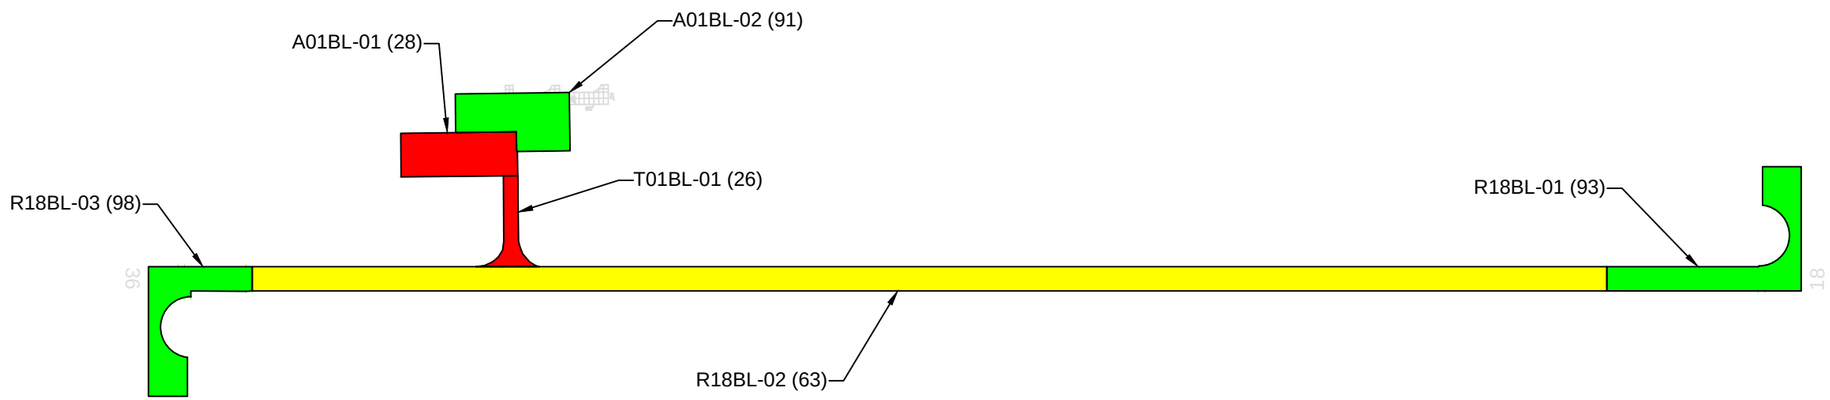
FIGURE 8. PCI MAP.

The pavements at Bloomfield Municipal Airport were inspected on September 9, 2011. The 2011 area-weighted condition of Bloomfield Municipal Airport is 69, with conditions ranging from 26 to 98 (on a scale of 0 [failed] to 100 [excellent]). During the previous pavement inspection in 2008, the area-weighted PCI of the airport was 67.

Runway 18-36 is defined by three sections. Section 01, an extension located at the Runway 18 approach, is in good condition with only medium-severity joint seal damage observed at the time of inspection. Section 02, which consists of the majority of the runway, is in fair condition with medium- and high-severity joint seal damage recorded throughout. Extensive amounts of low- and medium-severity durability cracking were also identified. Joint sealant was applied on the durability cracking to minimize the foreign object damage (FOD) potential. Section 03, the Runway 36 approach extension, is in excellent condition with only low-severity joint seal damage observed.

Taxiway 01 connects Runway 18-36 with the apron area. This taxiway consists of one section in poor condition with extensive amounts of low- and medium-severity durability cracking, medium- and high-severity scaling and blow-ups, and low-severity longitudinal, transverse, and diagonal (LTD) cracking recorded throughout. In addition, small amounts of low-severity faulting and large patching were noted. The joints were recently resealed and some of the high-severity durability cracking and scaling were patched.

The apron area (Apron 01) is comprised of two sections. Section 01, the southern portion of the apron, is in poor condition with extensive amounts of low-severity longitudinal and transverse (L&T) cracking and joint reflection cracking identified throughout. All of the low-severity cracking was sealed. In addition, significant amounts of medium-severity alligator cracking, low-severity depression, and low-, medium, and high-severity swelling were recorded. A small portion of the apron had low-severity raveling and weathering recorded due to chipping and cracking of the seal coat. Section 02, the northern portion of the apron, is in good condition with low-severity joint seal damage recorded throughout along with small amounts of shrinkage cracking and low-severity LTD cracking and corner breaking recorded.

Year	Branch[1]	Section[1]	Type of Repair[2]	Estimated Cost[3]
2012	A01BL	01	Major Rehabilitation	$199,752
	R18BL	02	Major Rehabilitation	$1,020,583
	T01BL	01	Major Rehabilitation	$107,756
			Total:	**$1,328,091**
