TIPTON MUNICIPAL – MATHEWS MEMORIAL AIRPORT PAVEMENT MANAGEMENT REPORT

Prepared For:
Iowa Department of Transportation
Office of Aviation

Prepared By:
Applied Pavement Technology, Inc.

December 2010

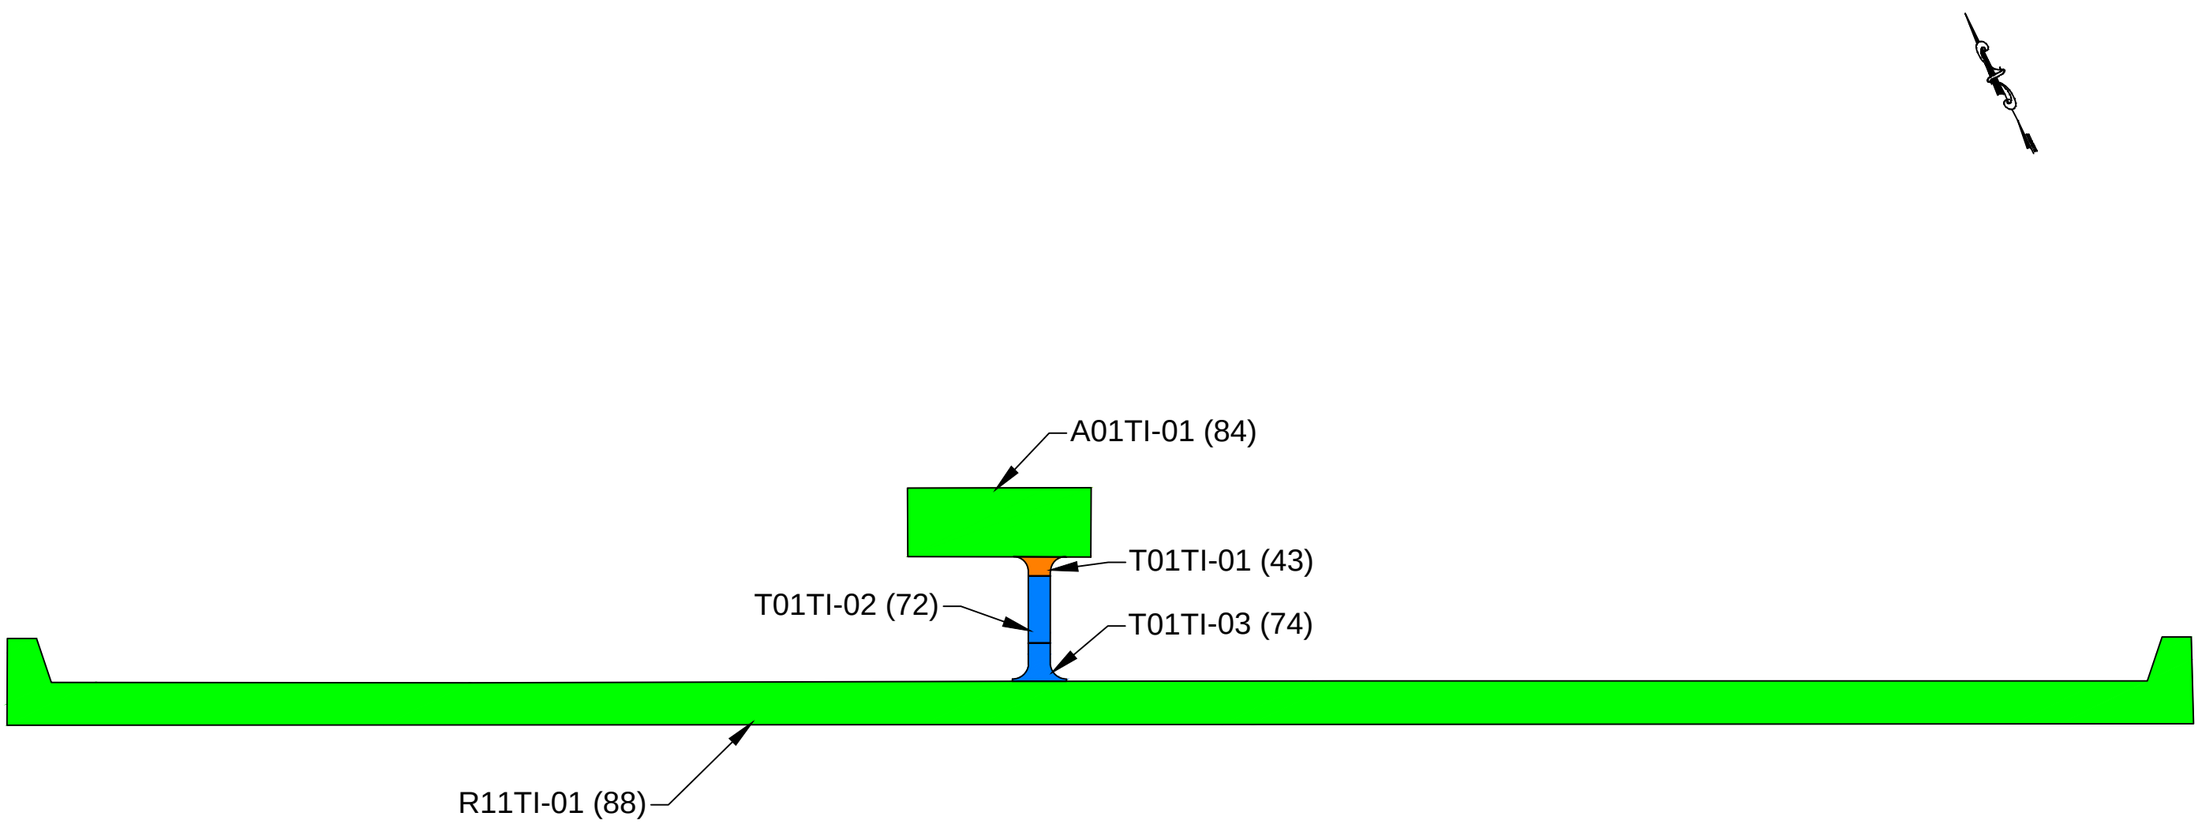
FIGURE 8. PCI MAP.

Runway 11-29 is comprised of one section. Section 01 is in good condition with low-severity joint seal damage recorded throughout. Small amounts of low-severity linear cracking, joint spalling, and corner spalling were also identified.

Taxiway 01 connects the runway to the apron area and consists of three sections. Section 01, located adjacent to the apron area, is in poor condition with low-severity joint seal damage and significant quantities of low-severity linear cracking and medium-severity shattered slabs observed. Section 02, located in the middle of the taxiway, is in satisfactory condition with low-severity joint seal damage recorded. Additionally, significant quantities of low- and medium-severity linear cracking and corner spalling and high-severity joint spalling were identified. Section 03, located adjacent to the runway, is in satisfactory condition with moderate amounts of low-severity linear cracking, corner spalling, and corner breaking observed.

Apron 01 is defined by one section that is in good condition with small quantities of low-severity linear cracking and corner breaks identified.

Year	Branch[1]	Section[1]	Type of Repair[2]	Estimated Cost[3]
2011	T01TI	01	Major Rehabilitation	$12,756
			Total:	**$12,756**

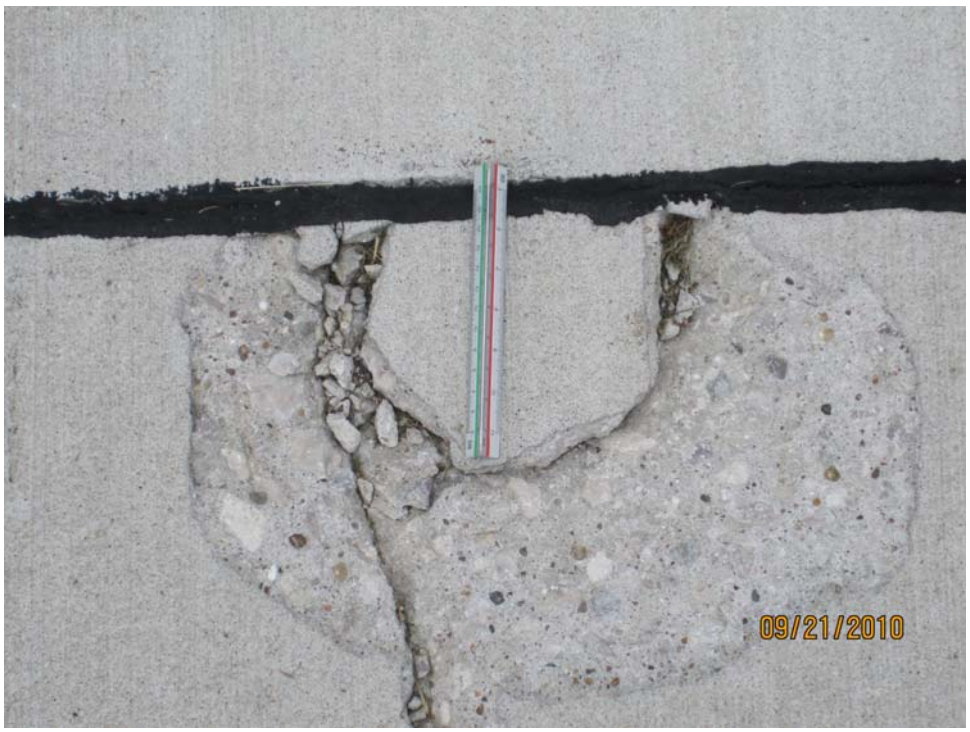
T01TI-02. Overview.
