AUDUBON COUNTY AIRPORT
PAVEMENT MANAGEMENT REPORT

Prepared By:
Applied Pavement Technology, Inc.

January 2007

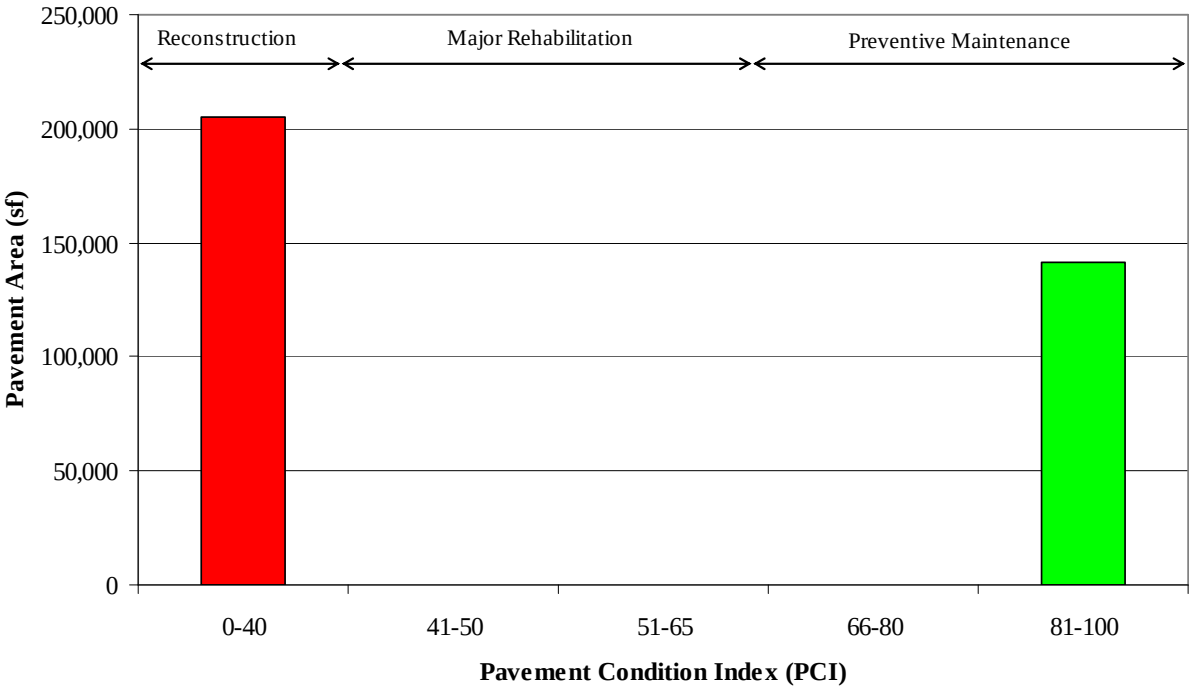
Figure 6. Overall condition.

The pavements at Audubon County Airport were inspected on September 13, 2006. The 2006 area-weighted condition of Audubon County Airport is 59, with conditions ranging from 31 to 100 (on a scale of 0 [failed] to 100 [excellent]). In 2003 the area-weighted PCI of the airport was 49.
