ATLANTIC MUNICIPAL AIRPORT PAVEMENT MANAGEMENT REPORT

Prepared For:
Iowa Department of Transportation
Office of Aviation

Prepared By:
Applied Pavement Technology, Inc.

December 2010

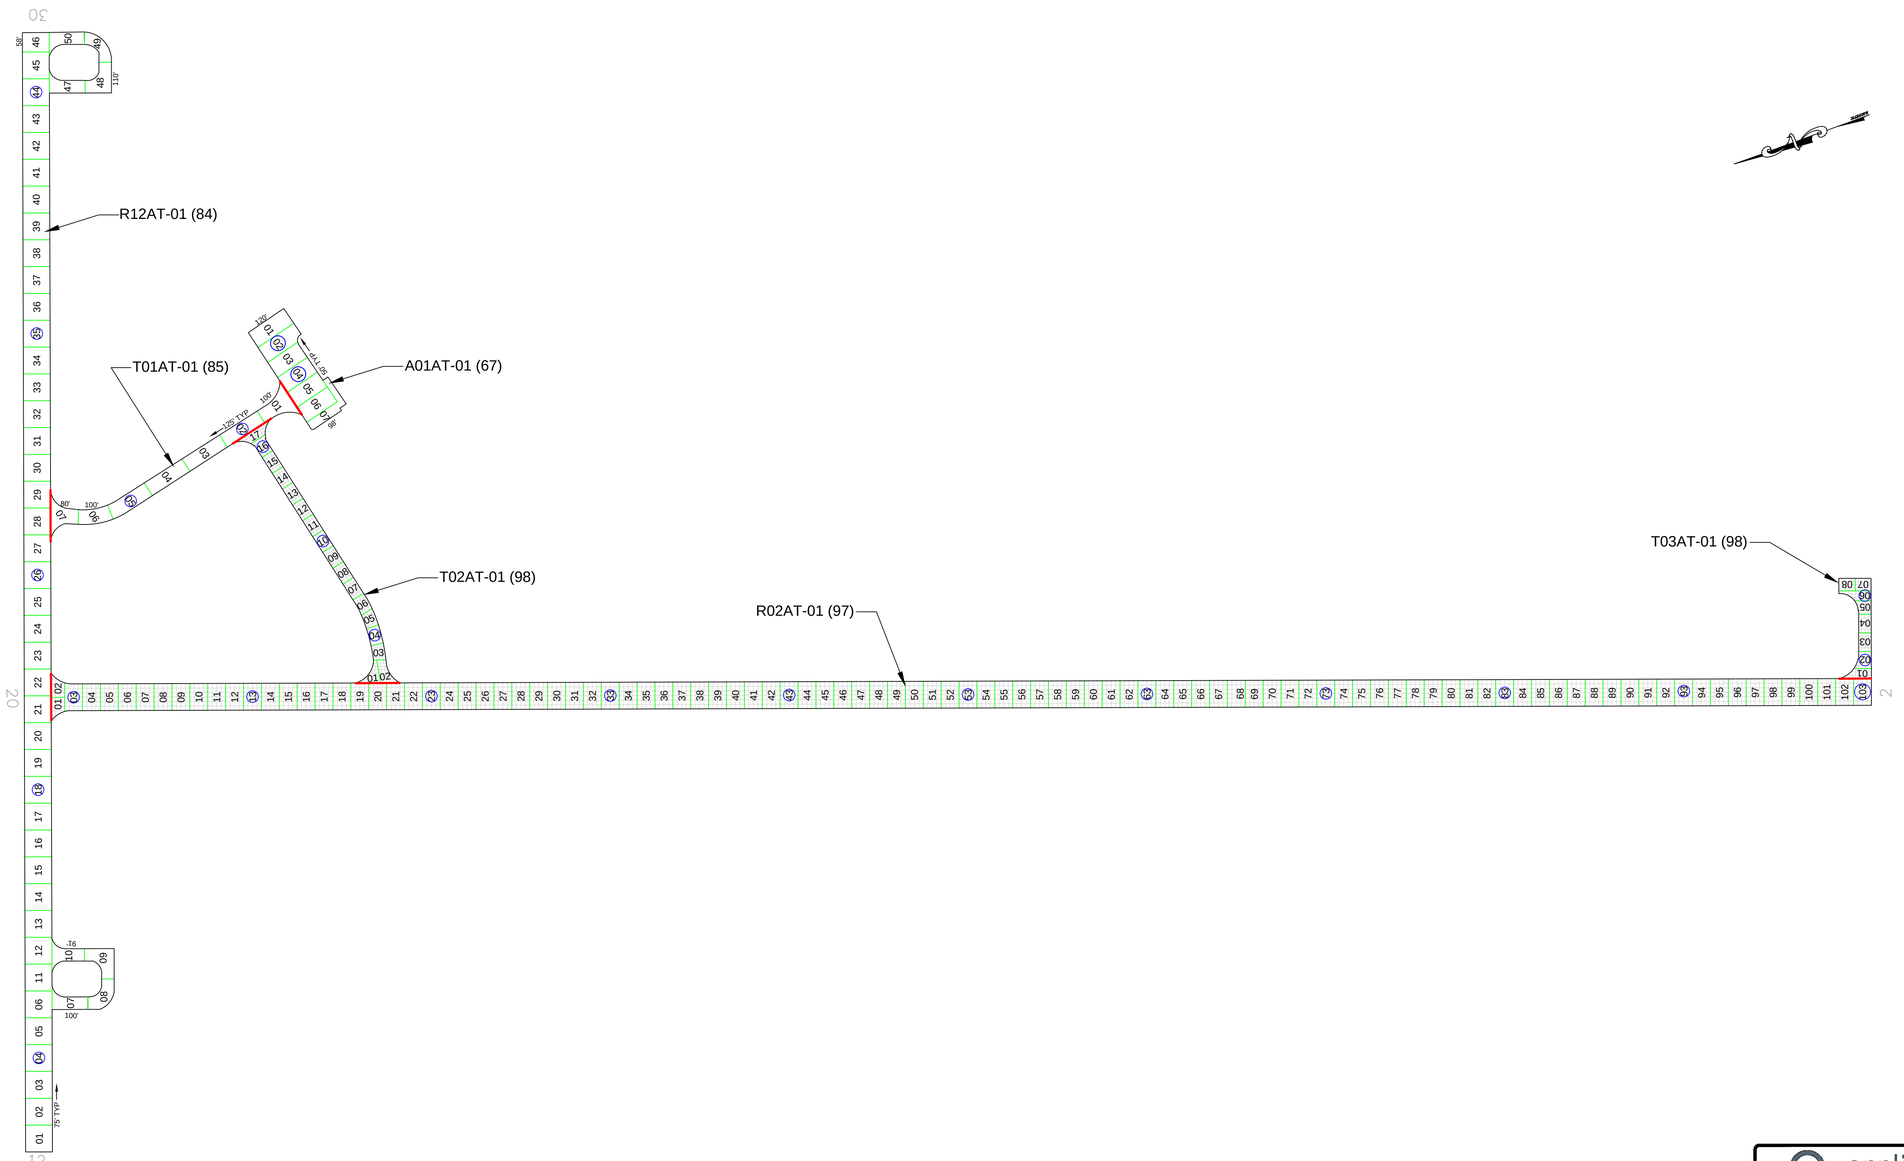
FIGURE 3. NETWORK DEFINITION MAP.

Figure 3 is a network definition map that identifies the pavements at Atlantic Municipal Airport that were evaluated during this project. This map shows how the pavement network was divided into branches, sections, and sample units for pavement management purposes. It also shows the nomenclature used in the MicroPAVER pavement management database to identify the different pavement areas.

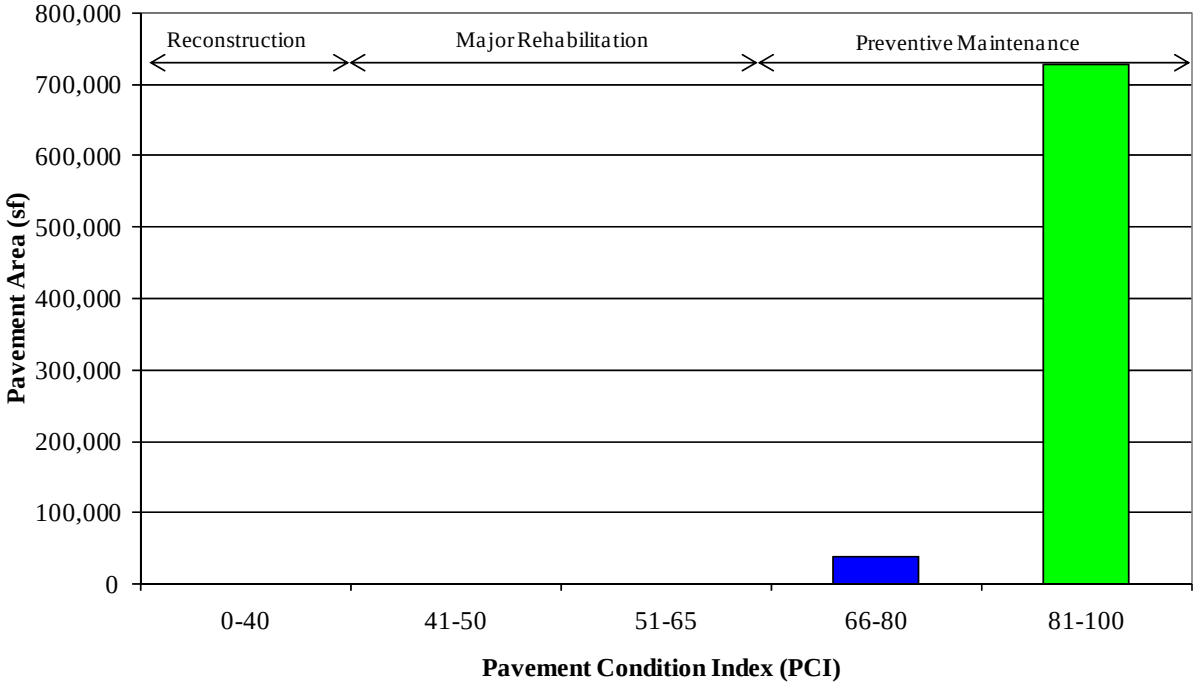
Figure 6. Overall condition.

The pavements at Atlantic Municipal Airport were inspected on September 16, 2010. The 2010 area-weighted condition of Atlantic Municipal Airport is 91, with conditions ranging from 67 to 98 (on a scale of 0 [failed] to 100 [excellent]). During the previous pavement inspection in 2006, the area-weighted PCI of the airport was 90.

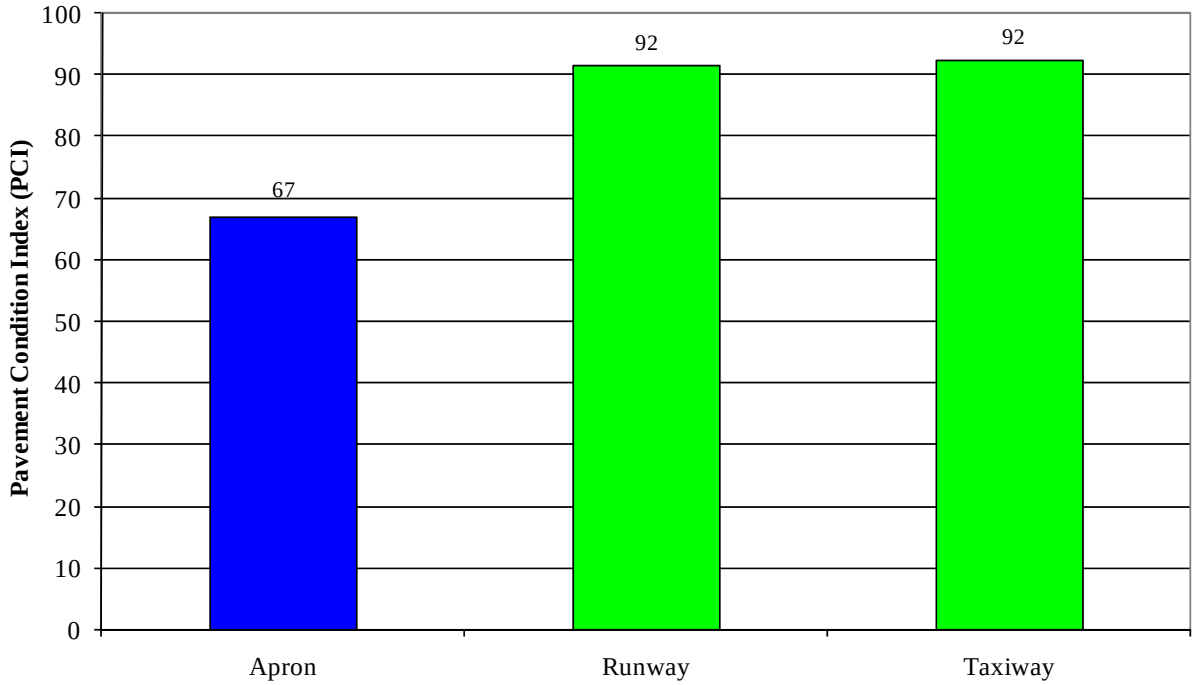
Figure 7. Condition by use.

(Values on chart are area weighted)

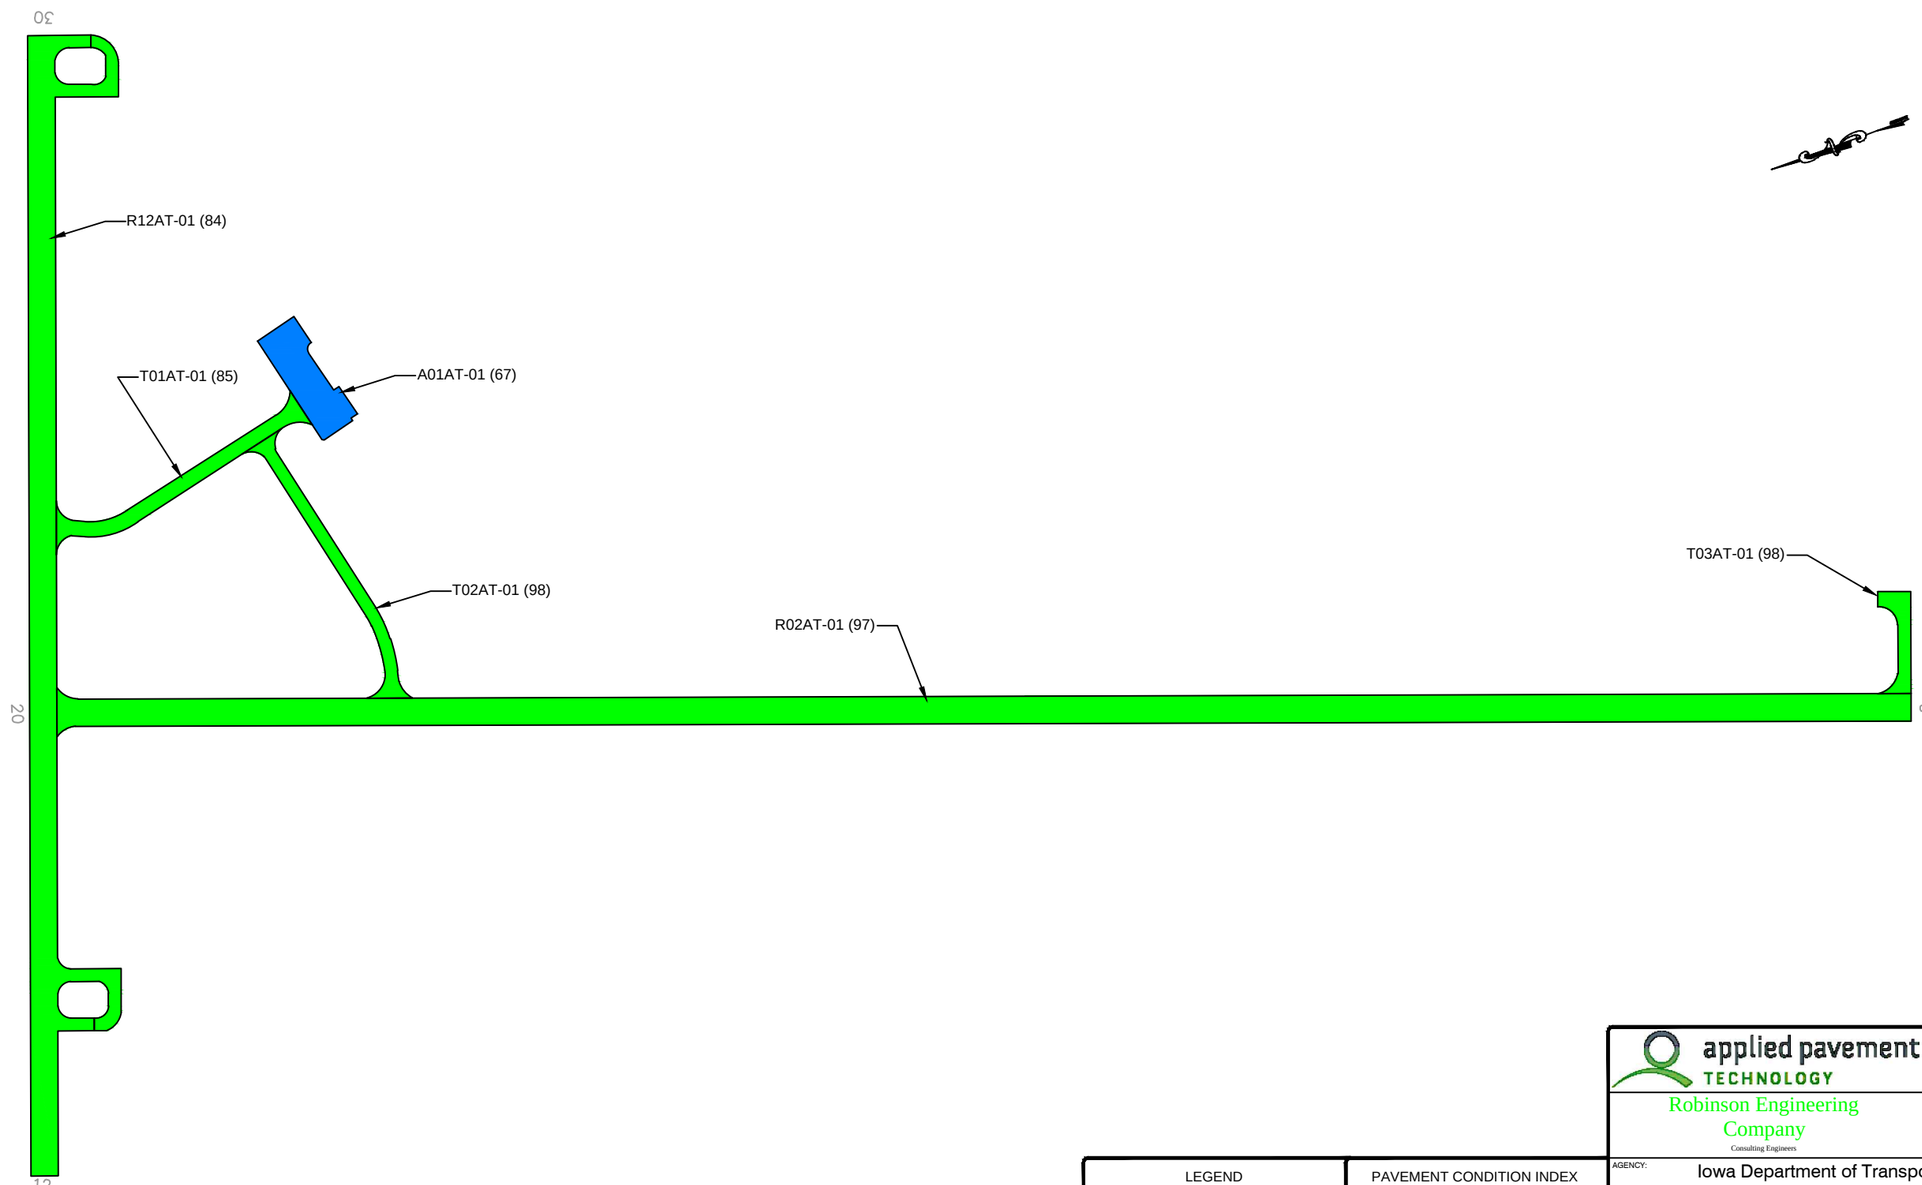
FIGURE 8. PCI MAP.

Figures 6 and 7 provide graphs summarizing the overall condition of the pavements at the Atlantic Municipal Airport. Figure 8 is a map that displays the condition of the pavements evaluated. Table 1 summarizes the results of the pavement evaluation. Appendix C presents photographs taken during the PCI inspection, and Appendix D contains detailed information on the distresses observed during the visual survey. Appendix E includes detailed work history
