WASHINGTON MUNICIPAL AIRPORT PAVEMENT MANAGEMENT REPORT

Prepared For:
Iowa Department of Transportation
Office of Aviation

Prepared By:
Applied Pavement Technology, Inc.

December 2011

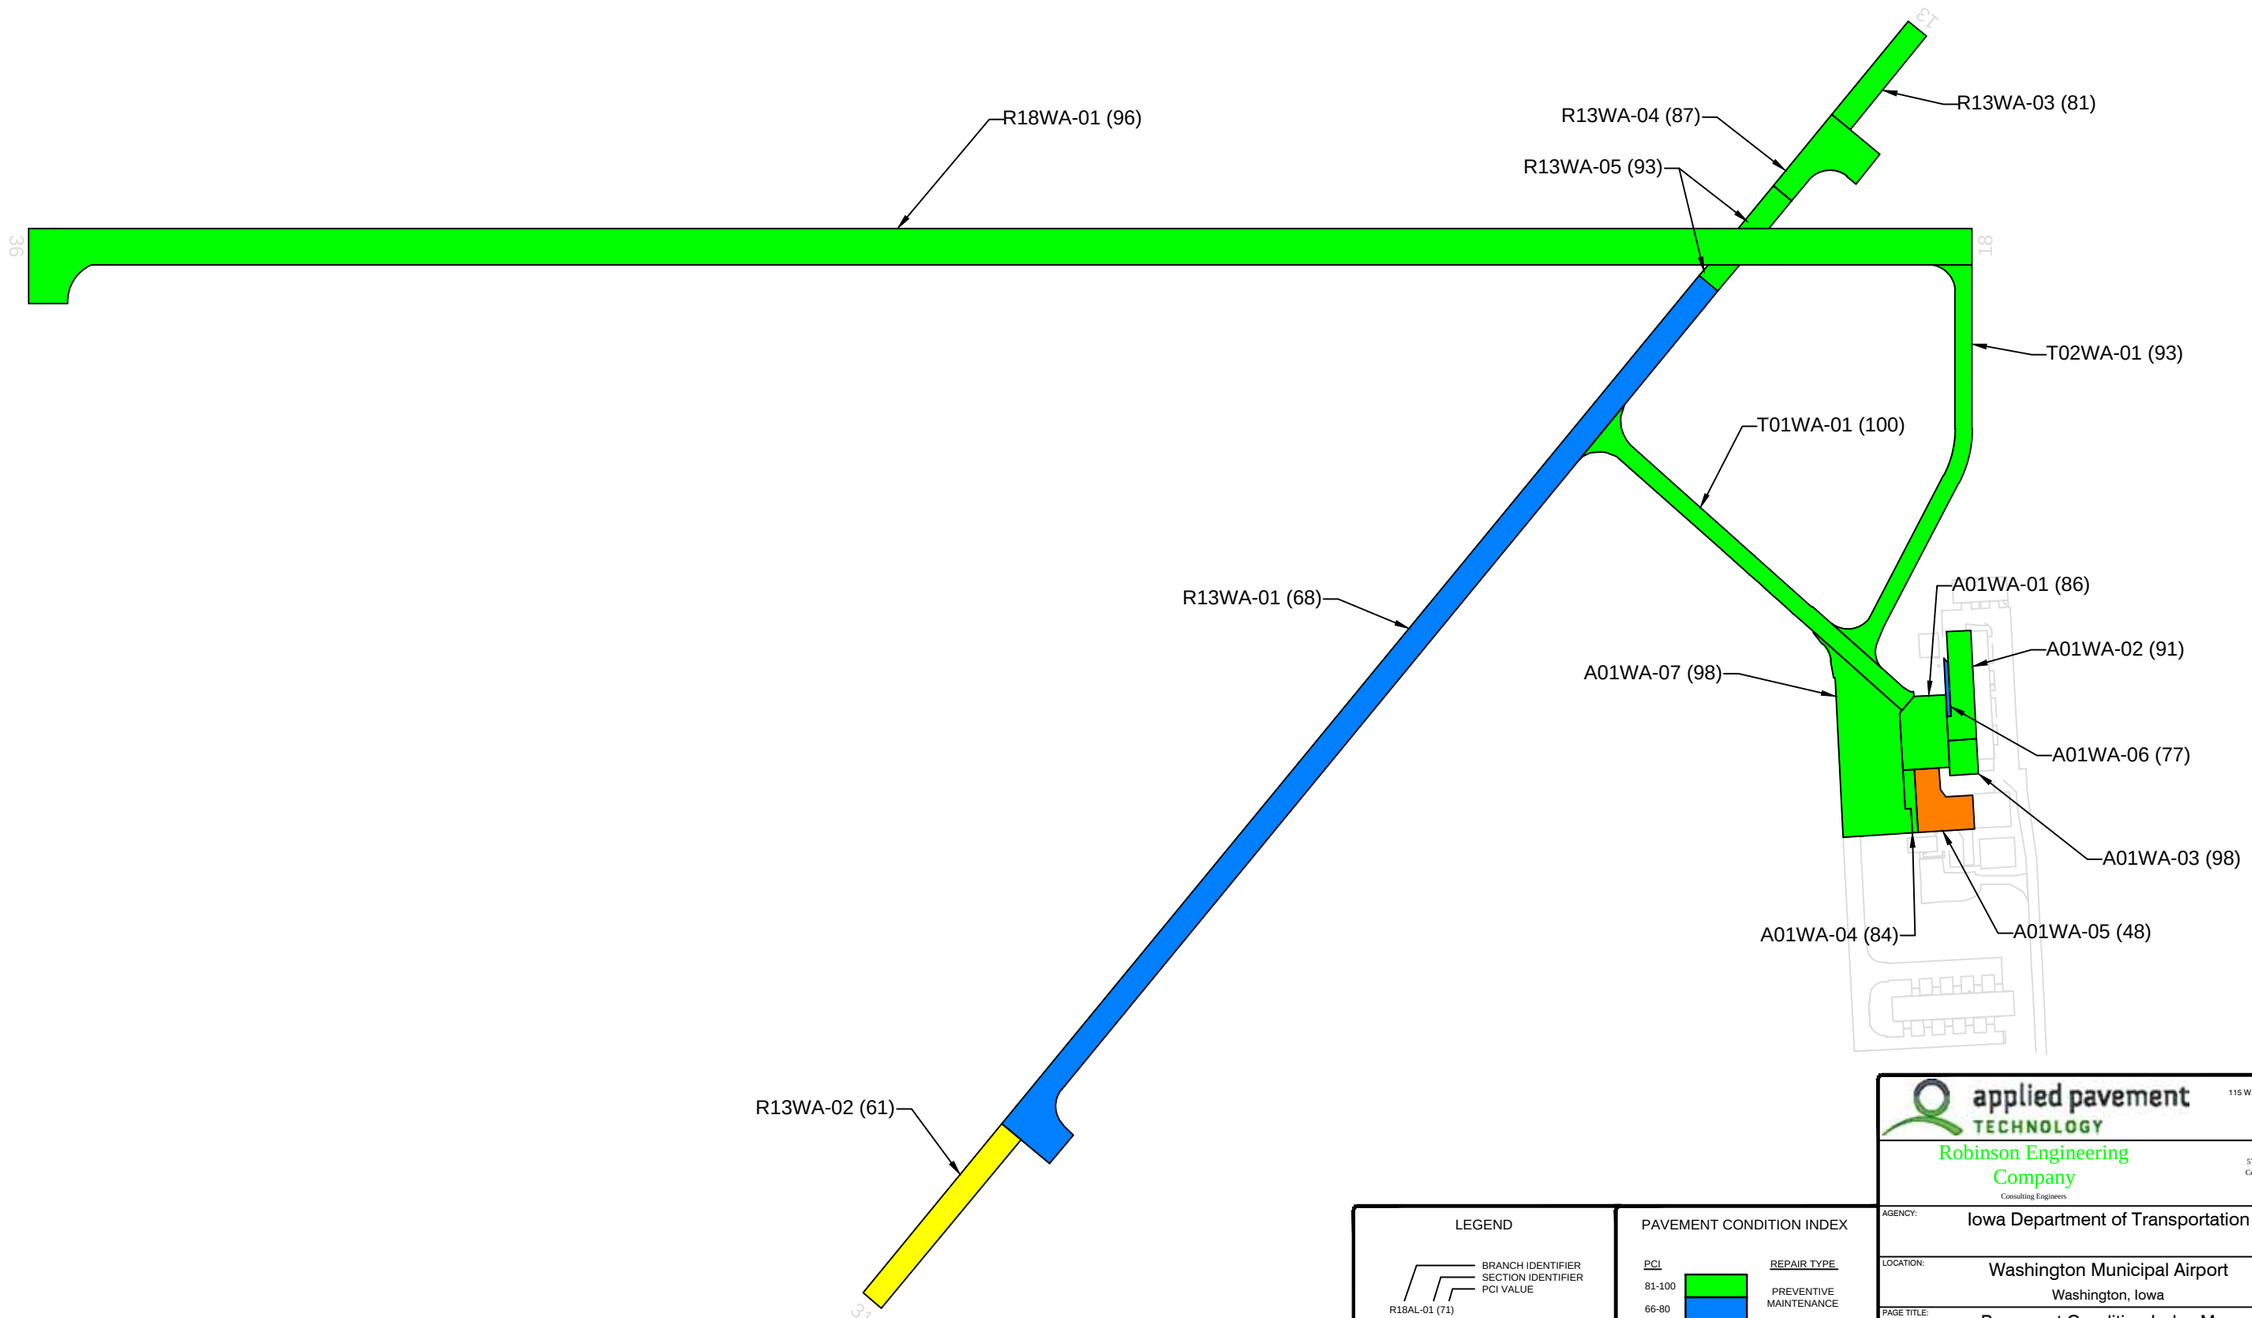
FIGURE 8. PCI MAP.

The pavements at Washington Municipal Airport were inspected on September 8, 2011. The 2011 area-weighted condition of Washington Municipal Airport is 88, with conditions ranging from 48 to 100 (on a scale of 0 [failed] to 100 [excellent]). During the previous pavement inspection in 2008, the area-weighted PCI of the airport was 90.

Runway 18-36 consists of one section in excellent condition. Low- and medium-severity joint seal damage was identified along with small amounts of low-severity joint spalling, corner spalling, and durability cracking. An additional sample unit was recorded where high-severity joint spalling was observed.

Runway 13-31 is defined by five sections. Section 01, the majority of the runway, is in satisfactory condition with high-severity joint seal damage recorded throughout. Moderate quantities of low- and medium-severity joint spalling, corner spalling, and longitudinal, transverse, and diagonal (LTD) cracking were noted. Shrinkage cracking; low-severity shattered slabs, large patching, shrinkage cracking, and corner breaking; and low- and medium-severity durability cracking were also observed. Section 02, the runway extension on the southeast end of the runway, is in fair condition with medium- and high-severity joint seal damage recorded. Low- and medium-severity durability cracking, LTD cracking, and corner spalling were also observed. In addition, isolated amounts of low- and high-severity joint spalling and shrinkage cracking were identified. Section 03, an extension on the northwest end of the runway, is in good condition with high-severity joint seal damage and small amounts of low-severity durability cracking and faulting recorded. Section 04, located west of Runway 18-36, is in good condition with medium-severity joint seal damage and small amounts of low- and medium-severity joint spalling identified. Section 05 is located adjacent to Runway 18-36 on both sides. This section is in good condition with only medium-severity joint seal damage recorded at the time of inspection.

Taxiway 01 connects the apron area with Runway 13-31 and is comprised of one section. Section 01 is in excellent condition with no distresses identified at the time of inspection.

Taxiway 02 connects the apron area with Runway 18-36. This taxiway contains one section in good condition with low- and medium-severity joint seal damage and low-severity large patching recorded.

Apron 01 is defined by seven sections. Sections 03 and 07 are both in excellent condition with only low-severity joint seal damage recorded. Sections 01, 02, and 04 are in good condition. Low-severity joint seal damage was recorded in Sections 02 and 04, while medium-severity joint seal damage was identified in Section 01. Additional distresses were observed in each section, including low- and medium-severity joint spalling in Section 01, low-severity faulting in Section 04, and low-severity large patching and high-severity joint spalling in Section 02. Section 05 is in poor condition with medium-severity joint seal damage recorded. Moderate quantities of low-severity LTD cracking and low- and medium-severity corner breaks were noted. Small amounts of low-severity shattered slabs, joint spalling, corner spalling, large patching, and shrinkage cracking were also observed. Section 06 is in satisfactory condition with medium-severity joint seal damage and corner breaking identified along with low-severity LTD cracking.

Year	Branch[1]	Section[1]	Type of Repair[2]	Estimated Cost[3]
2012	A01WA	05	Major Rehabilitation	$103,003
	R13WA	02	Major Rehabilitation	$165,483
			Total:	**$268,486**
