ALGONA MUNICIPAL AIRPORT
PAVEMENT MANAGEMENT REPORT

Prepared By:
Applied Pavement Technology, Inc.

January 2010

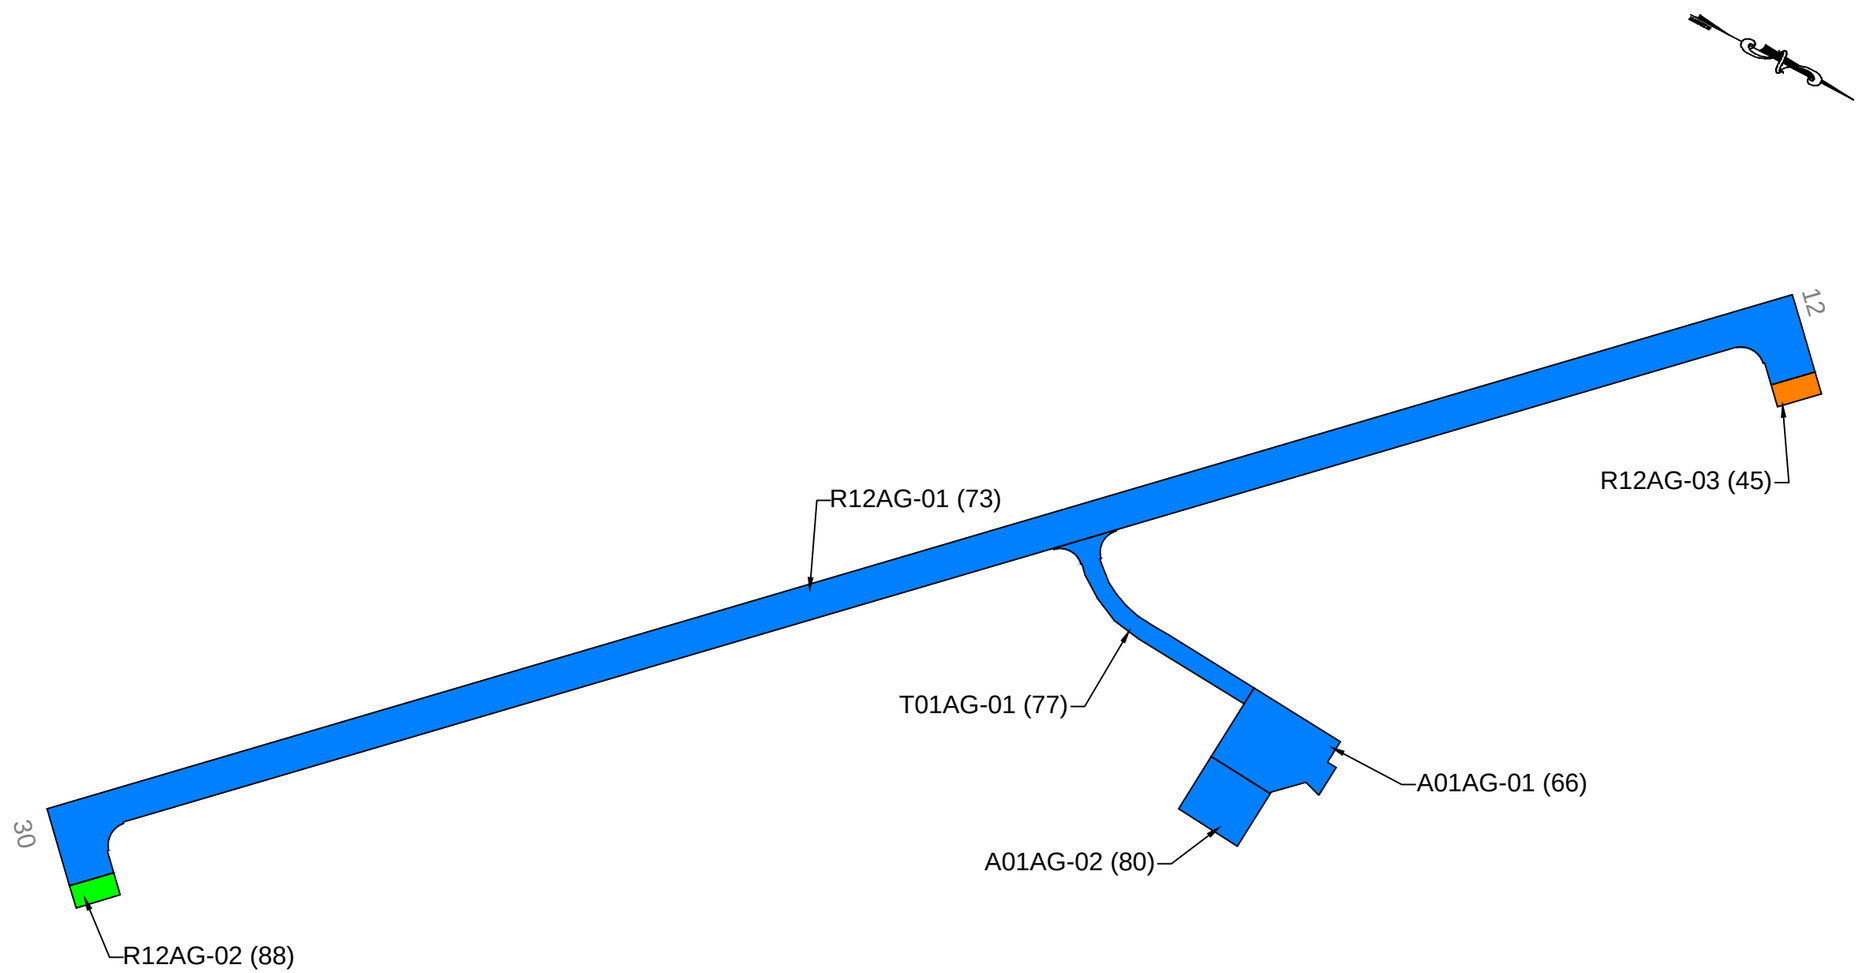
FIGURE 8. PCI MAP.

The pavements at Algona Municipal Airport were inspected on September 17, 2009. The 2009 area-weighted condition of Algona Municipal Airport is 73, with conditions ranging from 45 to 88 (on a scale of 0 [failed] to 100 [excellent]). During the previous pavement inspection in 2005, the area-weighted PCI of the airport was 79.
