BOONE MUNICIPAL AIRPORT
PAVEMENT MANAGEMENT REPORT

Prepared For:
Iowa Department of Transportation
Office of Aviation

Prepared By:
Applied Pavement Technology, Inc.

January 2007

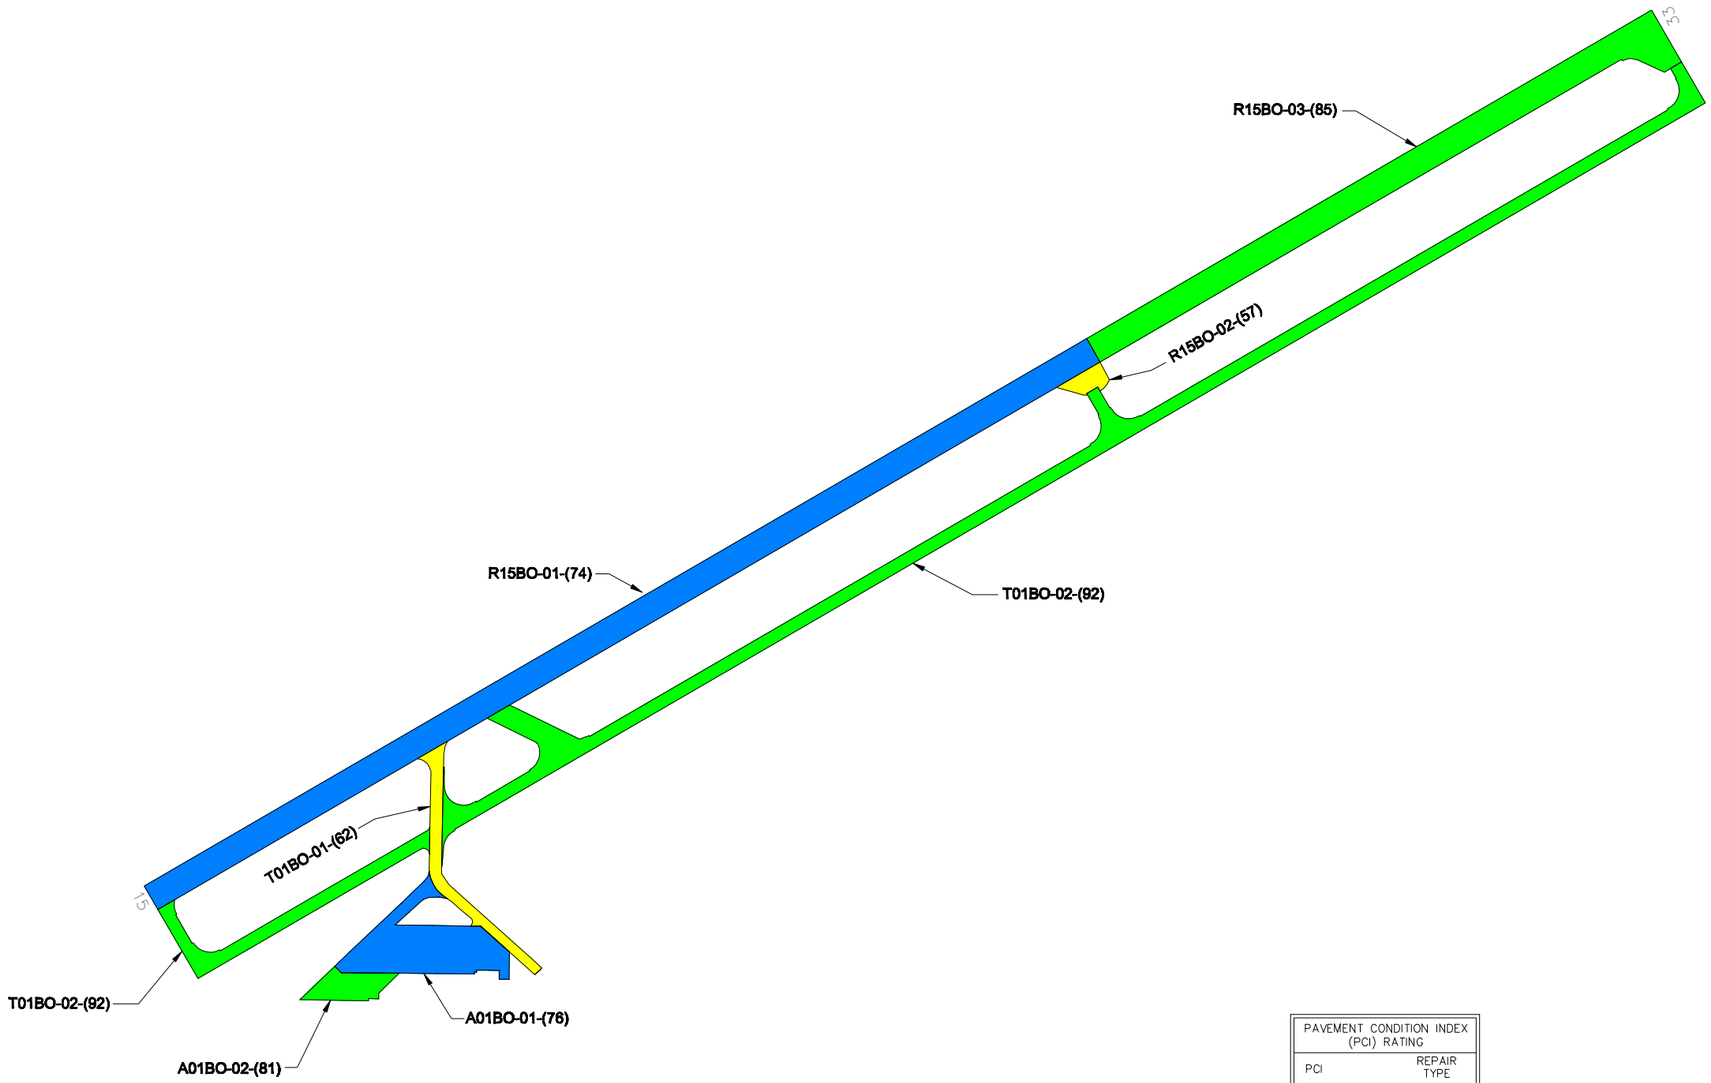
PAGE TITLE: Pavement Condition Index Map

The pavements at Boone Municipal Airport were inspected on September 16, 2006. The 2006 area-weighted condition of Boone Municipal Airport is 81, with conditions ranging from 57 to 92 (on a scale of 0 [failed] to 100 [excellent]). In 2003 the area-weighted PCI of the airport was 83.

Figures 6 and 7 provide graphs summarizing the overall condition of the pavements at the Boone Municipal Airport. Figure 8 is a map that displays the condition of the pavements evaluated. Table 1 summarizes the results of the pavement evaluation. Appendix C presents photographs taken during the PCI inspection, and Appendix D contains detailed information on the distresses observed during the visual survey. Appendix E includes detailed work history information that
