BURLINGTON-SOUTHEAST IOWA REGIONAL AIRPORT PAVEMENT MANAGEMENT REPORT

Prepared By:
Applied Pavement Technology, Inc.

December 2011

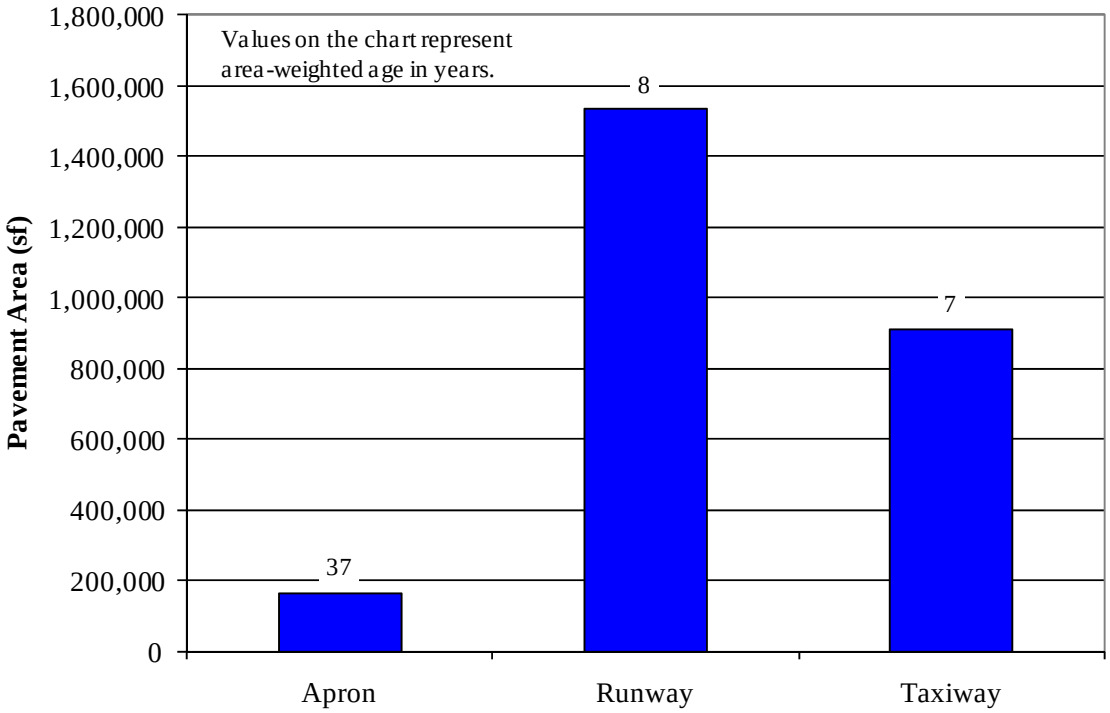
Figure 2. Pavement inventory.

Approximately 2,612,216 square feet of runway, taxiway, and apron pavements were evaluated at Burlington-Southeast Iowa Regional Airport, as shown in Figure 2. This figure also shows the area-weighted age of the pavements.

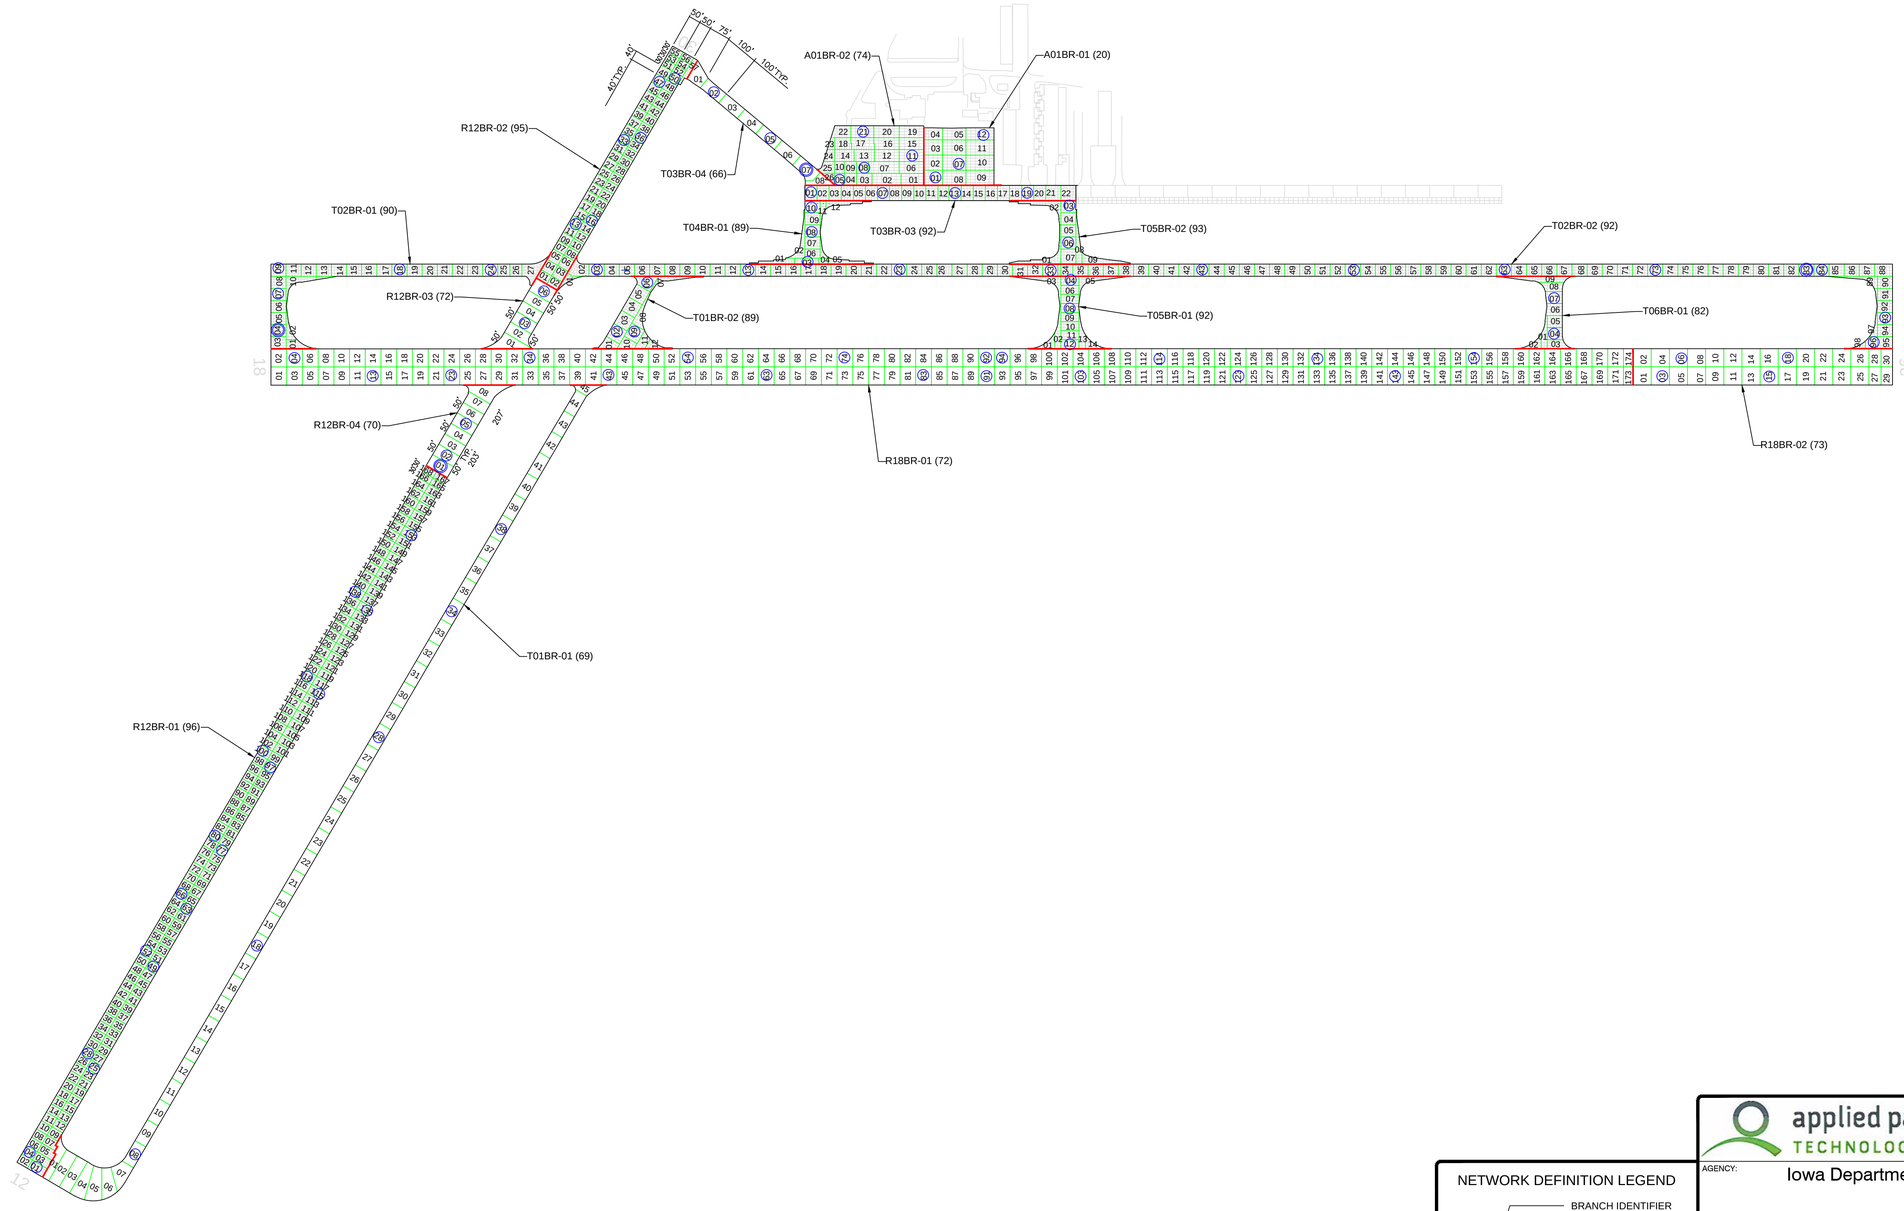
FIGURE 3. NETWORK DEFINITION MAP.

Figure 3 is a network definition map that identifies the pavements at Burlington-Southeast Iowa Regional Airport that were evaluated during this project. This map shows how the pavement network was divided into branches, sections, and sample units for pavement management purposes. It also shows the nomenclature used in the MicroPAVER pavement management database to identify the different pavement areas.

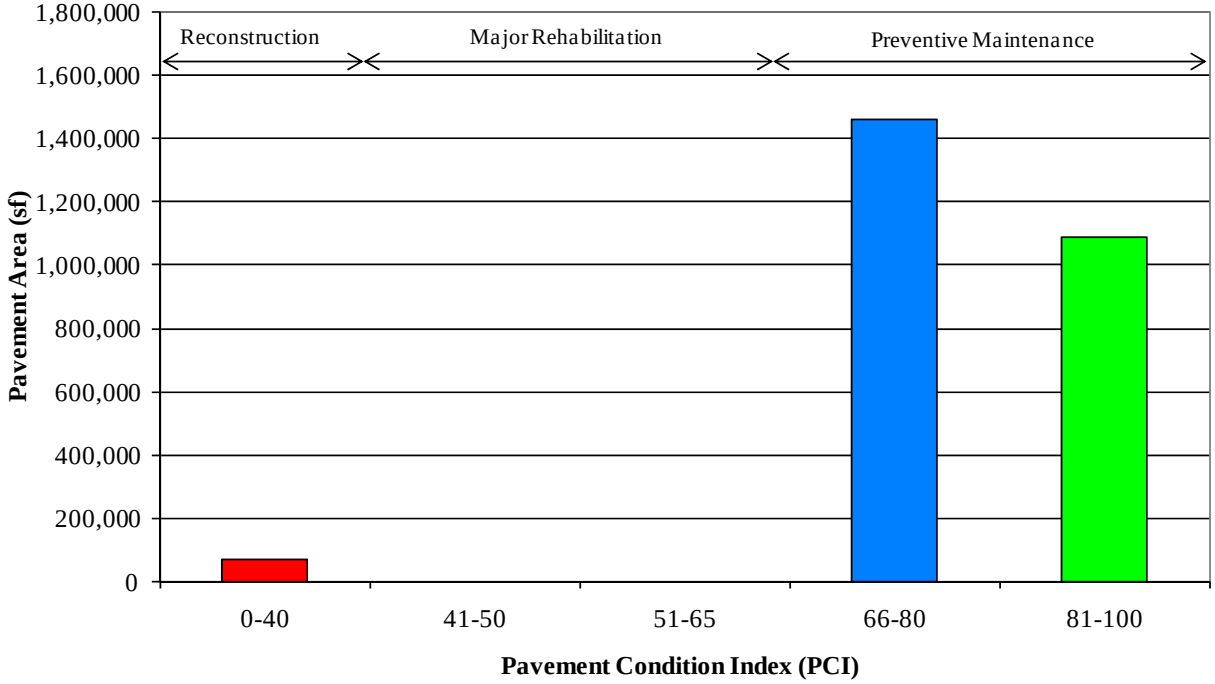
Figure 6. Overall condition.

The pavements at Burlington-Southeast Iowa Regional Airport were inspected on September 8, 2011. The 2011 area-weighted condition of Burlington-Southeast Iowa Regional Airport is 79, with conditions ranging from 20 to 96 (on a scale of 0 [failed] to 100 [excellent]). During the previous pavement inspection in 2008, the area-weighted PCI of the airport was 85.

Figures 6 and 7 provide graphs summarizing the overall condition of the pavements at Burlington-Southeast Iowa Regional Airport. Figure 8 is a map that displays the condition of the pavements evaluated. Table 1 summarizes the results of the pavement evaluation. Appendix C presents photographs taken during the PCI inspection, and Appendix D contains detailed information on the distresses observed during the visual survey. Appendix E includes detailed
