WAVERLY MUNICIPAL AIRPORT
PAVEMENT MANAGEMENT REPORT

Prepared For:
Iowa Department of Transportation
Office of Aviation

Prepared By:
Applied Pavement Technology, Inc.

January 2010

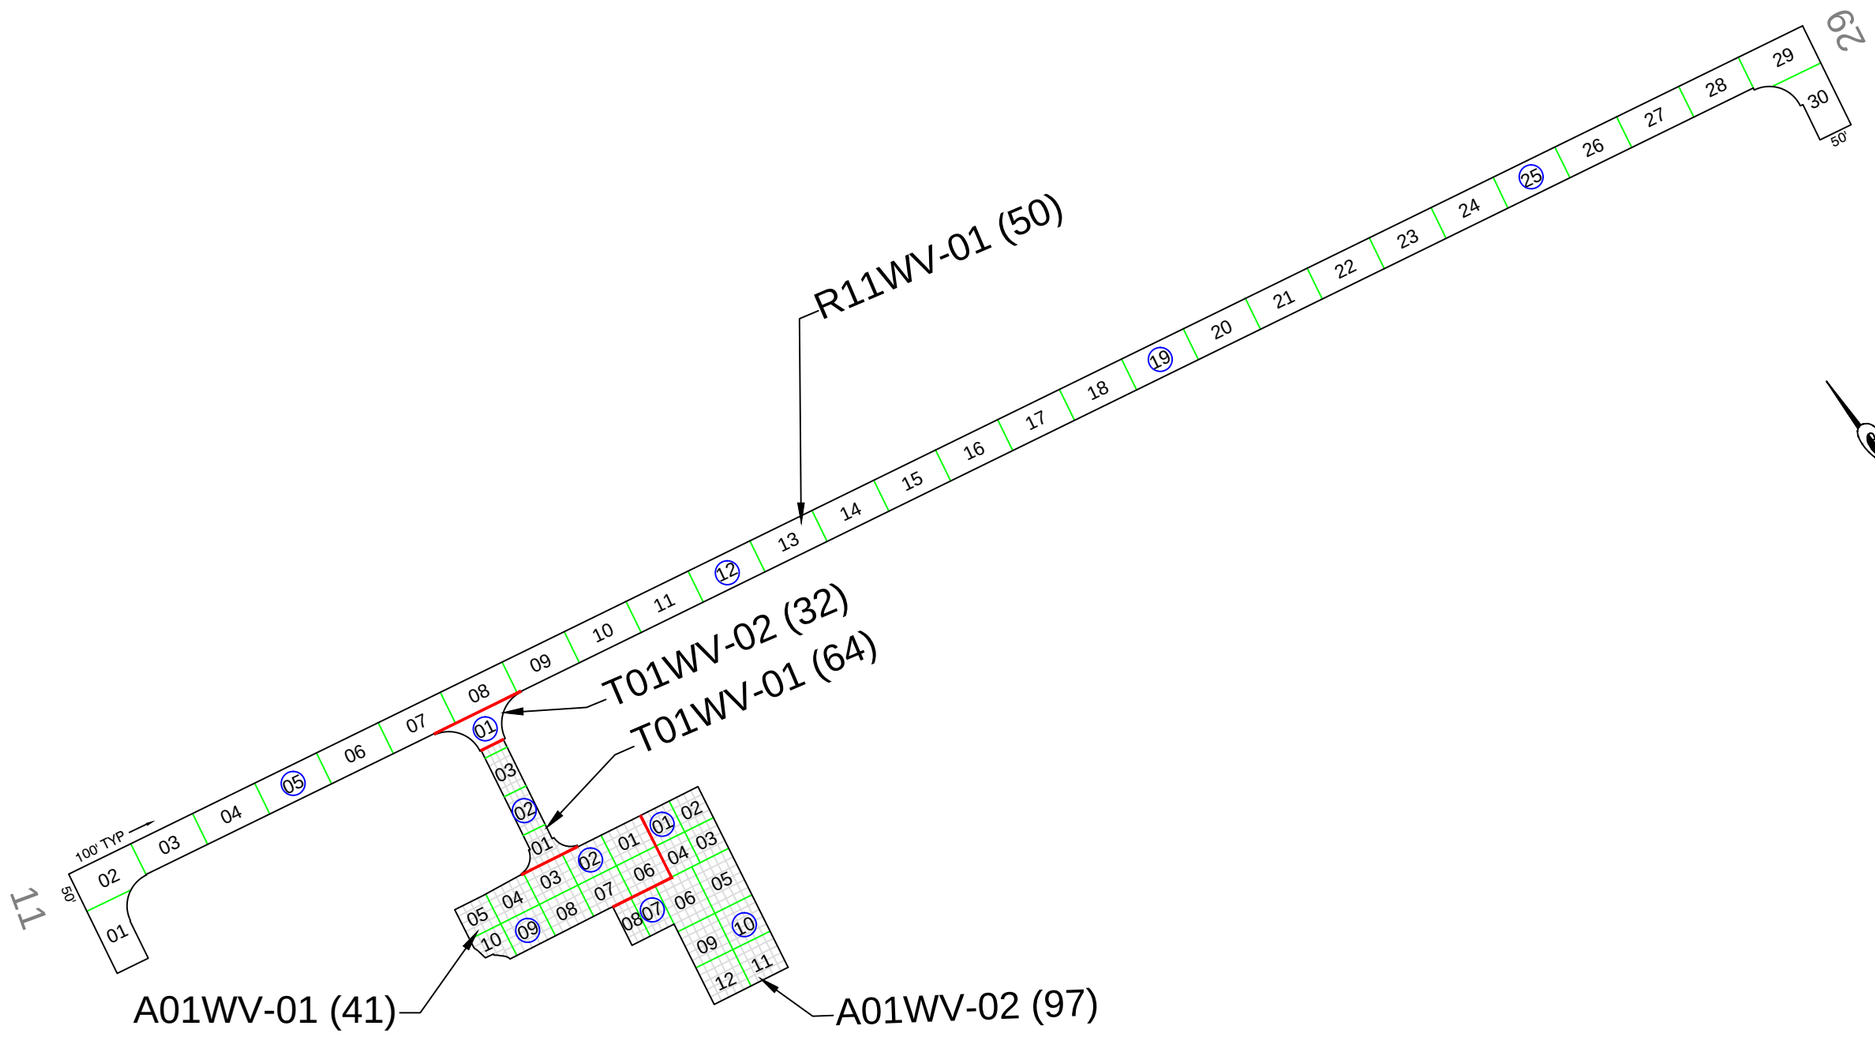
FIGURE 3. NETWORK DEFINITION MAP.

Figure 3 is a network definition map that identifies the pavements at Waverly Municipal Airport that were evaluated during this project. This map shows how the pavement network was divided into branches, sections, and sample units for pavement management purposes. It also shows the nomenclature used in the MicroPAVER pavement management database to identify the different pavement areas.

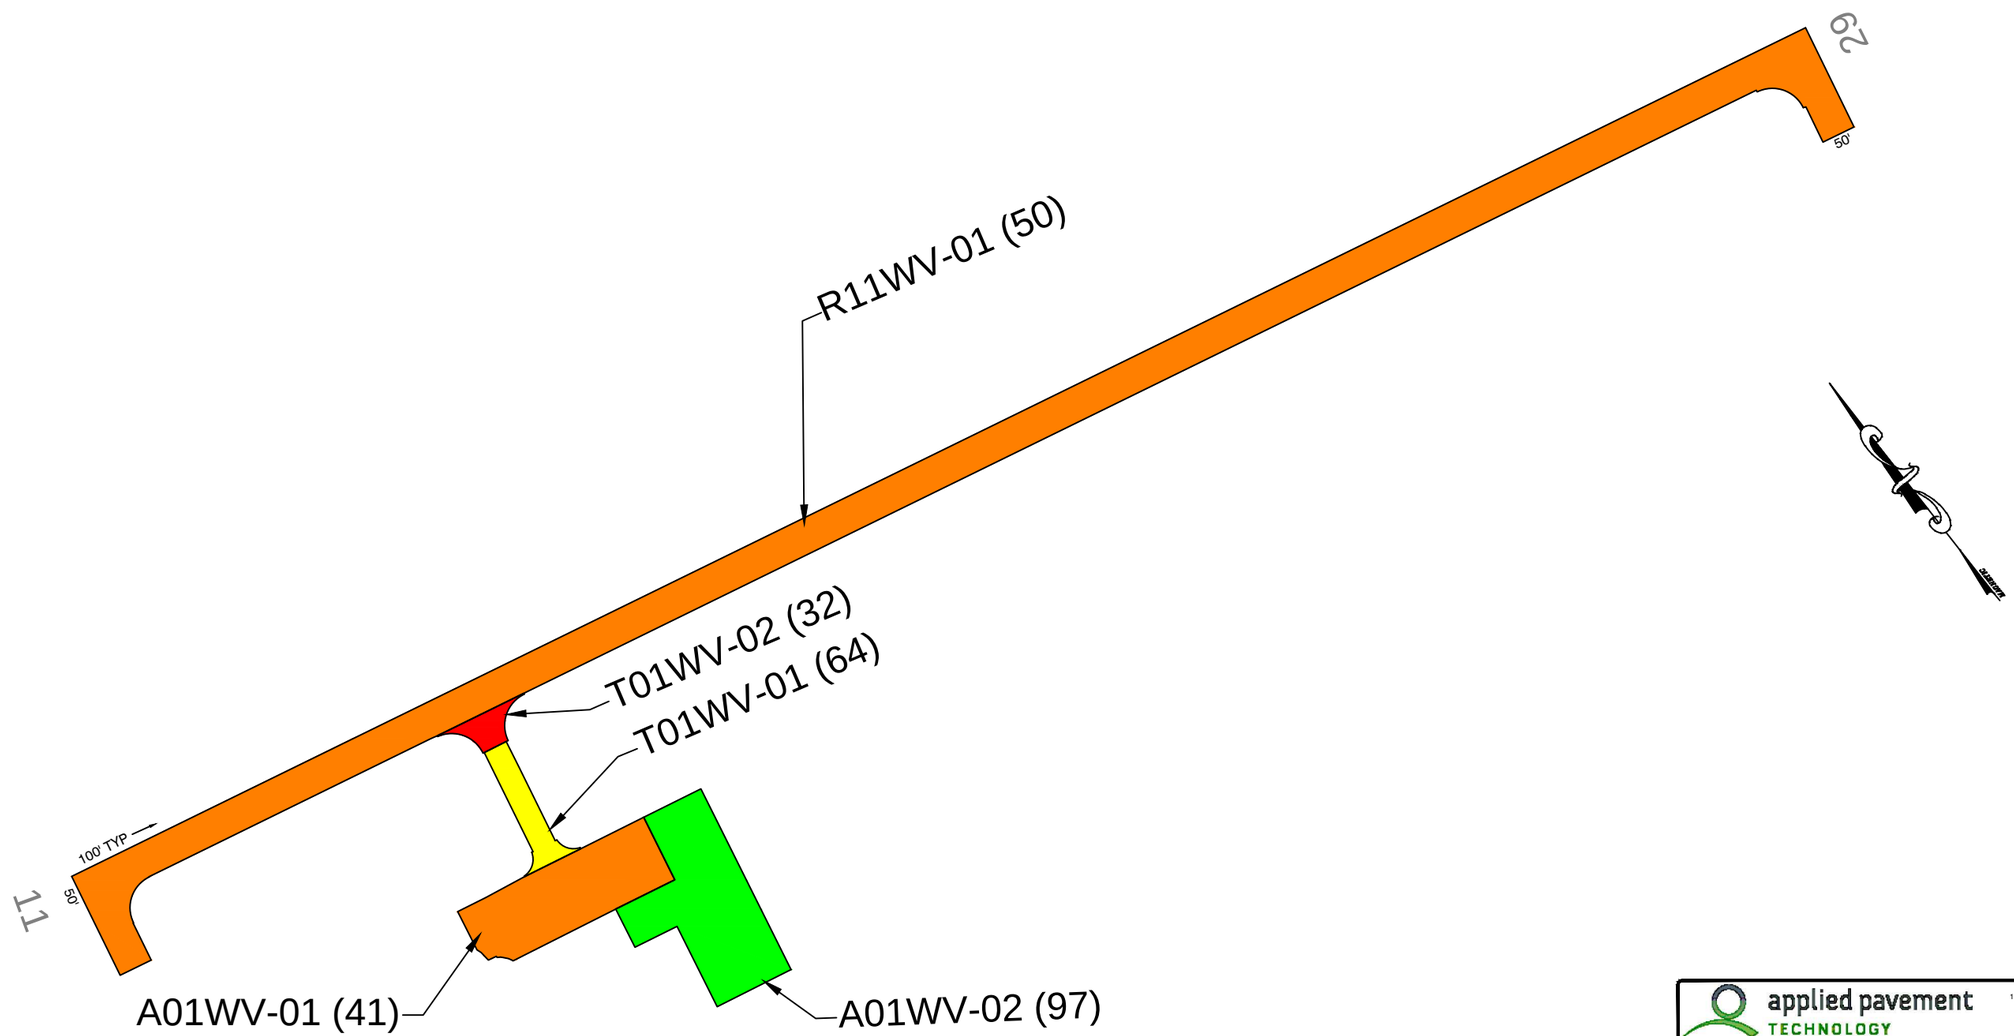
FIGURE 8. PCI MAP.

The pavements at Waverly Municipal Airport were inspected on September 20, 2009. The 2009 area-weighted condition of Waverly Municipal Airport is 57, with conditions ranging from 32 to 97 (on a scale of 0 [failed] to 100 [excellent]). During the previous pavement inspection in 2005, the area-weighted PCI of the airport was 79.

Runway 9-27 contains one section that is in poor condition with extensive amounts of low- and medium-severity longitudinal and transverse (L&T) cracking and medium-severity joint reflection cracking observed. Most of the low-severity cracks were unsealed and the medium-severity cracking was due to either failed crack sealant or unsealed crack widths greater than ¼ inch.

Two sections are defined in Taxiway 01. Section 01, located adjacent to the apron area, is in fair condition with medium-severity joint seal damage identified. Additionally, significant amounts of low- and medium-severity joint and corner spalling and small amounts of low-severity durability cracking, shrinkage cracking, and low-severity faulting were recorded. Section 02, located adjacent to the runway, is in failed condition. Extensive quantities of medium-severity joint reflection cracking were observed. In addition, small amounts of low- and medium-severity L&T cracking and isolated areas of low-severity swelling and high-severity raveling and weathering were noted. The majority of the low-severity cracking was sealed and the medium-severity cracking was due to either failed crack sealant or unsealed crack widths greater than ¼ inch.

The terminal apron area consists of two sections. Section 01, the western portion of the terminal apron, is in poor condition with medium-severity joint seal damage recorded. Extensive quantities of low- and medium-severity linear cracking, low-severity patching, and low- and medium-severity joint and corner spalling were also observed. In addition, small amounts of low-severity faulting and corner breaking and low- and medium-severity durability cracking were identified. Section 02, the eastern portion of the terminal apron, is in excellent condition with moderate amounts of low-severity joint seal damage observed. Additionally, isolated areas of low-severity patching, corner spalling, and joint spalling were recorded.
