MANCHESTER MUNICIPAL AIRPORT
PAVEMENT MANAGEMENT REPORT

Prepared By:
Applied Pavement Technology, Inc.

November 2003

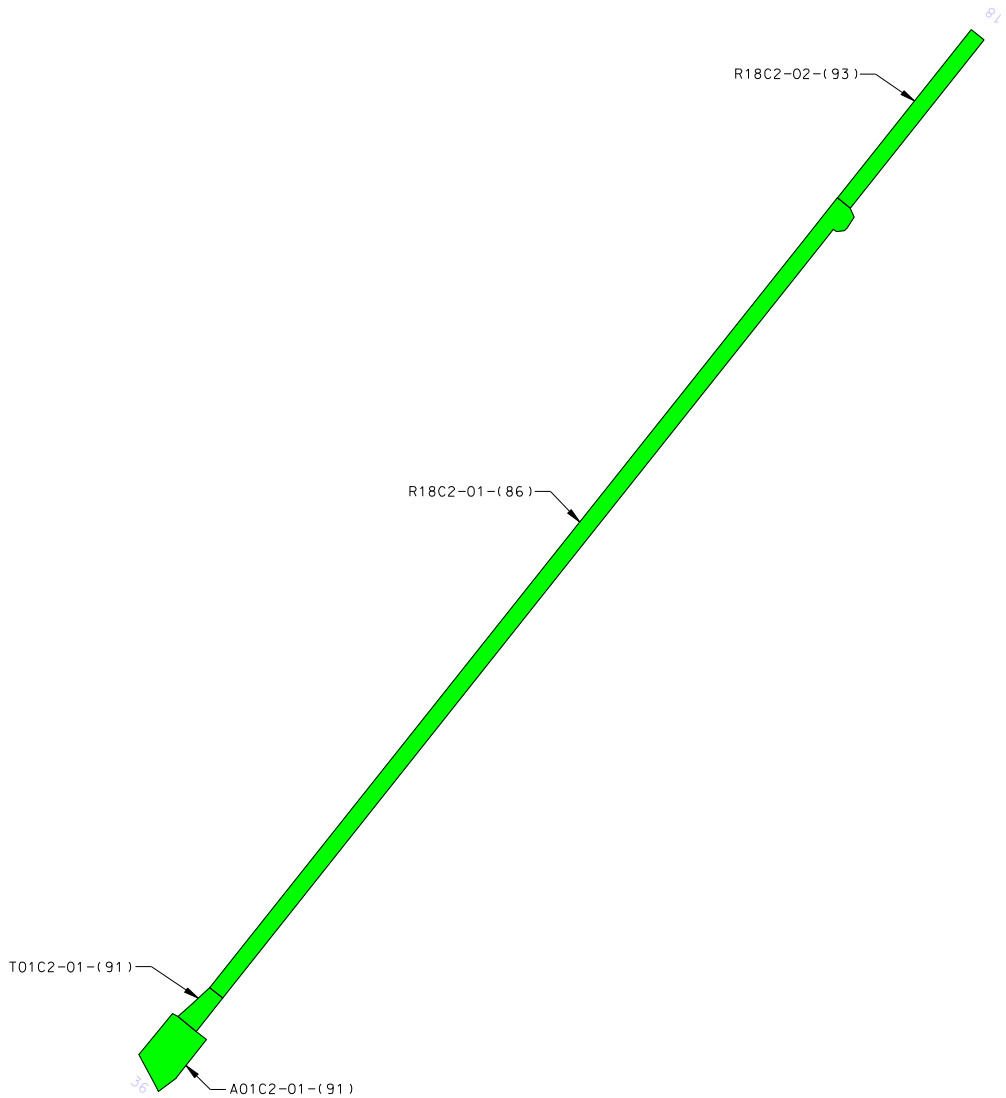
PAVEMENT CONDITION INDEX MAP

The pavements at Manchester Municipal Airport were inspected on November 23, 2003. The 2003 area-weighted condition of Manchester Municipal Airport is 88, with conditions ranging from 86 to 93 (on a scale of 0 [failed] to 100 [excellent]).
