CLARION MUNICIPAL AIRPORT PAVEMENT MANAGEMENT REPORT

Prepared By:
Applied Pavement Technology, Inc.

December 2010

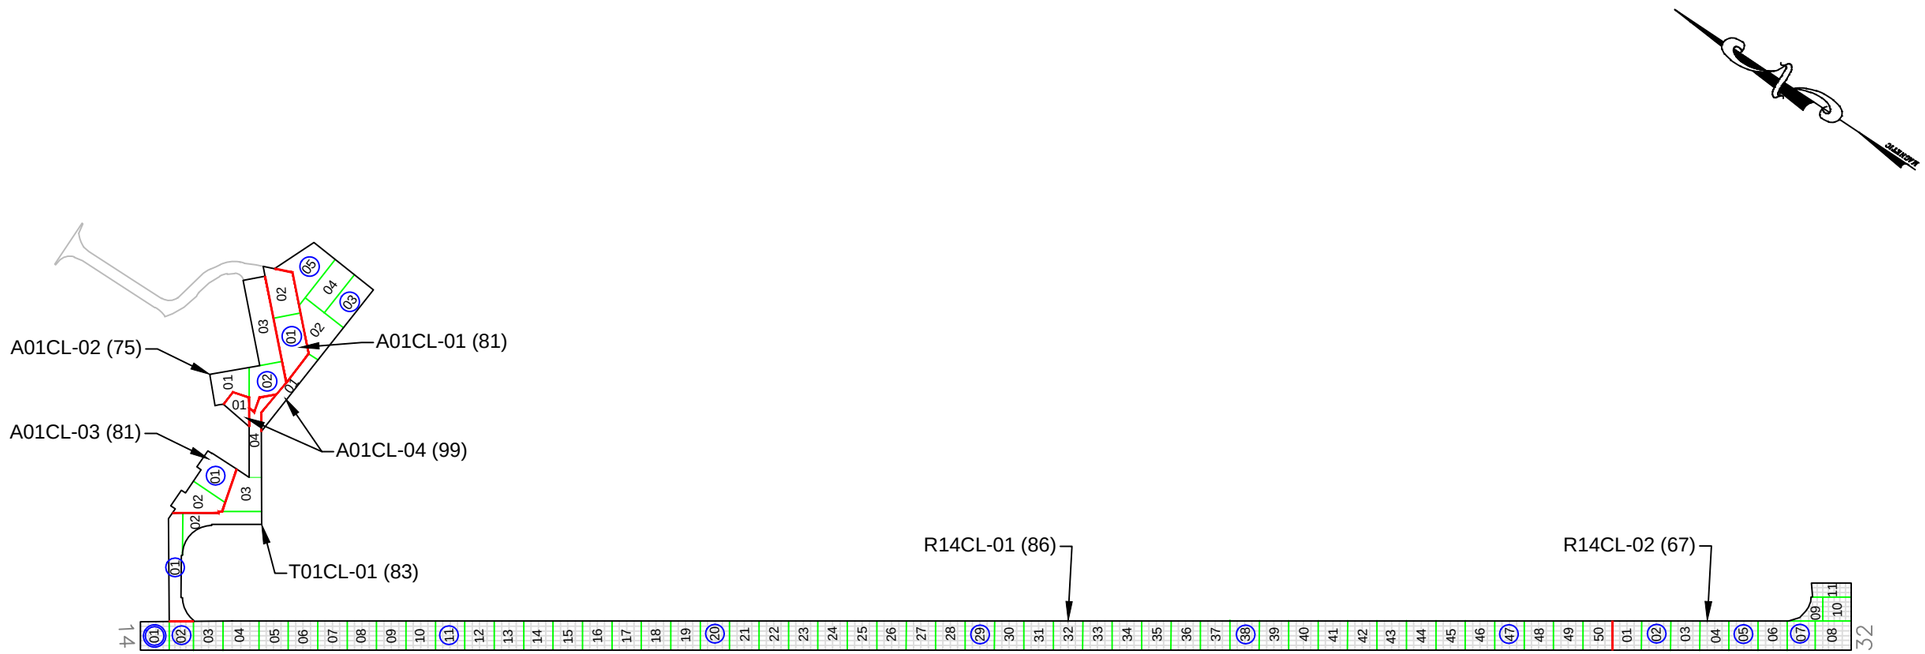
FIGURE 3. NETWORK DEFINITION MAP.

Runway 14-32 is defined by two sections. Section 01, the majority of the runway, is in good condition with medium- and high-severity joint seal damage recorded throughout. Small amounts of low-severity durability cracking and high-severity joint spalling and popouts were also identified. Section 02, the southern portion of the runway, is in satisfactory condition with high-severity joint seal damage observed. Additionally, small amounts of low-, medium-, and high-severity corner spalling and medium- and high-severity joint spalling were noted at the time of inspection. Isolated amounts of medium-severity linear cracking were also recorded.

Taxiway 01 consists of one section that is in good condition with low- and medium-severity longitudinal and transverse (L&T) cracking recorded throughout. All of the low-severity cracking was unsealed, and the medium-severity cracking was due to unsealed crack widths greater than ¼ inch. In addition, an isolated area of low-severity depression was also observed.

Four sections are defined in the apron area (Apron 01). Sections 01 and 03 are in good condition with low- and medium-severity L&T cracking identified. Section 02 is in satisfactory condition with low- and medium-severity L&T cracking observed. All of the low-severity cracking was unsealed, and the medium-severity cracking was due to unsealed crack widths greater than ¼ inch. Section 04 was recently constructed and is in excellent condition with isolated areas of low-severity depression recorded during the inspection.

Year	Branch[1]	Section[1]	Type of Repair[2]	Estimated Cost[3]
2014	R14CL	02	Major Rehabilitation	$304,471
			Total:	**$304,471**

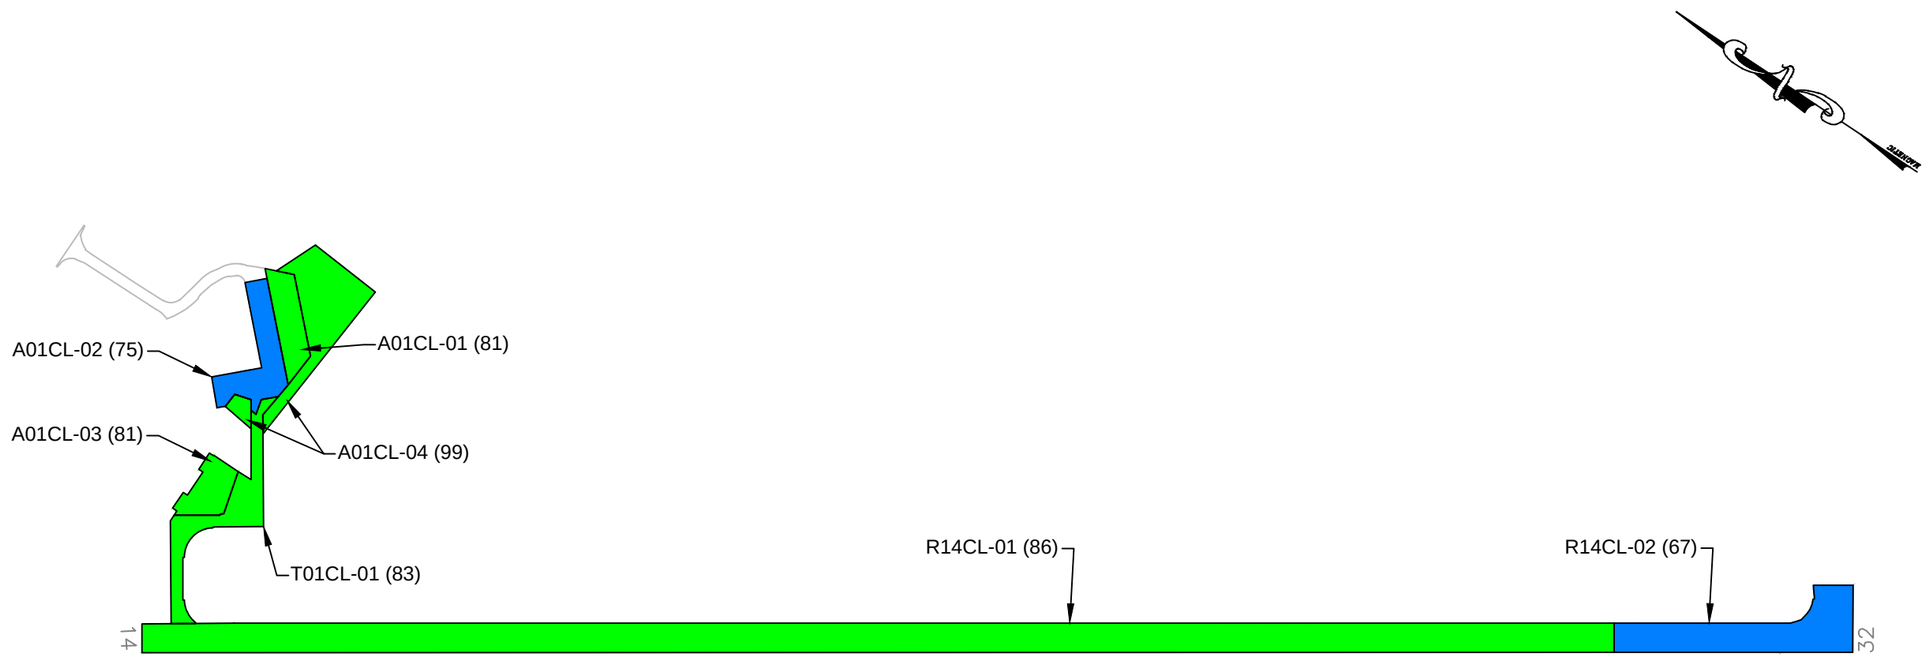
FIGURE 8. PCI MAP.

The pavements at Clarion Municipal Airport were inspected on September 19, 2010. The 2010 area-weighted condition of Clarion Municipal Airport is 84, with conditions ranging from 67 to 99 (on a scale of 0 [failed] to 100 [excellent]). During the previous pavement inspection in 2006, the area-weighted PCI of the airport was 88.

Figures 6 and 7 provide graphs summarizing the overall condition of the pavements at the Clarion Municipal Airport. Figure 8 is a map that displays the condition of the pavements evaluated. Table 1 summarizes the results of the pavement evaluation. Appendix C presents photographs taken during the PCI inspection, and Appendix D contains detailed information on the distresses observed during the visual survey. Appendix E includes detailed work history
