COUNCIL BLUFFS MUNICIPAL AIRPORT PAVEMENT MANAGEMENT REPORT

Prepared For:
Iowa Department of Transportation
Office of Aviation

Prepared By:
Applied Pavement Technology, Inc.

January 2010

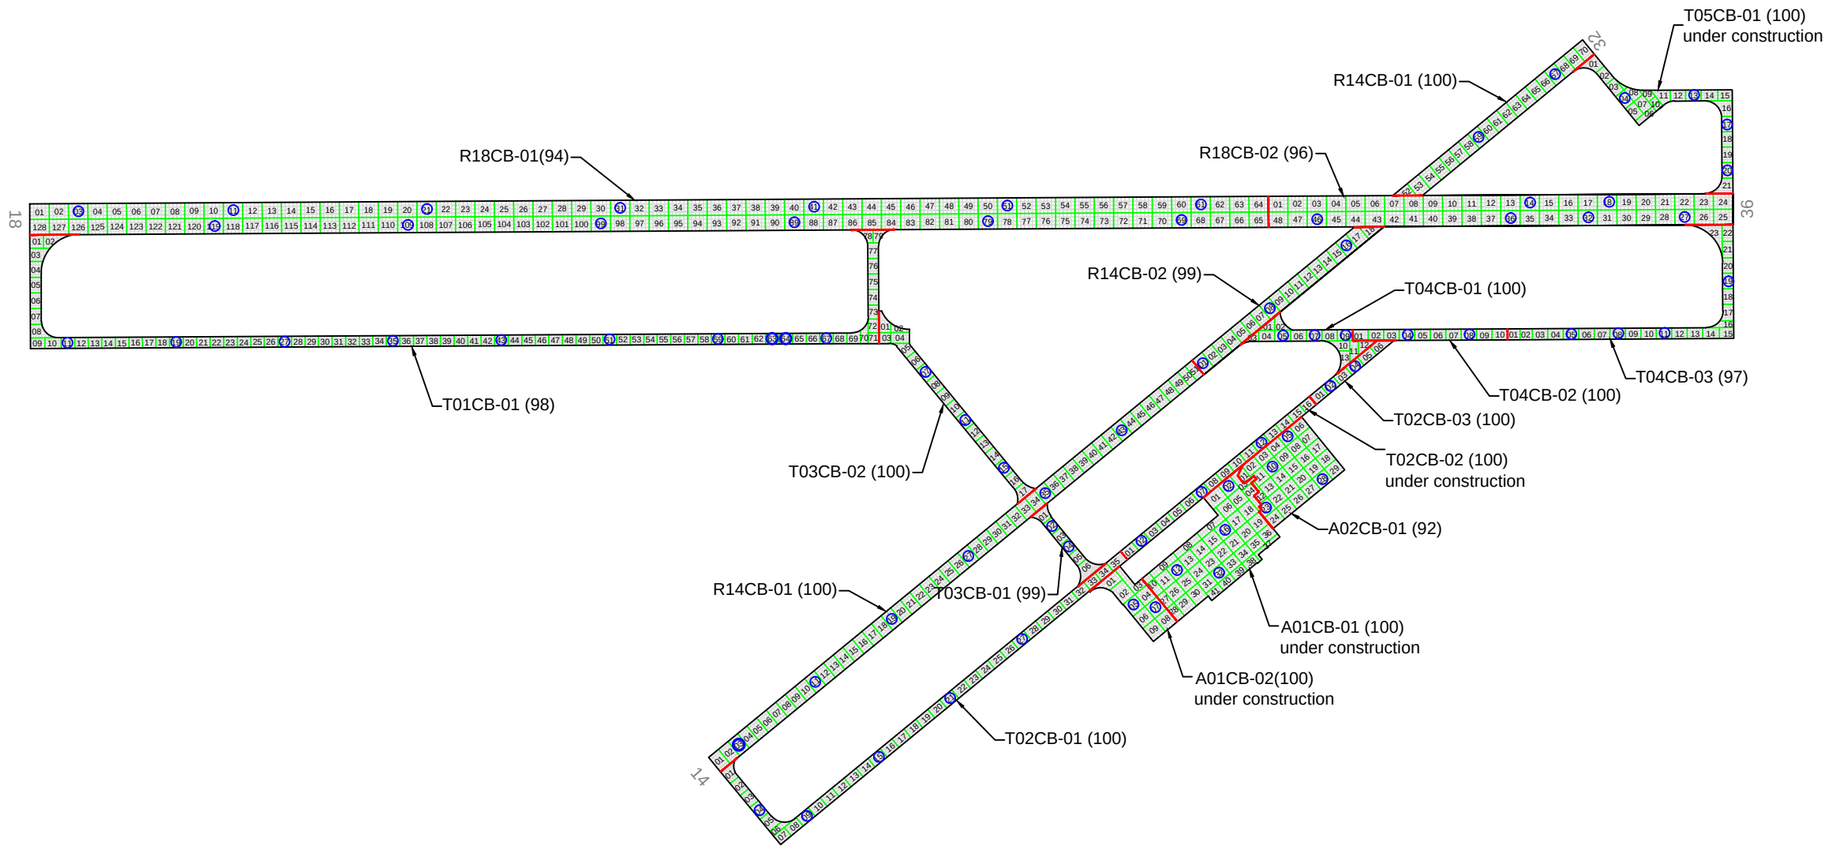
FIGURE 3. NETWORK DEFINITION MAP.

Figure 3 is a network definition map that identifies the pavements at Council Bluffs Municipal Airport that were evaluated during this project. This map shows how the pavement network was divided into branches, sections, and sample units for pavement management purposes. It also shows the nomenclature used in the MicroPAVER pavement management database to identify the different pavement areas.

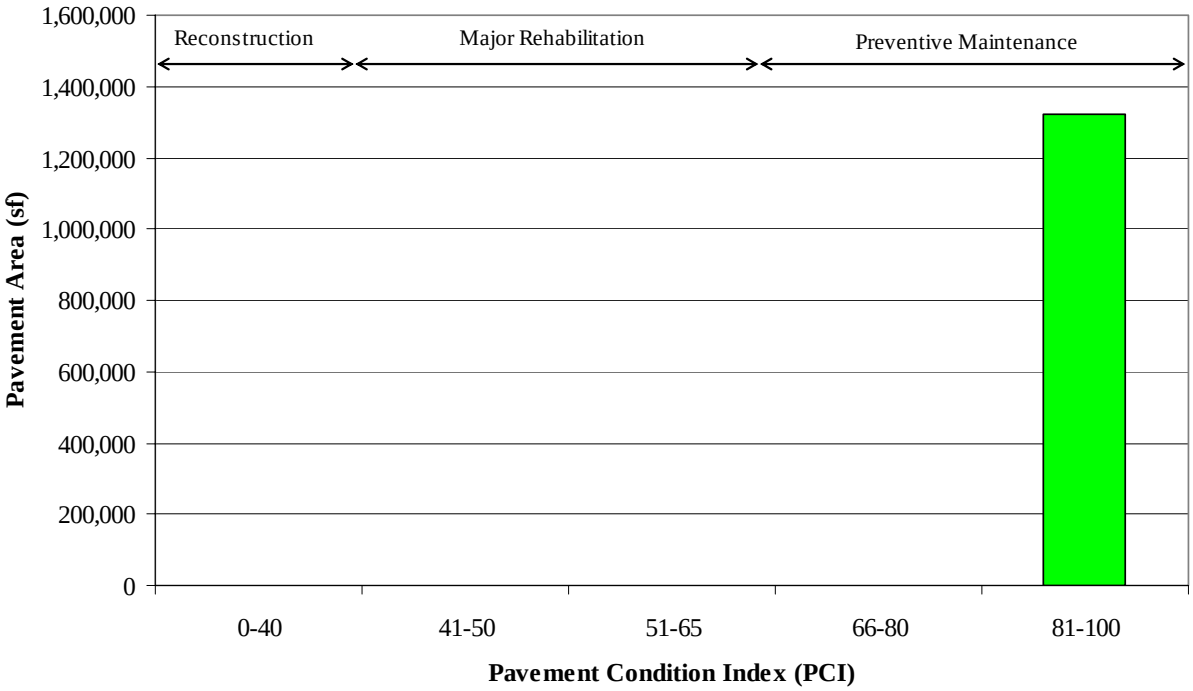
Figure 6. Overall condition.

The pavements at Council Bluffs Municipal Airport were inspected on September 14, 2009. The 2009 area-weighted condition of Council Bluffs Municipal Airport is 97, with conditions ranging from 92 to 100 (on a scale of 0 [failed] to 100 [excellent]). During the previous pavement inspection in 2005, the area-weighted PCI of the airport was 86.

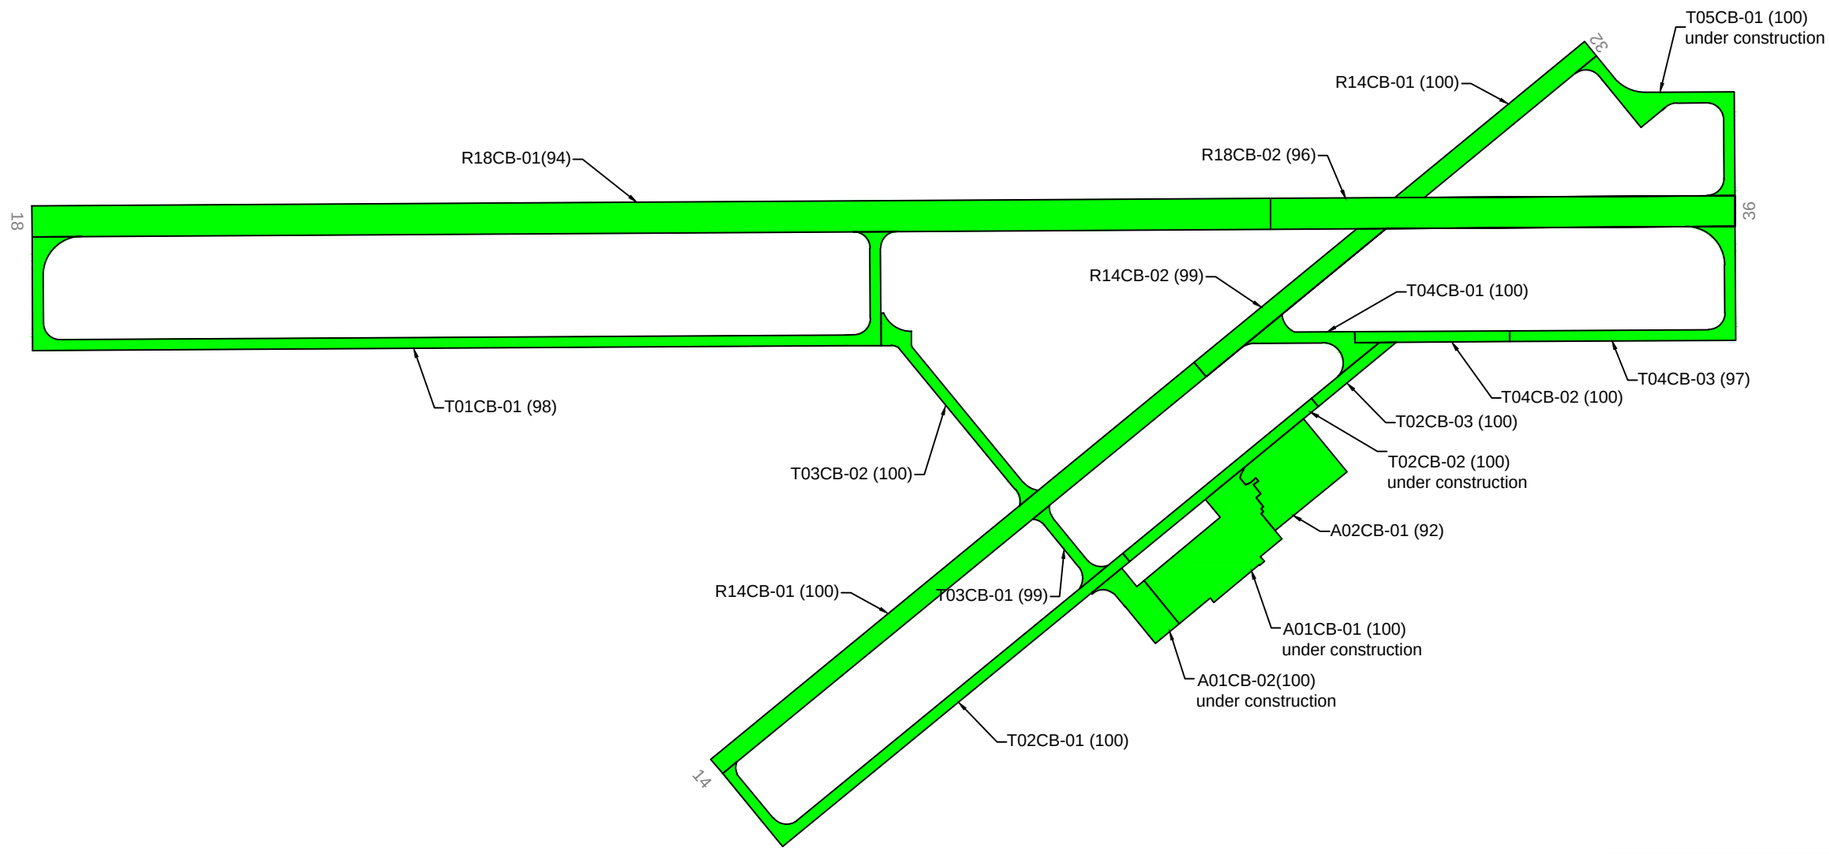
FIGURE 8. PCI MAP.

Figures 6 and 7 provide graphs summarizing the overall condition of the pavements at the Council Bluffs Municipal Airport. Figure 8 is a map that displays the condition of the pavements evaluated. Table 1 summarizes the results of the pavement evaluation. Appendix C presents photographs taken during the PCI inspection, and Appendix D contains detailed information on the distresses observed during the visual survey. Appendix E includes detailed
