NORTHEAST IOWA REGIONAL AIRPORT PAVEMENT MANAGEMENT REPORT

Prepared By:
Applied Pavement Technology, Inc.

January 2010

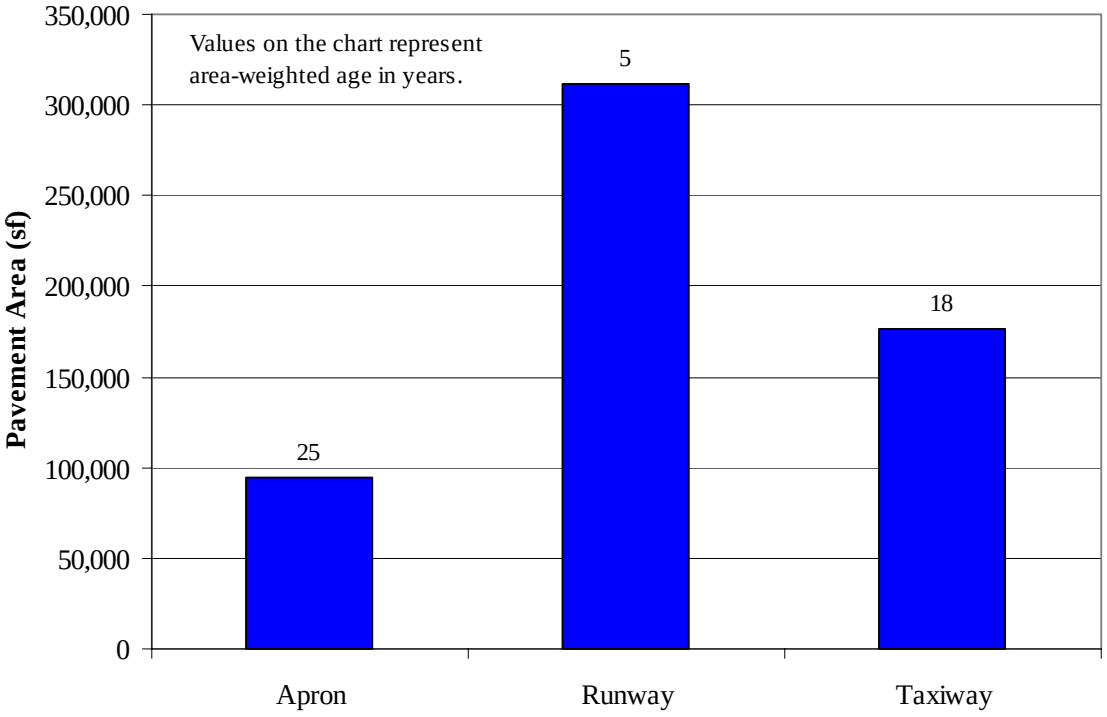
Figure 2. Pavement inventory.

Approximately 582,674 square feet of runway, taxiway, and apron pavements were evaluated at Northeast Iowa Regional Airport, as shown in Figure 2. This figure also shows the area-weighted age of the pavements.

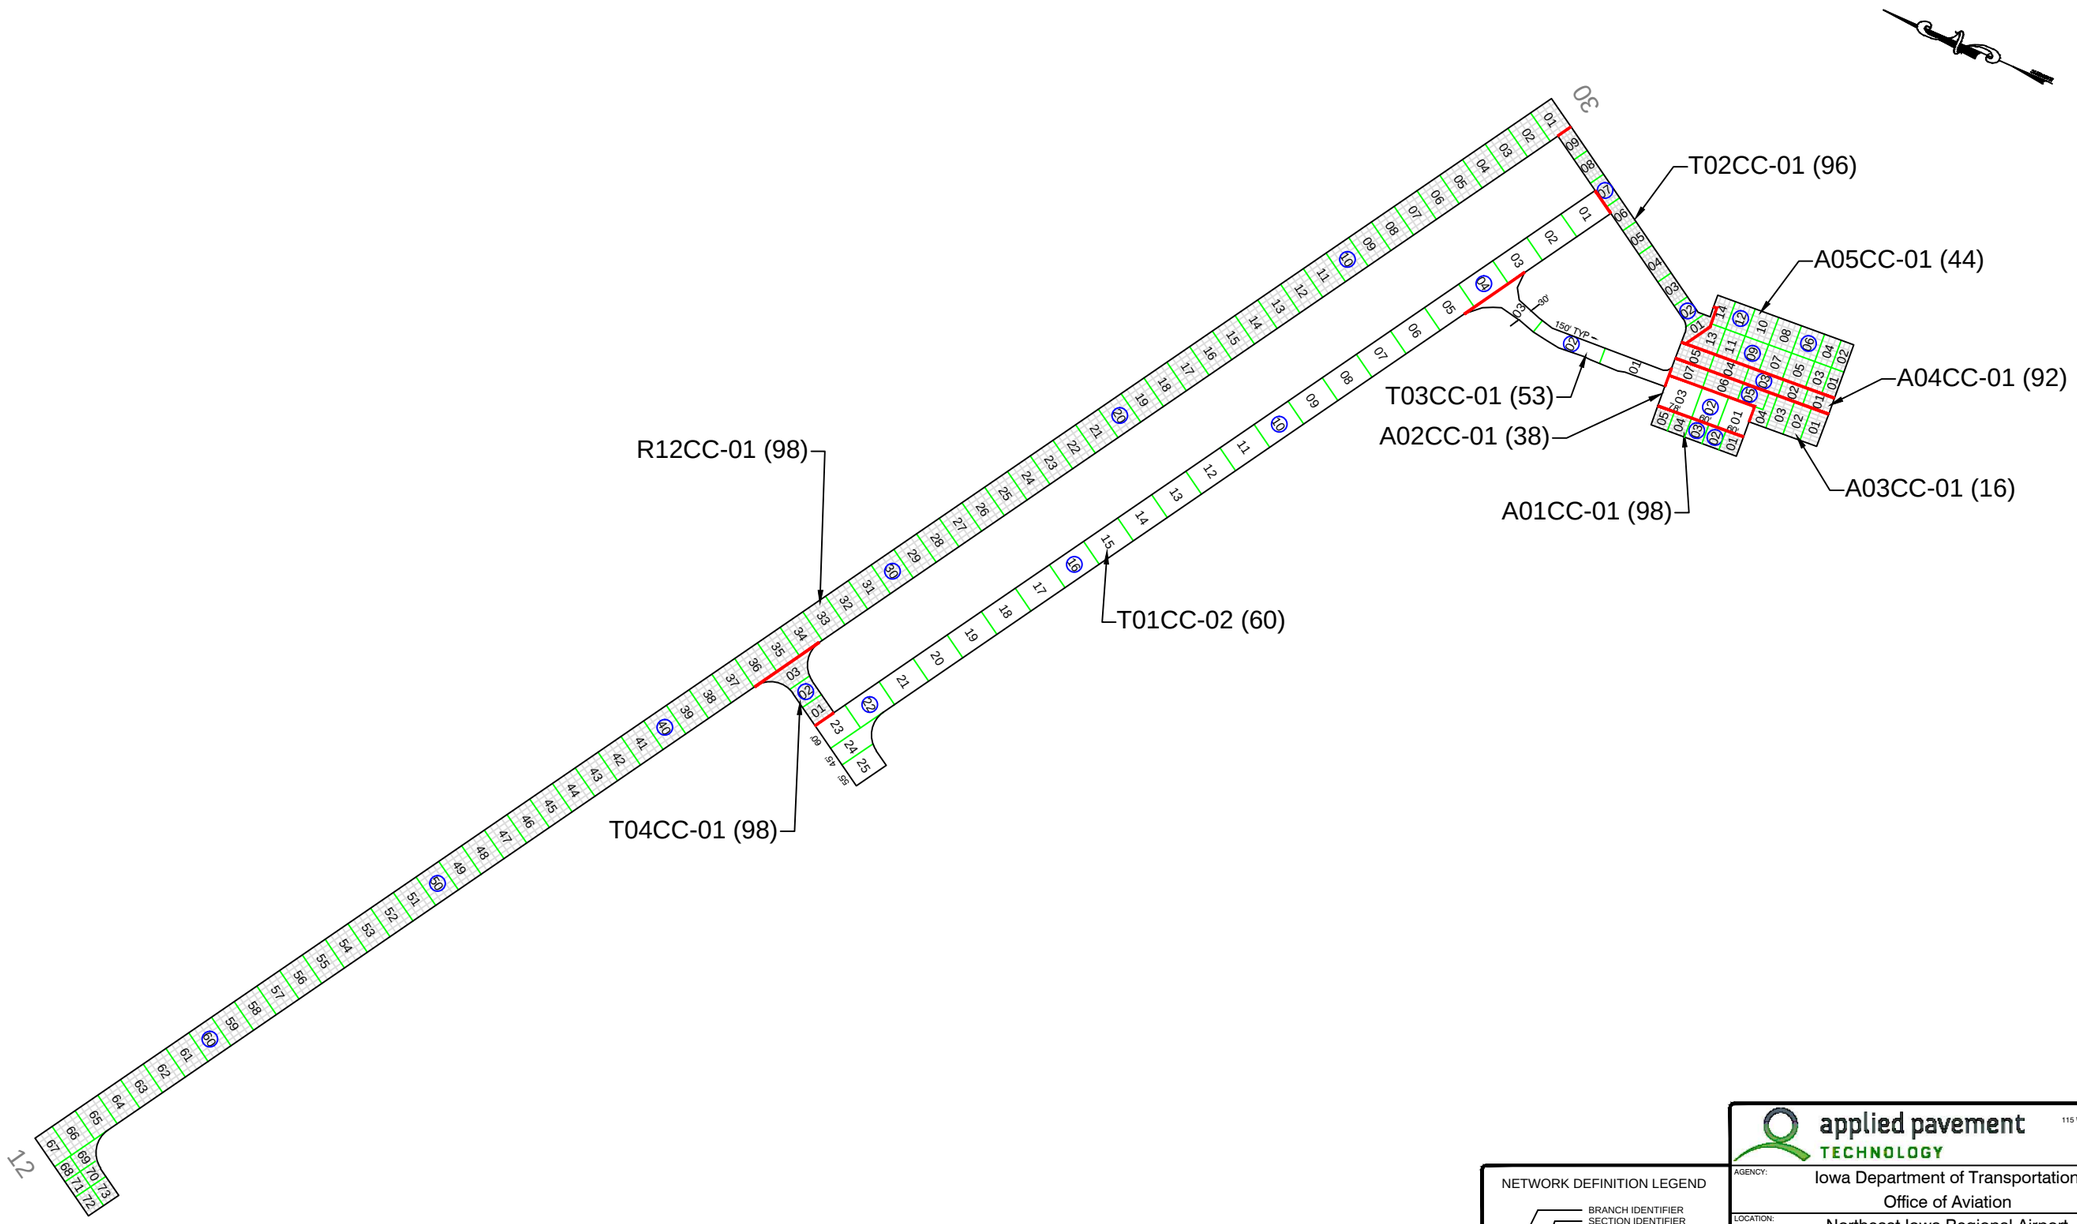
FIGURE 3. NETWORK DEFINITION MAP.

Figure 3 is a network definition map that identifies the pavements at Northeast Iowa Regional Airport that were evaluated during this project. This map shows how the pavement network was divided into branches, sections, and sample units for pavement management purposes. It also shows the nomenclature used in the MicroPAVER pavement management database to identify the different pavement areas.

The network definition map provided in Figure 3 of this report shows the location of all runways, taxiways, and aprons at Northeast Iowa Regional Airport. If any new pavements are constructed or any pavement areas are permanently closed, this map must be updated. Updates can be done by submitting your project plans to the Iowa DOT after project completion.

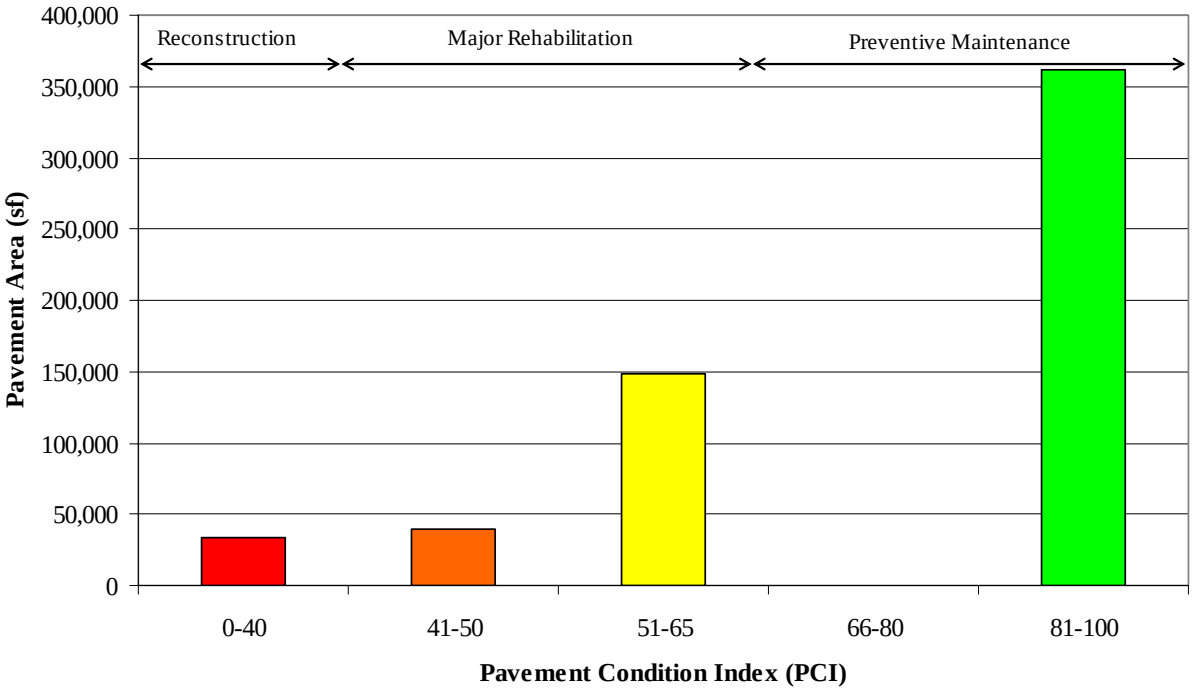
Figure 6. Overall condition.

The pavements at Northeast Iowa Regional Airport were inspected on September 20, 2009. The 2009 area-weighted condition of Northeast Iowa Regional Airport is 80, with conditions ranging from 16 to 98 (on a scale of 0 [failed] to 100 [excellent]). During the previous pavement inspection in 2005, the area-weighted PCI of the airport was 84.

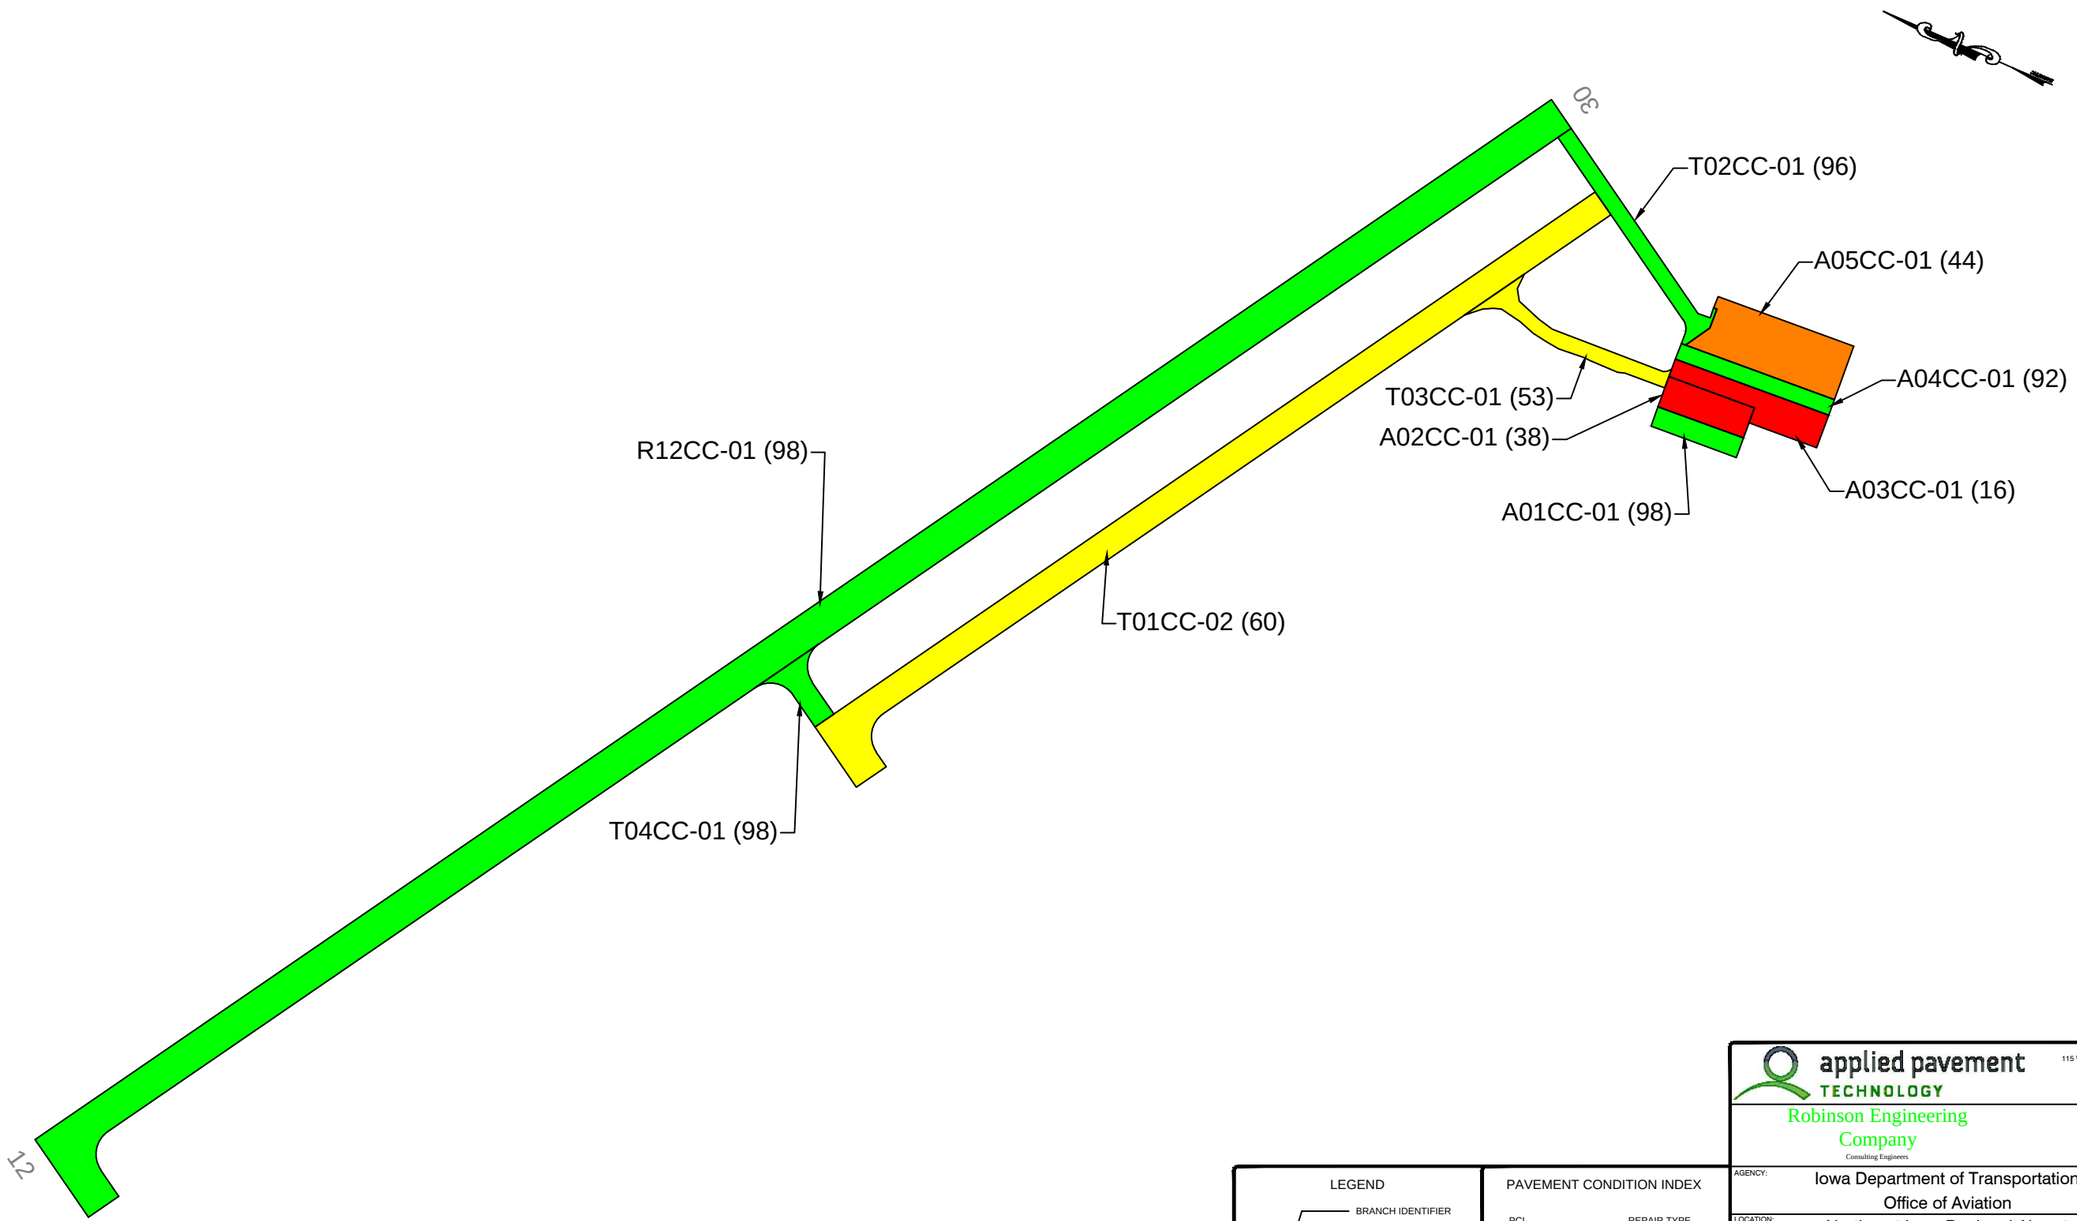
FIGURE 8. PCI MAP.

Taxiway 01, a partial parallel to the runway, consists of one section. Section 02 is in fair condition with extensive quantities of low- and medium-severity longitudinal and transverse (L&T) cracking observed. In addition, small amounts of low-severity patching, low- and medium-severity alligator cracking, and high-severity L&T cracking were noted. The low-severity cracking was unsealed and the medium-severity cracking was due to unsealed crack widths greater than ¼ inch. The high-severity cracking have widths greater than 3 inches.

Taxiway 03 connects the terminal apron to Taxiway 01 and is comprised of one section in fair condition. Extensive amounts of low- and medium-severity L&T cracking and small quantities of low-severity alligator cracking were recorded. Most of the low-severity cracking was unsealed and the medium-severity cracking was due to unsealed crack widths greater than ¼ inch.

Apron 02 consists of one section that is located adjacent to Taxiway 03. Section 01 is in failed condition with extensive amounts of low- and medium-severity L&T cracking and low-severity block cracking identified. In addition, small quantities of low- and medium-severity alligator cracking were noted. The majority of the low-severity cracking was unsealed and the medium-severity cracking was due to failed crack sealant or unsealed crack widths greater than ¼ inch.

Aprons 03 and 04, each defined by one section, comprise the center portion of the terminal apron area. Apron 03 is in failed condition with significant amounts of low- and medium-severity linear cracking, corner breaking, and durability cracking recorded. Additionally, small amounts of medium-severity shattered slabs and joint spalling and low- and medium-severity corner spalling were identified. Apron 04 is in good condition with small quantities of low-severity linear cracking and medium-severity corner spalling observed.

Apron 05, the eastern portion of the terminal apron, is in poor condition with low- and medium-severity joint seal damage recorded. In addition, extensive quantities of low- and medium-severity linear cracking and corner breaking along with all severities of durability cracking were observed. Small amounts of low- and medium-severity shattered slabs and low-severity corner spalling were also noted.

Year	Branch[1]	Section	Type of Repair[2]	Estimated Cost[3]
2010	A02CC	01	Major Rehabilitation	$128,615
	A03CC	01	Major Rehabilitation	$304,870
	A05CC	01	Major Rehabilitation	$486,431
	T01CC	02	Major Rehabilitation	$579,909
	T03CC	01	Major Rehabilitation	$70,729
			Total:	**$1,570,555**
