CARROLL MUNICIPAL – ARTHUR N. NEU AIRPORT PAVEMENT MANAGEMENT REPORT

Prepared For:
Iowa Department of Transportation
Office of Aviation

Prepared By:
Applied Pavement Technology, Inc.

December 2010

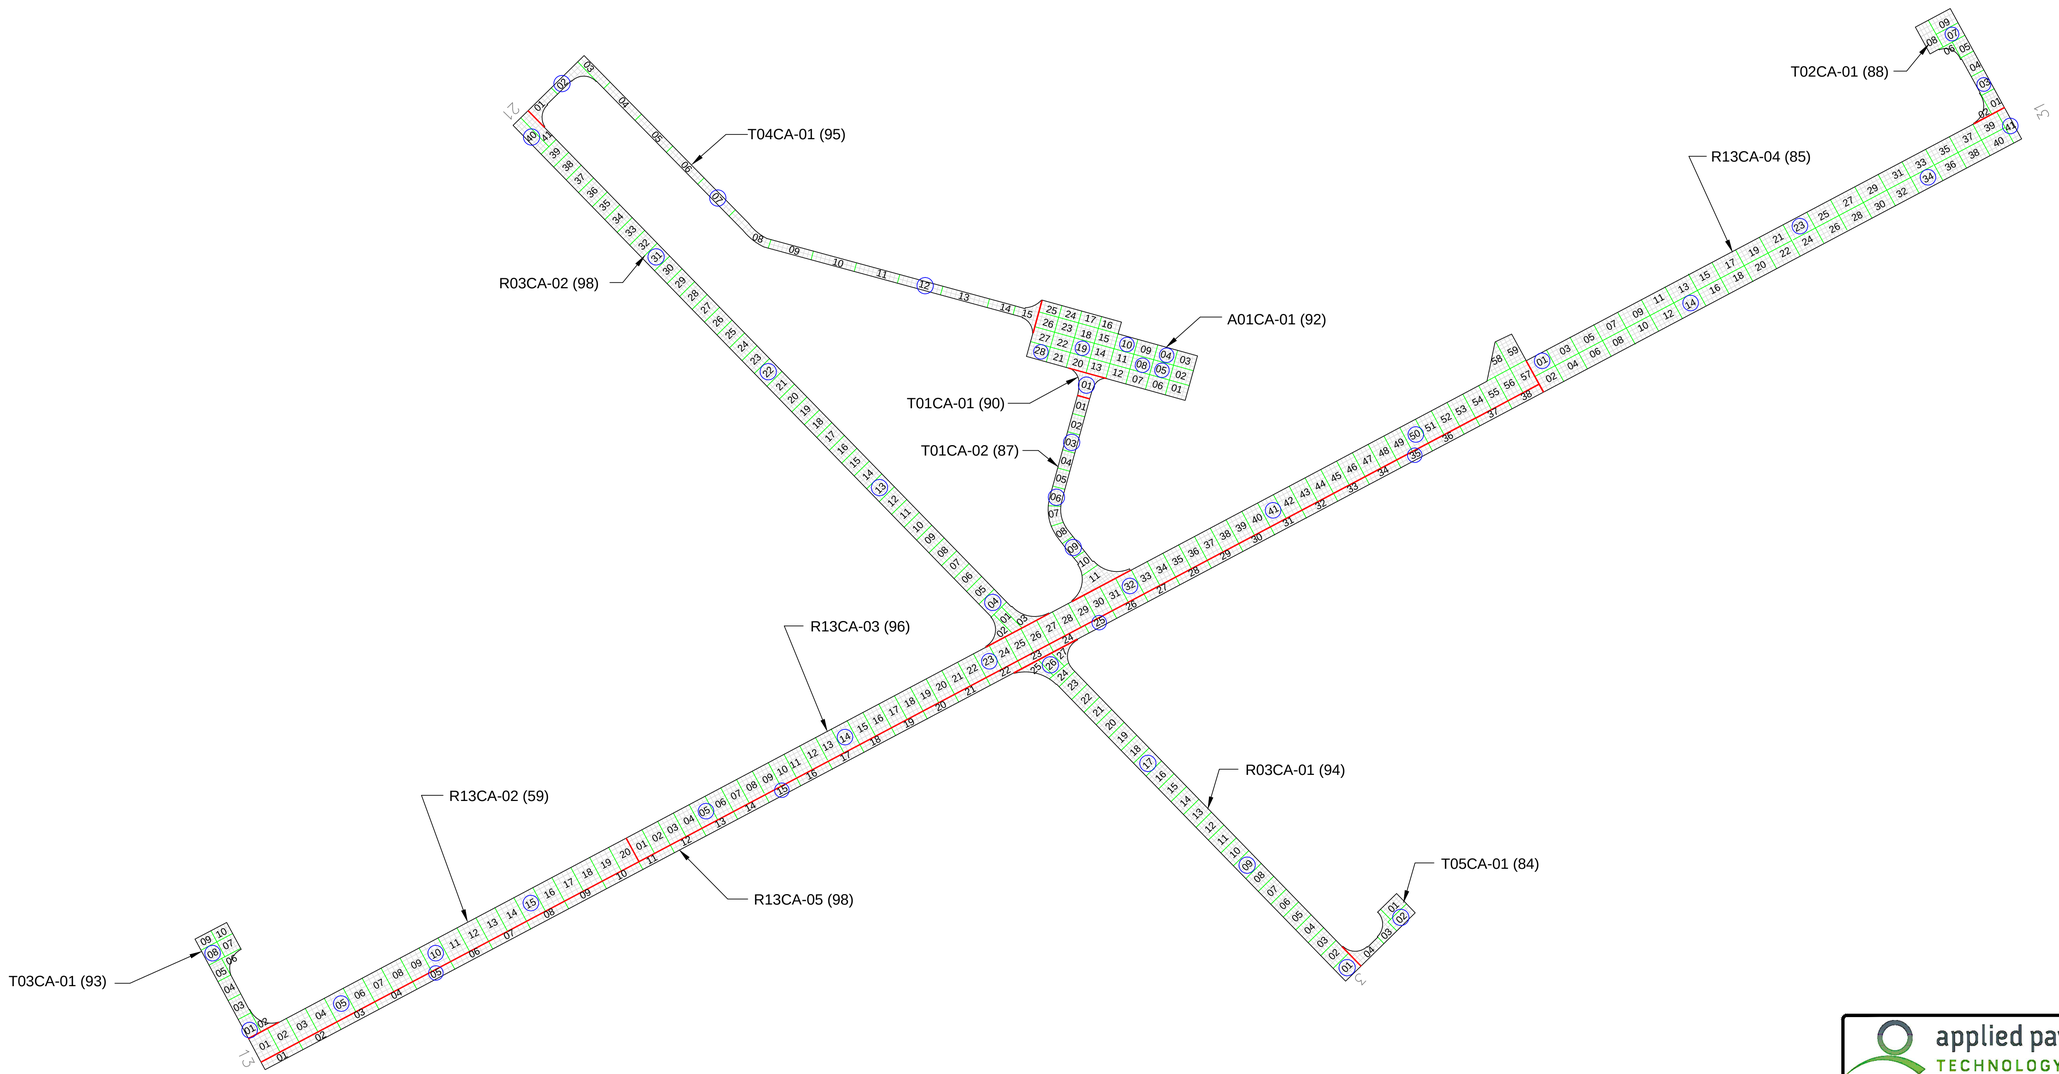
FIGURE 3. NETWORK DEFINITION MAP.

Runway 3-21 is defined by two sections that were recently reconstructed. Section 01, located northeast of Runway 13-31, is in good condition with low- and medium-severity joint seal damage recorded throughout. Isolated quantities of low-severity linear cracking were also identified. Section 02, located southwest of Runway 13-31, is in excellent condition with low-severity joint seal damage observed.

Runway 13-31 is comprised of four sections. Section 02, the northern portion of the runway, is in fair condition with low-severity joint seal damage recorded throughout. Significant amounts of popouts; low-severity small patching; and low-, medium-, and high-severity corner spalling and durability cracking were also identified. Additionally, isolated quantities of low-severity linear cracking were noted. Section 03, the middle portion of the runway, is in excellent condition with low-severity joint seal damage and low- and medium-severity small patching observed. In addition, small quantities of low-severity corner and joint spalling were noted at the time of inspection. Section 04, the southern portion of the runway, is in good condition with low- and medium-severity joint seal damage and low-severity small patching, linear cracking, and faulting observed. Small amounts of low- and medium-severity joint spalling were also recorded. Section 05, the western portion of the runway, is in excellent condition with isolated amounts of low-severity linear cracking and corner spalling identified.

Taxiway 01 connects Runway 13-31 with the apron area and it consists of two sections. Section 01, located adjacent to the apron area, is in good condition with low-severity joint seal damage and isolated quantities of low-severity corner breaking and corner spalling observed. Section 02, the majority of the taxiway, is in good condition with low- and medium-severity joint seal damage observed throughout. Small quantities of low- and medium-severity durability cracking and low- and high-severity corner spalling were also recorded.

Taxiway 02, located at the Runway 31 approach, is defined by one section. Section 01 is in good condition with medium-severity joint seal damage identified. In addition, small amounts of medium-severity faulting and joint spalling were noted.

Taxiway 03 is located at the Runway 13 approach and contains one section. Section 01 is in good condition with medium-severity joint seal damage recorded.

Taxiway 04 is a partial parallel taxiway to Runway 3-21 and consists of one section that was recently reconstructed. Section 01 is in excellent condition with low-severity joint seal damage and isolated quantities of low-severity linear cracking observed.

Taxiway 05, located at the Runway 3 approach, is defined by one section. Section 01 is in good condition with medium-severity joint seal damage and isolated amounts of low-severity shattered slabs identified.

One section is defined in the apron area (Apron 01). This apron is in good condition with low- and medium-severity joint seal damage and isolated amounts of medium-severity linear cracking and joint spalling recorded.

Year	Branch[1]	Section[1]	Type of Repair[2]	Estimated Cost[3]
2011	R13CA	02	Major Rehabilitation	$655,607
			Total:	**$655,607**

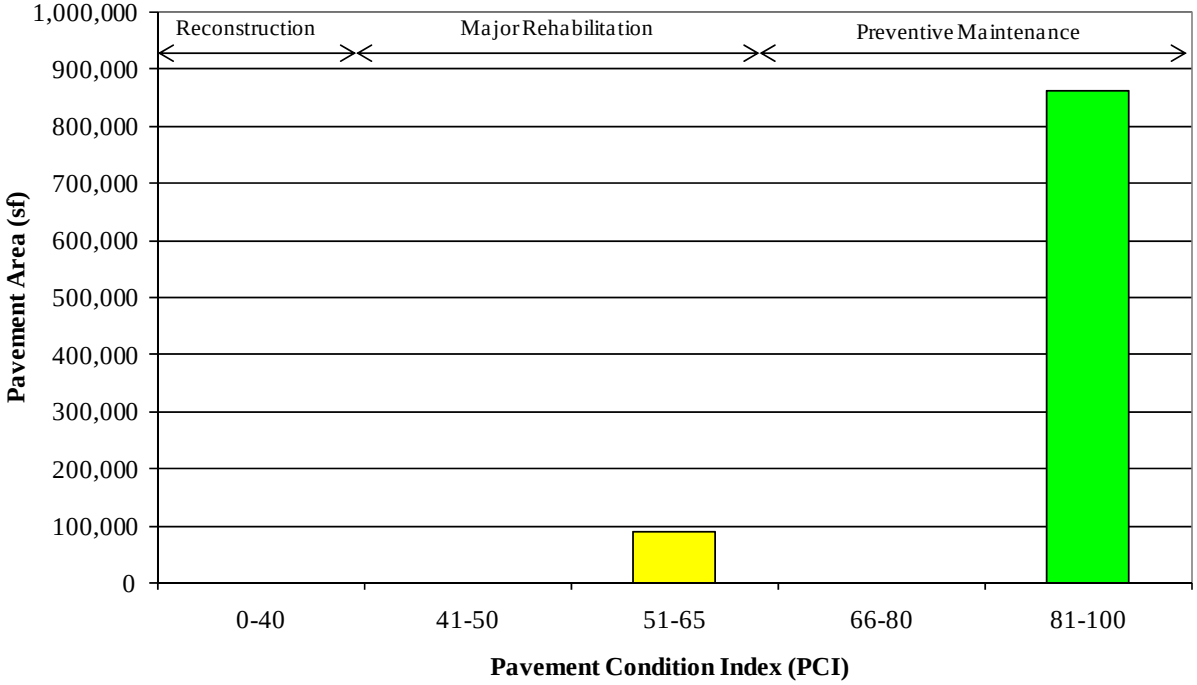
Figure 6. Overall condition.

The pavements at Carroll Municipal - Arthur N. Neu Airport were inspected on September 17, 2010. The 2010 area-weighted condition of Carroll Municipal - Arthur N. Neu Airport is 90, with conditions ranging from 59 to 98 (on a scale of 0 [failed] to 100 [excellent]). During the previous pavement inspection in 2006, the area-weighted PCI of the airport was 90.

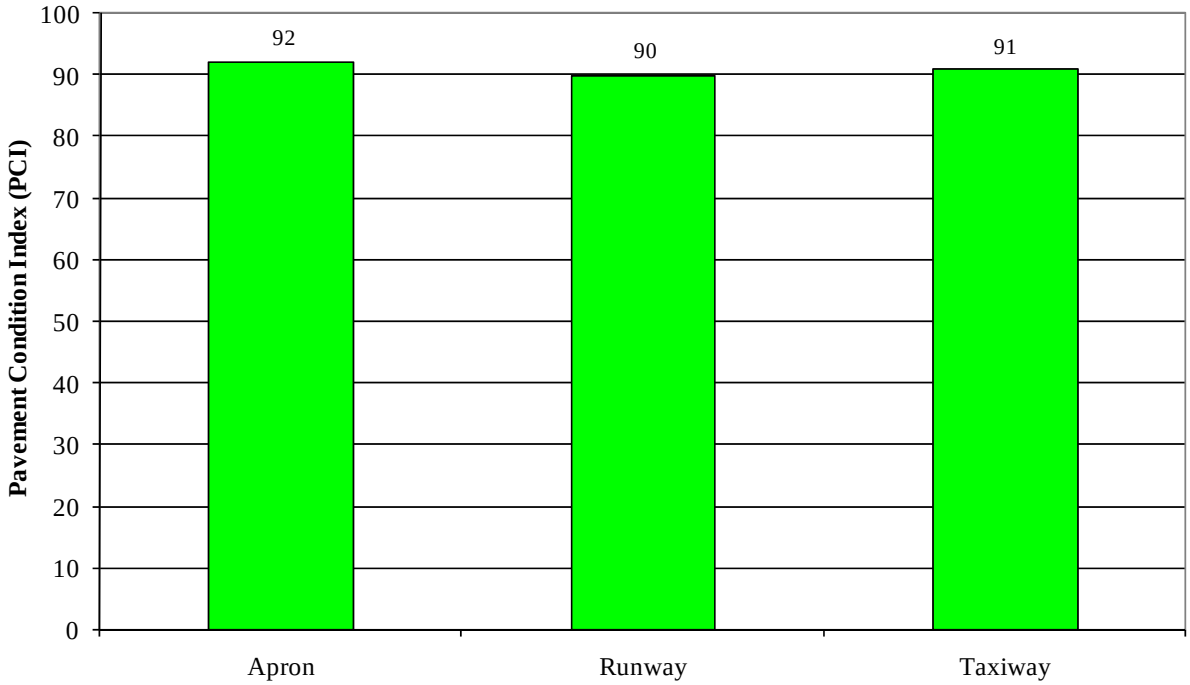
Figure 7. Condition by use.

Figures 6 and 7 provide graphs summarizing the overall condition of the pavements at the Carroll Municipal - Arthur N. Neu Airport. Figure 8 is a map that displays the condition of the pavements evaluated. Table 1 summarizes the results of the pavement evaluation. Appendix C presents photographs taken during the PCI inspection, and Appendix D contains detailed information on the distresses observed during the visual survey. Appendix E includes detailed
