CARROLL MUNICIPAL – ARTHUR N. NEU AIRPORT PAVEMENT MANAGEMENT REPORT

Prepared For:
Iowa Department of Transportation
Office of Aviation

Prepared By:
Applied Pavement Technology, Inc.

January 2007

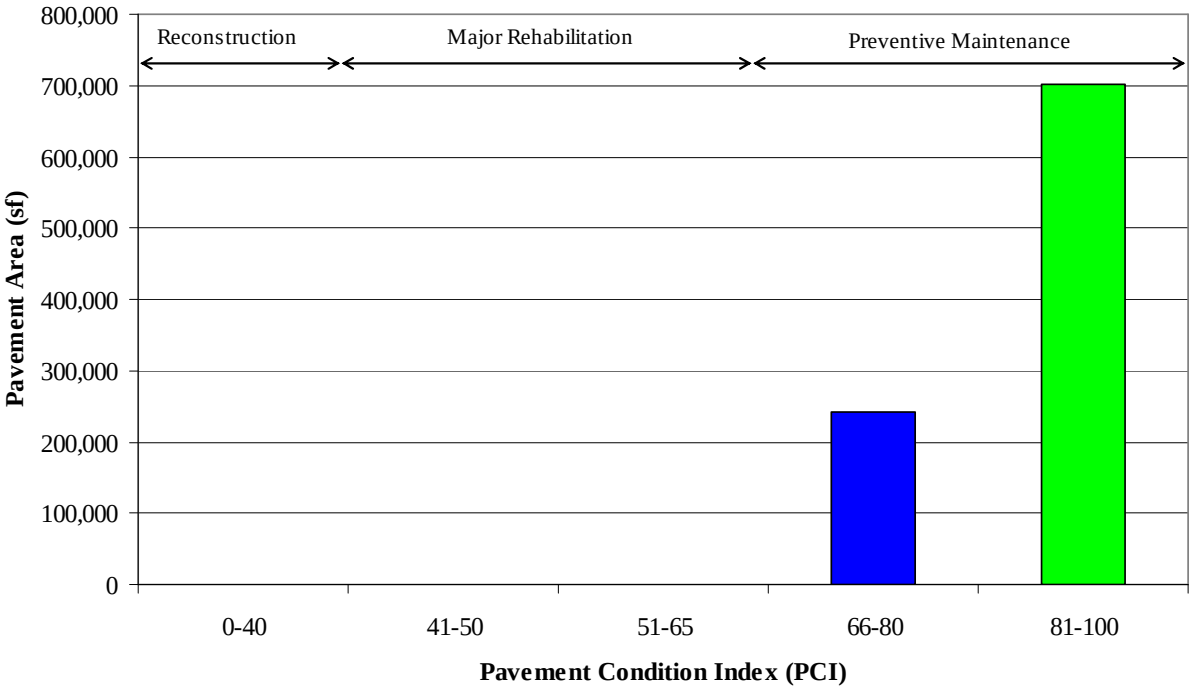
Figure 6. Overall condition.

The pavements at Carroll Municipal – Arthur N. Neu Airport were inspected on September 14, 2006. The 2006 area-weighted condition of Carroll Municipal – Arthur N. Neu Airport is 90, with conditions ranging from 67 to 100 (on a scale of 0 [failed] to 100 [excellent]). In 2003 the area-weighted PCI of the airport was 91.

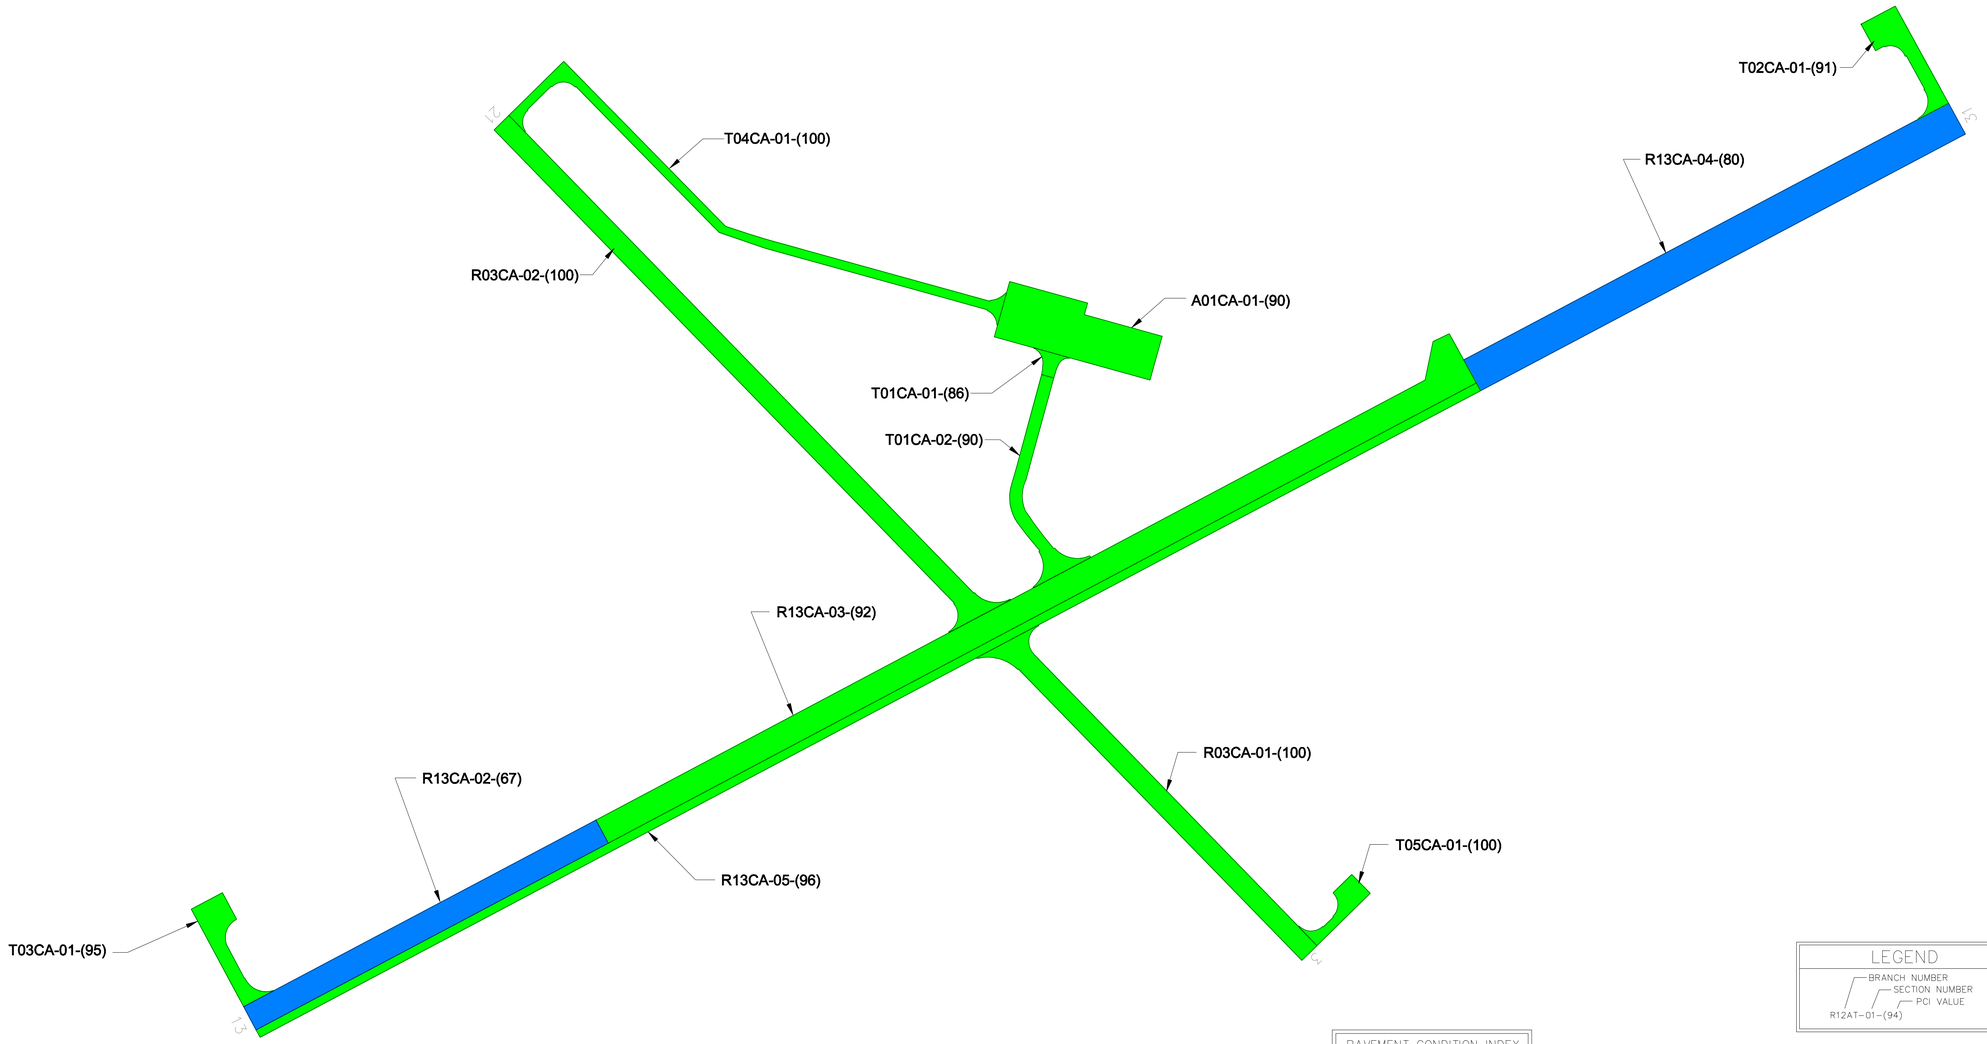
PAGE TITLE: Pavement Condition Index Map

Figures 6 and 7 provide graphs summarizing the overall condition of the pavements at the Carroll Municipal – Arthur N. Neu Airport. Figure 8 is a map that displays the condition of the pavements evaluated. Table 1 summarizes the results of the pavement evaluation. Appendix C presents photographs taken during the PCI inspection, and Appendix D contains detailed information on the distresses observed during the visual survey. Appendix E includes detailed
