CRESTON MUNICIPAL AIRPORT PAVEMENT MANAGEMENT REPORT

Prepared For:
Iowa Department of Transportation
Office of Aviation

Prepared By:
Applied Pavement Technology, Inc.

December 2011

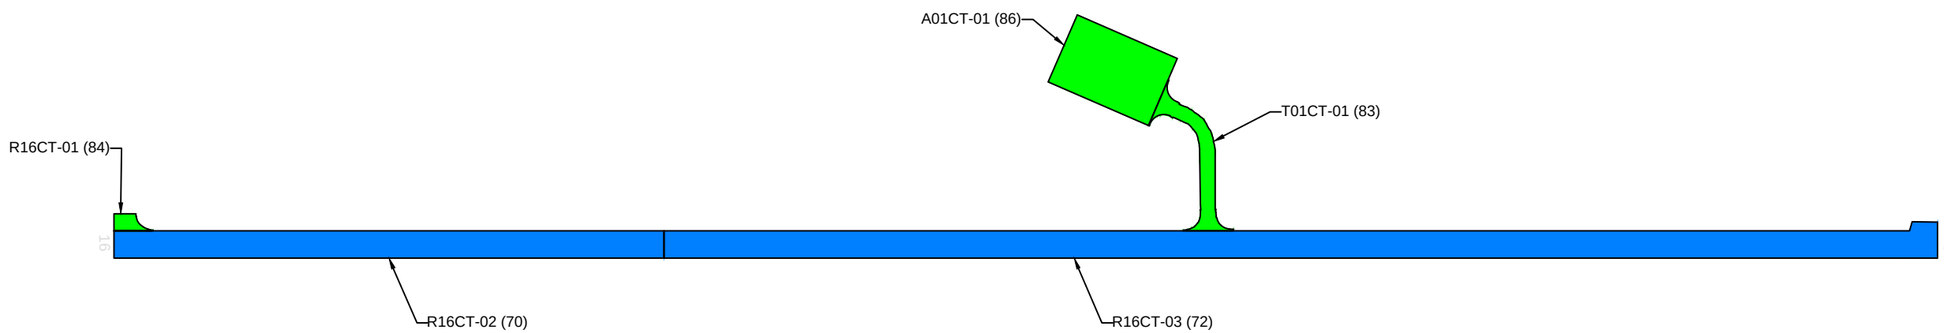
FIGURE 8. PCI MAP.

The pavements at Creston Municipal Airport were inspected on September 11, 2011. The 2011 area-weighted condition of Creston Municipal Airport is 74, with conditions ranging from 70 to 86 (on a scale of 0 [failed] to 100 [excellent]). During the previous pavement inspection in 2008, the area-weighted PCI of the airport was 76.

Runway 16-34 is defined by three sections. Section 01, a turnaround located at the Runway 16 approach, is in good condition with high-severity joint seal damage and medium-severity joint spalling identified. Section 02, the northern portion of the runway, is in satisfactory condition. Extensive amounts of low- and medium-severity longitudinal and transverse (L&T) cracking were observed. Moderate quantities of low-severity patching and isolated amounts of low-severity swelling and raveling and weathering were also noted. Section 03, the majority of the pavement at the south end of the runway, is also in satisfactory condition with extensive amounts of low- and medium-severity L&T cracking recorded. Additionally, medium- and high-severity patching were also observed. The majority of the low-severity cracking was sealed, and the medium-severity cracking was identified where the cracks had developed secondary cracking.

Taxiway 01 connects Runway 16-34 with the apron area and consists of one section. Section 01 is in good condition with high-severity joint seal damage recorded. In addition, small amounts of low- and medium-severity joint spalling and medium-severity corner spalling were identified.

The apron area (Apron 01) is comprised of one section, which is in good condition. High-severity joint seal damage was observed throughout along with isolated amounts of low-severity corner spalling and faulting.

Year	Branch[1]	Section[1]	Type of Repair[2]	Estimated Cost[3]
2014	R16CT	02	Major Rehabilitation	$542,920
2015	R16CT	03	Major Rehabilitation	$1,321,986
			Total:	**$1,864,906**
