DECORAH MUNICIPAL AIRPORT PAVEMENT MANAGEMENT REPORT

Prepared By:
Applied Pavement Technology, Inc.

December 2010

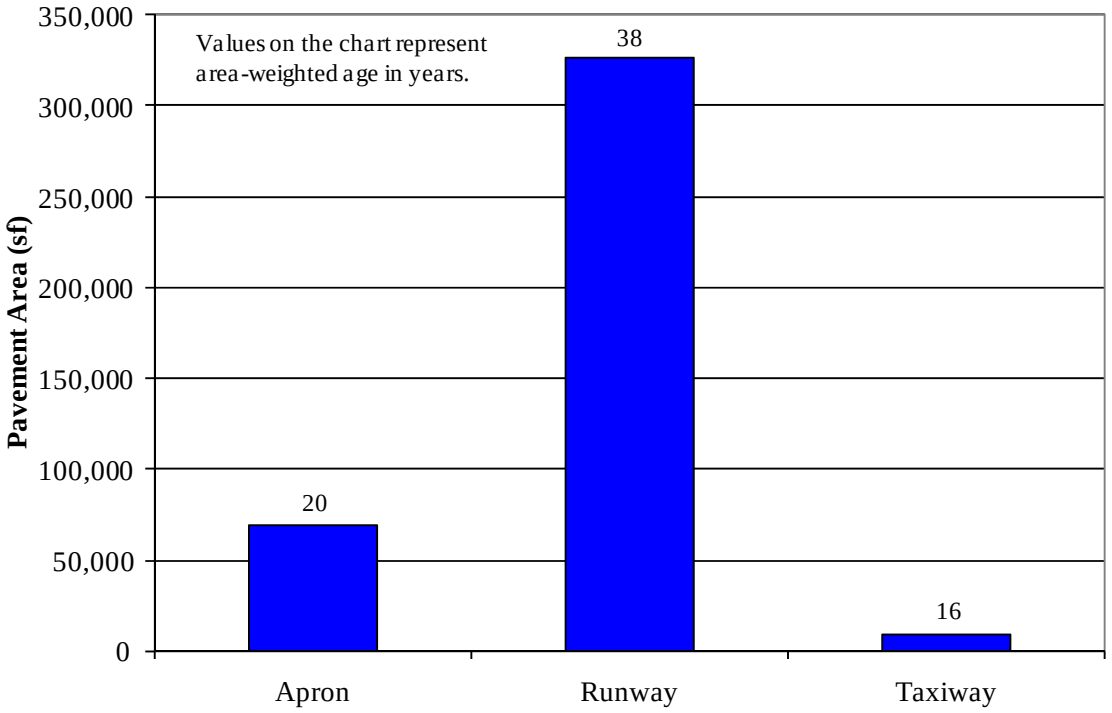
Figure 2. Pavement inventory.

Approximately 405,362 square feet of runway, taxiway, and apron pavements were evaluated at Decorah Municipal Airport, as shown in Figure 2. This figure also shows the area-weighted age of the pavements.

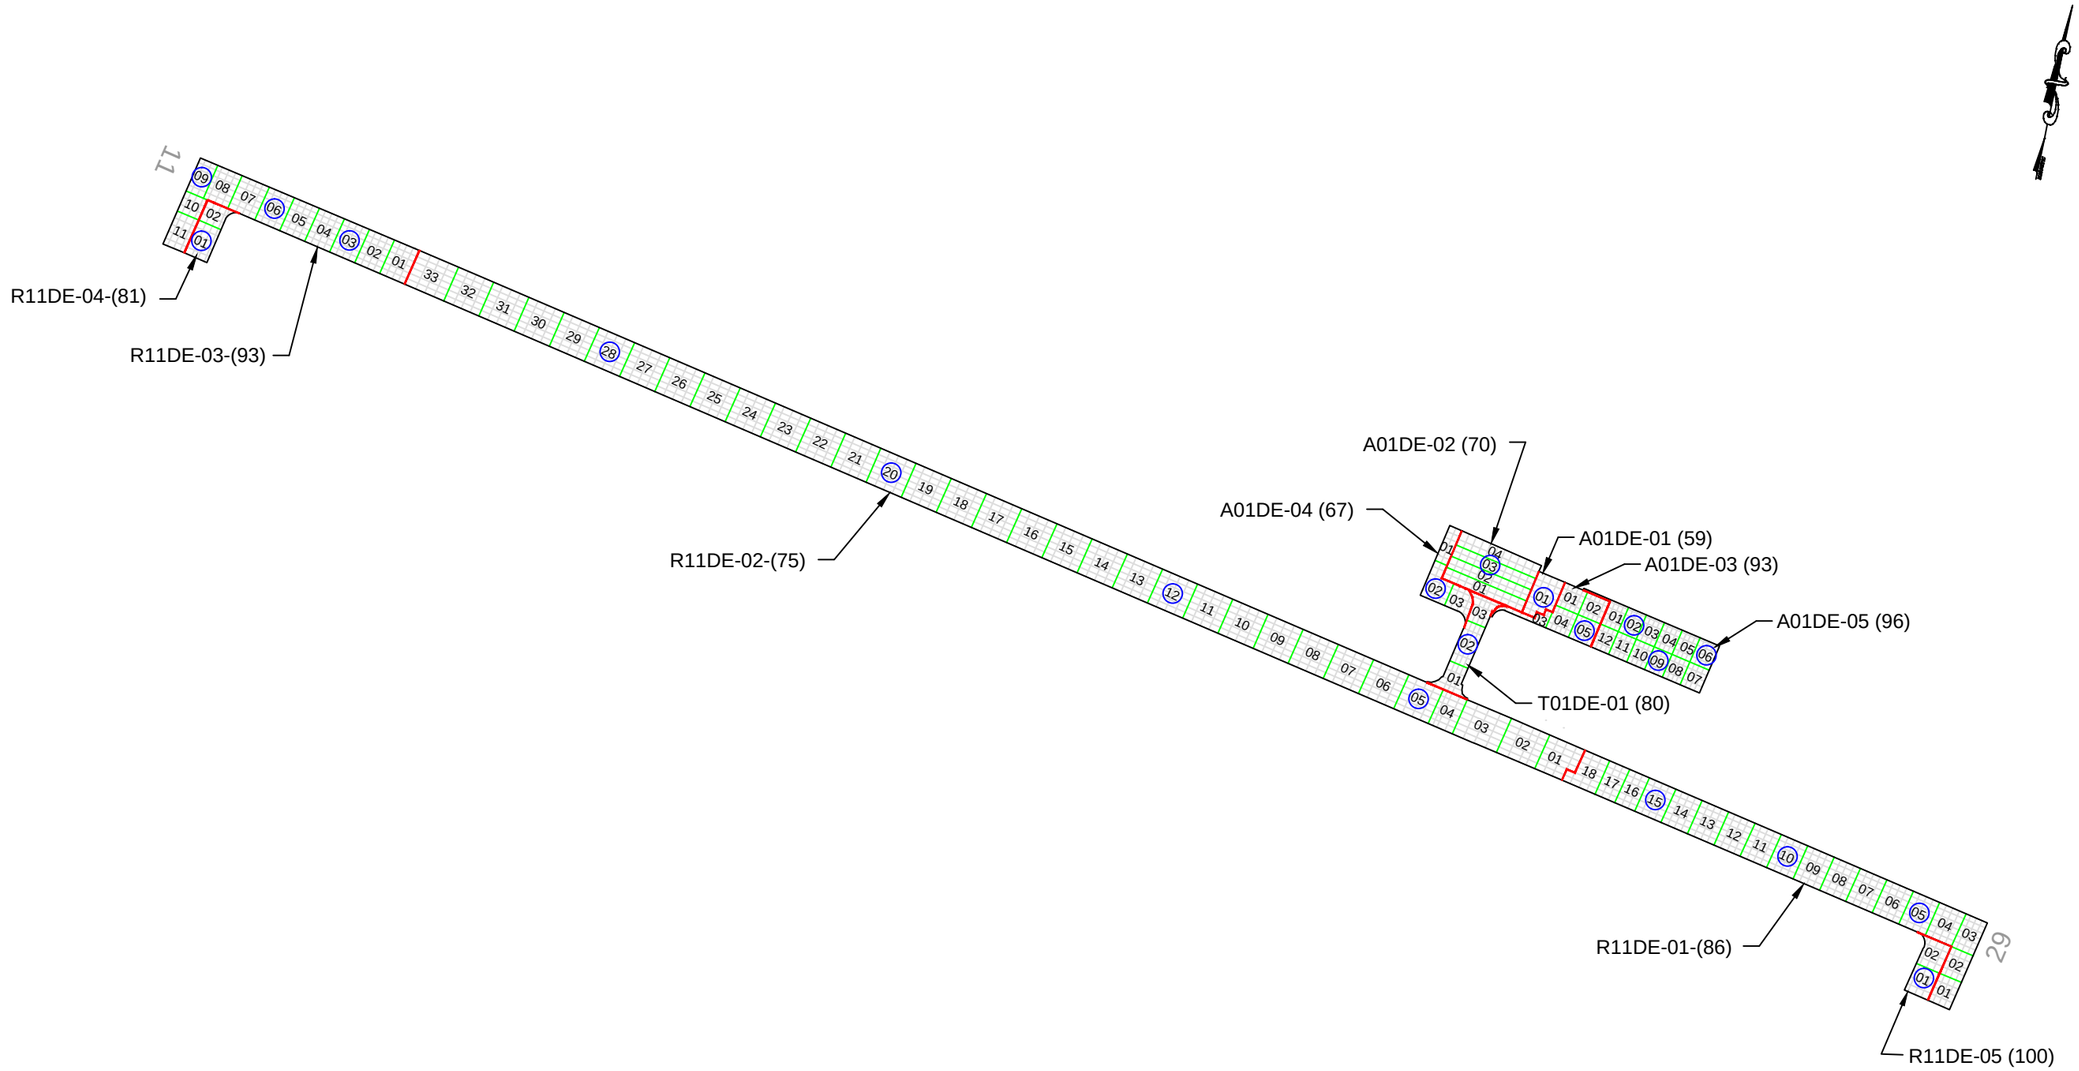
FIGURE 3. NETWORK DEFINITION MAP.

Figure 3 is a network definition map that identifies the pavements at Decorah Municipal Airport that were evaluated during this project. This map shows how the pavement network was divided into branches, sections, and sample units for pavement management purposes. It also shows the nomenclature used in the MicroPAVER pavement management database to identify the different pavement areas.

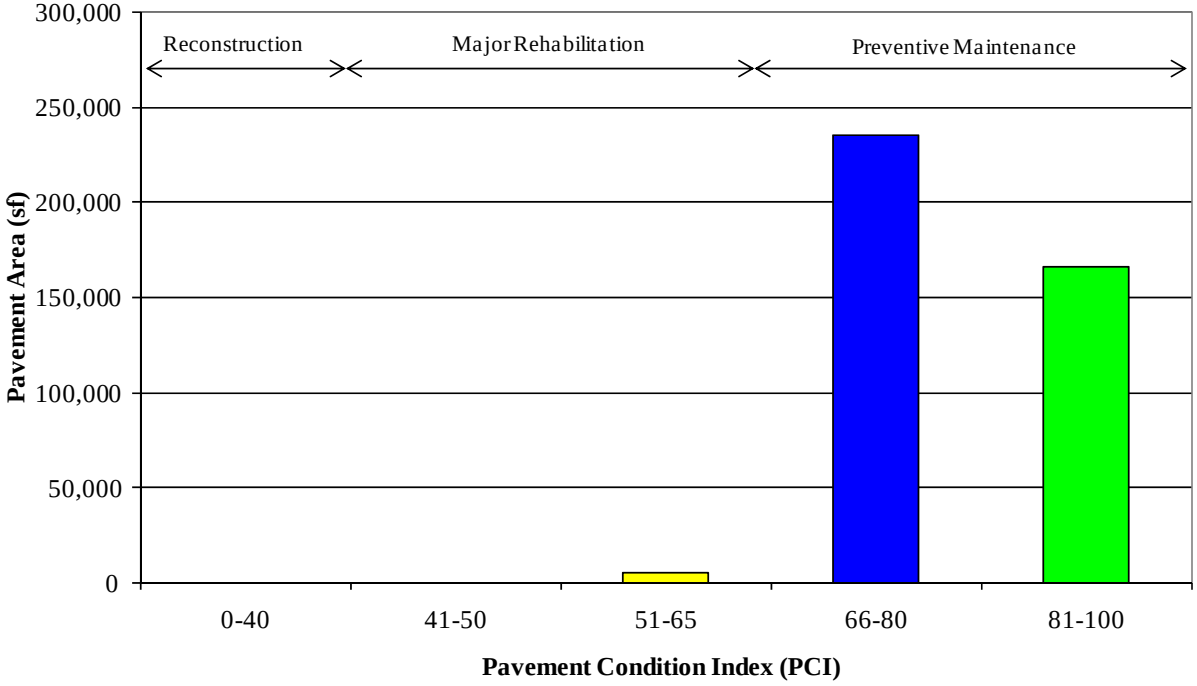
Figure 6. Overall condition.

The pavements at Decorah Municipal Airport were inspected on September 20, 2010. The 2010 area-weighted condition of Decorah Municipal Airport is 81, with conditions ranging from 59 to 100 (on a scale of 0 [failed] to 100 [excellent]). During the previous pavement inspection in 2006, the area-weighted PCI of the airport was 68.

Figures 6 and 7 provide graphs summarizing the overall condition of the pavements at the Decorah Municipal Airport. Figure 8 is a map that displays the condition of the pavements evaluated. Table 1 summarizes the results of the pavement evaluation. Appendix C presents photographs taken during the PCI inspection, and Appendix D contains detailed information on the distresses observed during the visual survey. Appendix E includes detailed work history

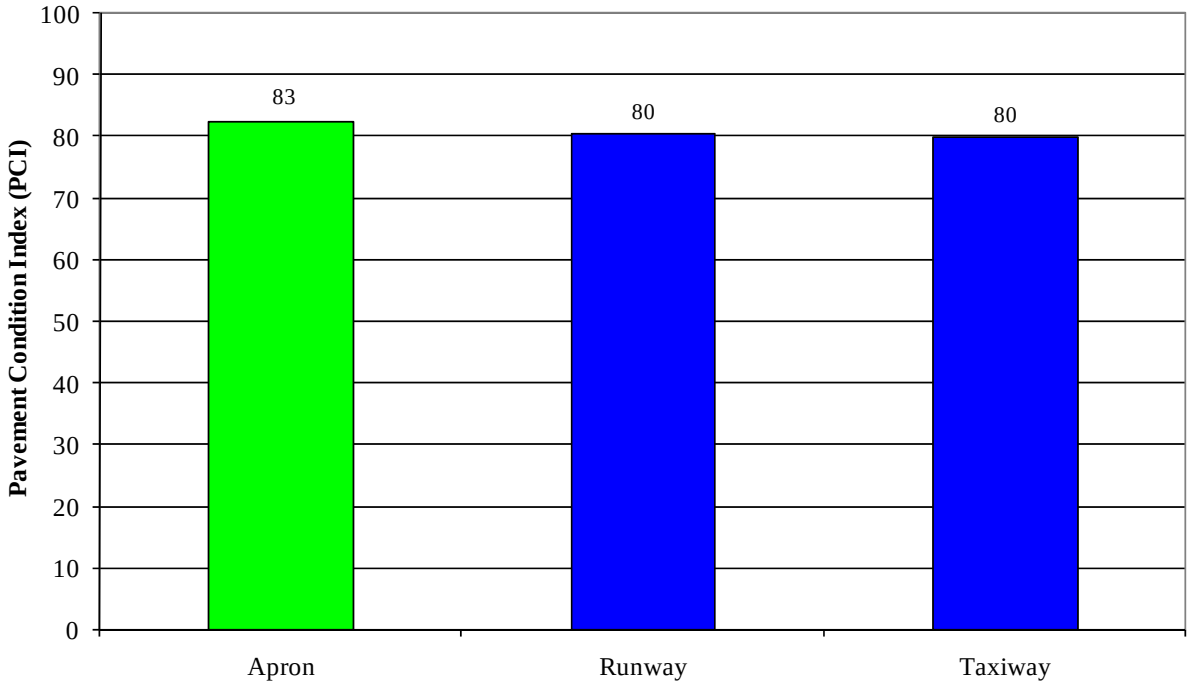
Figure 7. Condition by use.

(Values on chart are area weighted)

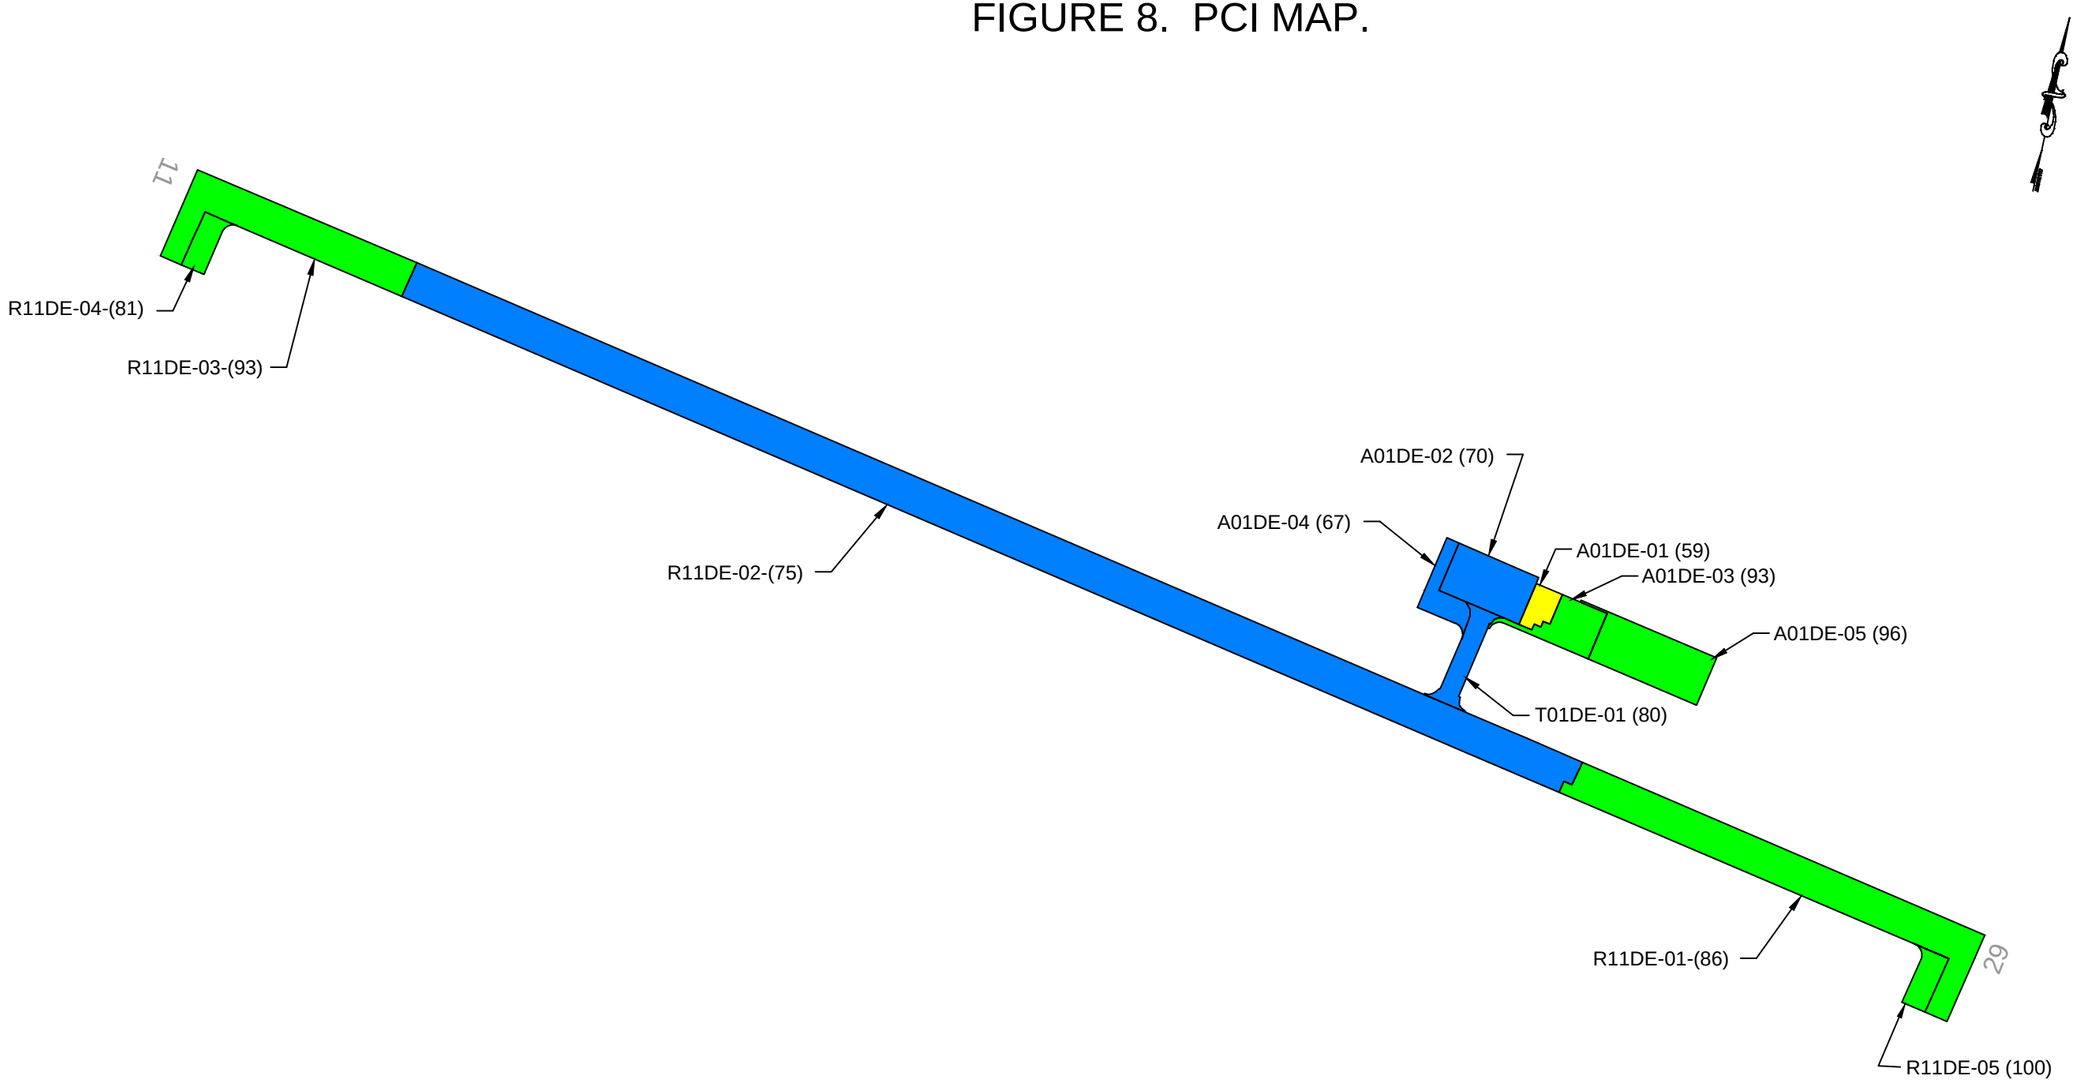
FIGURE 8. PCI MAP.

Runway 11-29 is defined by five sections. Section 01, the eastern portion of the runway, is in good condition. Small quantities of low-severity durability cracking and faulting along with isolated amounts of low-severity joint spalling, corner spalling, and shrinkage cracking were recorded. Section 02, the majority of the runway, is in satisfactory condition with low- and medium-severity linear cracking and large patching observed throughout. Small amounts of low-severity small patching, joint spalling, and corner spalling were also identified. Section 03, the western portion of the runway, is in good condition with small amounts of low-severity joint seal damage, faulting, large patching, corner breaks, and corner spalling recorded. Section 04 is a turnaround located at the Runway 11 approach that is in satisfactory condition with moderate quantities of low-severity linear cracking and corner breaks observed. Section 05 is a turnaround located at the Runway 29 approach that was recently reconstructed and is in excellent condition with no distresses identified during the inspection.

Taxiway 01 consists of one section that is in satisfactory condition with moderate quantities of low- and medium-severity linear cracking and low-severity joint spalling observed.

Five sections are defined in the apron area (Apron 01). Section 01 is in fair condition with low-severity joint seal damage and low- and medium-severity linear cracking recorded throughout. In addition, small quantities of low-severity corner spalling, shattered slabs, and corner breaks were observed. Section 02 is in satisfactory condition with moderate amounts of low-severity linear cracking and shattered slabs identified. Section 03 is in good condition with isolated quantities of low-severity linear cracking and joint spalling recorded. Section 04, the western portion of the apron area, is in satisfactory condition with low-severity joint seal damage and moderate amounts of low- and medium-severity linear cracking observed. In addition, isolated amounts of medium-severity joint spalling were identified. Section 05, the eastern portion of the apron area, is in excellent condition with low- and medium-severity joint seal damage recorded.

Year	Branch[1]	Section[1]	Type of Repair[2]	Estimated Cost[3]
2011	A01DE	01	Major Rehabilitation	$34,885
		02	Major Rehabilitation	$137,551
			Total:	**$172,436**
