DECORAH MUNICIPAL AIRPORT
PAVEMENT MANAGEMENT REPORT

Prepared For:
Iowa Department of Transportation
Office of Aviation

Prepared By:
Applied Pavement Technology, Inc.

January 2007

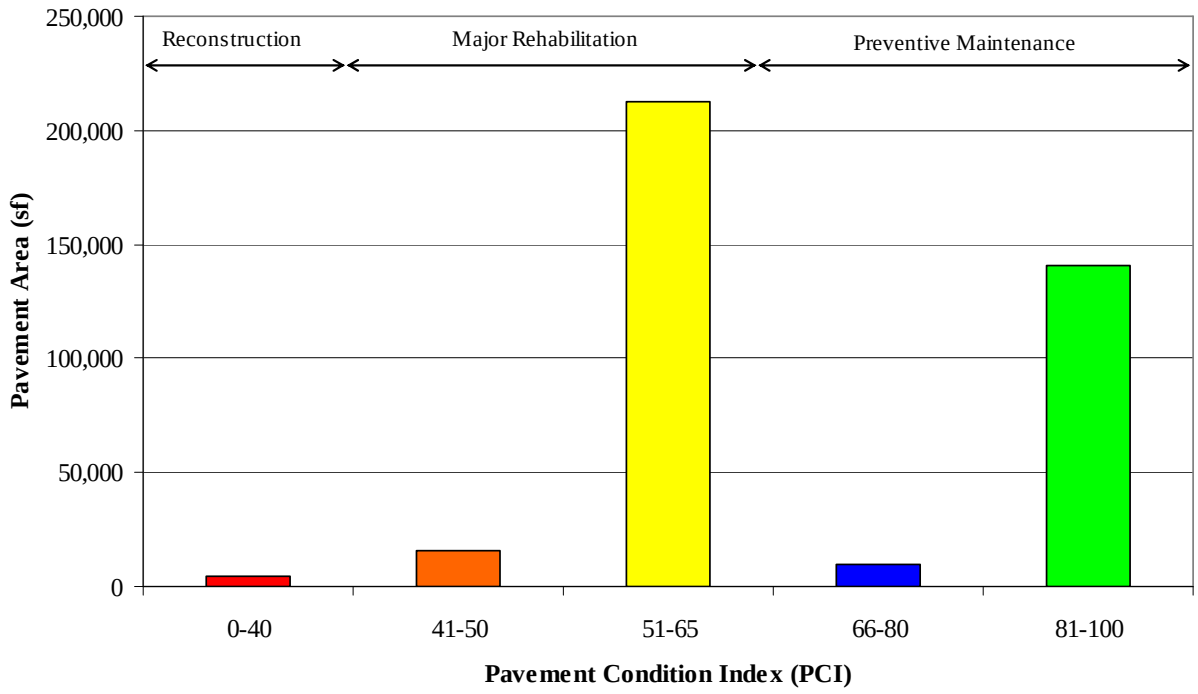
Figure 6. Overall condition.

The pavements at Decorah Municipal Airport were inspected on September 20, 2006. The 2006 area-weighted condition of Decorah Municipal Airport is 68, with conditions ranging from 34 to 100 (on a scale of 0 [failed] to 100 [excellent]). In 2003 the area-weighted PCI of the airport was 78.

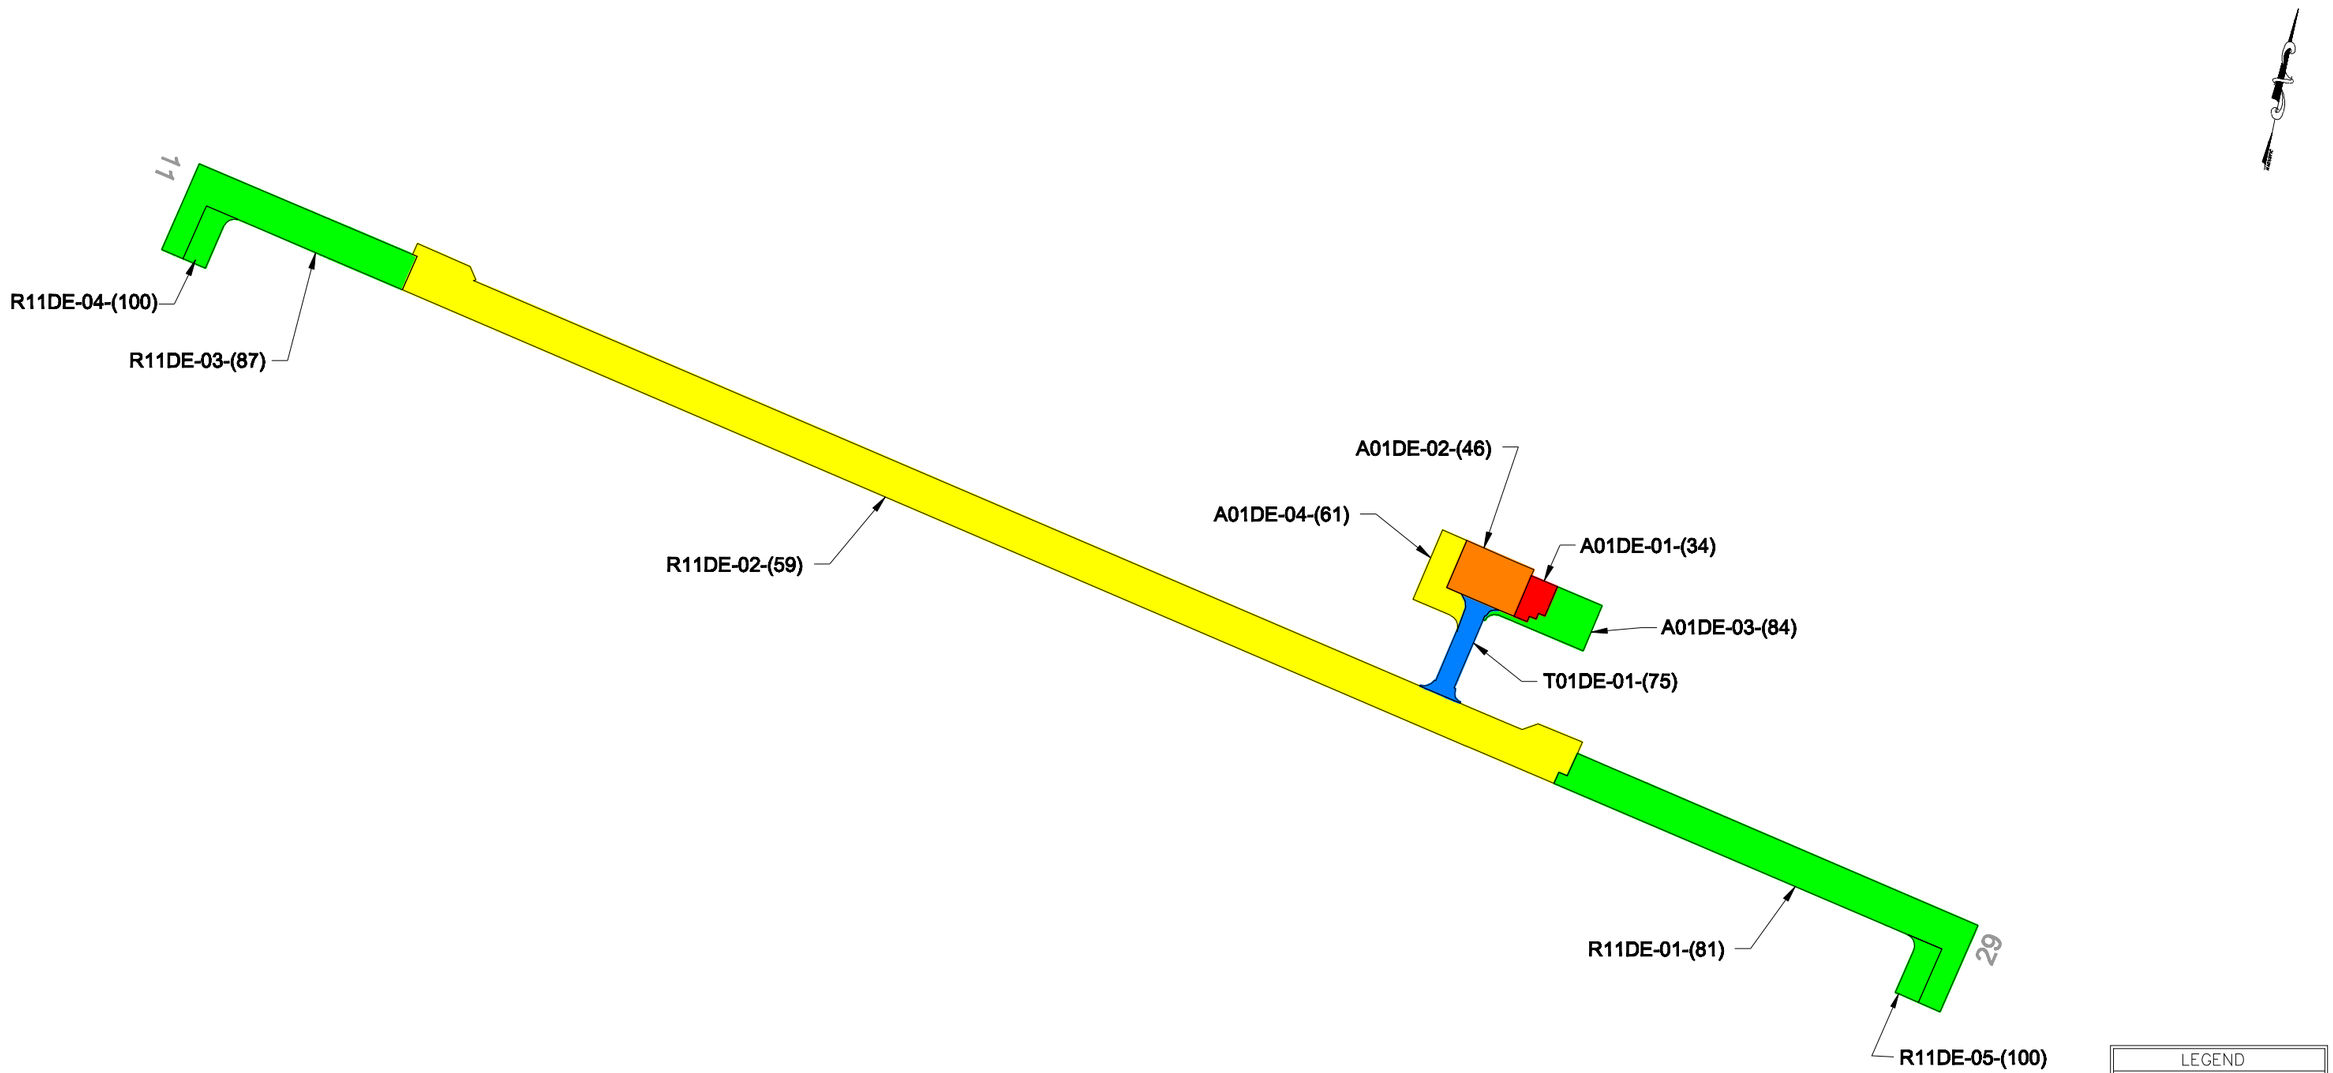
PAGE TITLE: Pavement Condition Index Map

Figures 6 and 7 provide graphs summarizing the overall condition of the pavements at the Decorah Municipal Airport. Figure 8 is a map that displays the condition of the pavements evaluated. Table 1 summarizes the results of the pavement evaluation. Appendix C presents photographs taken during the PCI inspection, and Appendix D contains detailed information on the distresses observed during the visual survey. Appendix E includes detailed work history
