DAVENPORT MUNICIPAL AIRPORT PAVEMENT MANAGEMENT REPORT

Prepared For:
Iowa Department of Transportation
Office of Aviation

Prepared By:
Applied Pavement Technology, Inc.

December 2011

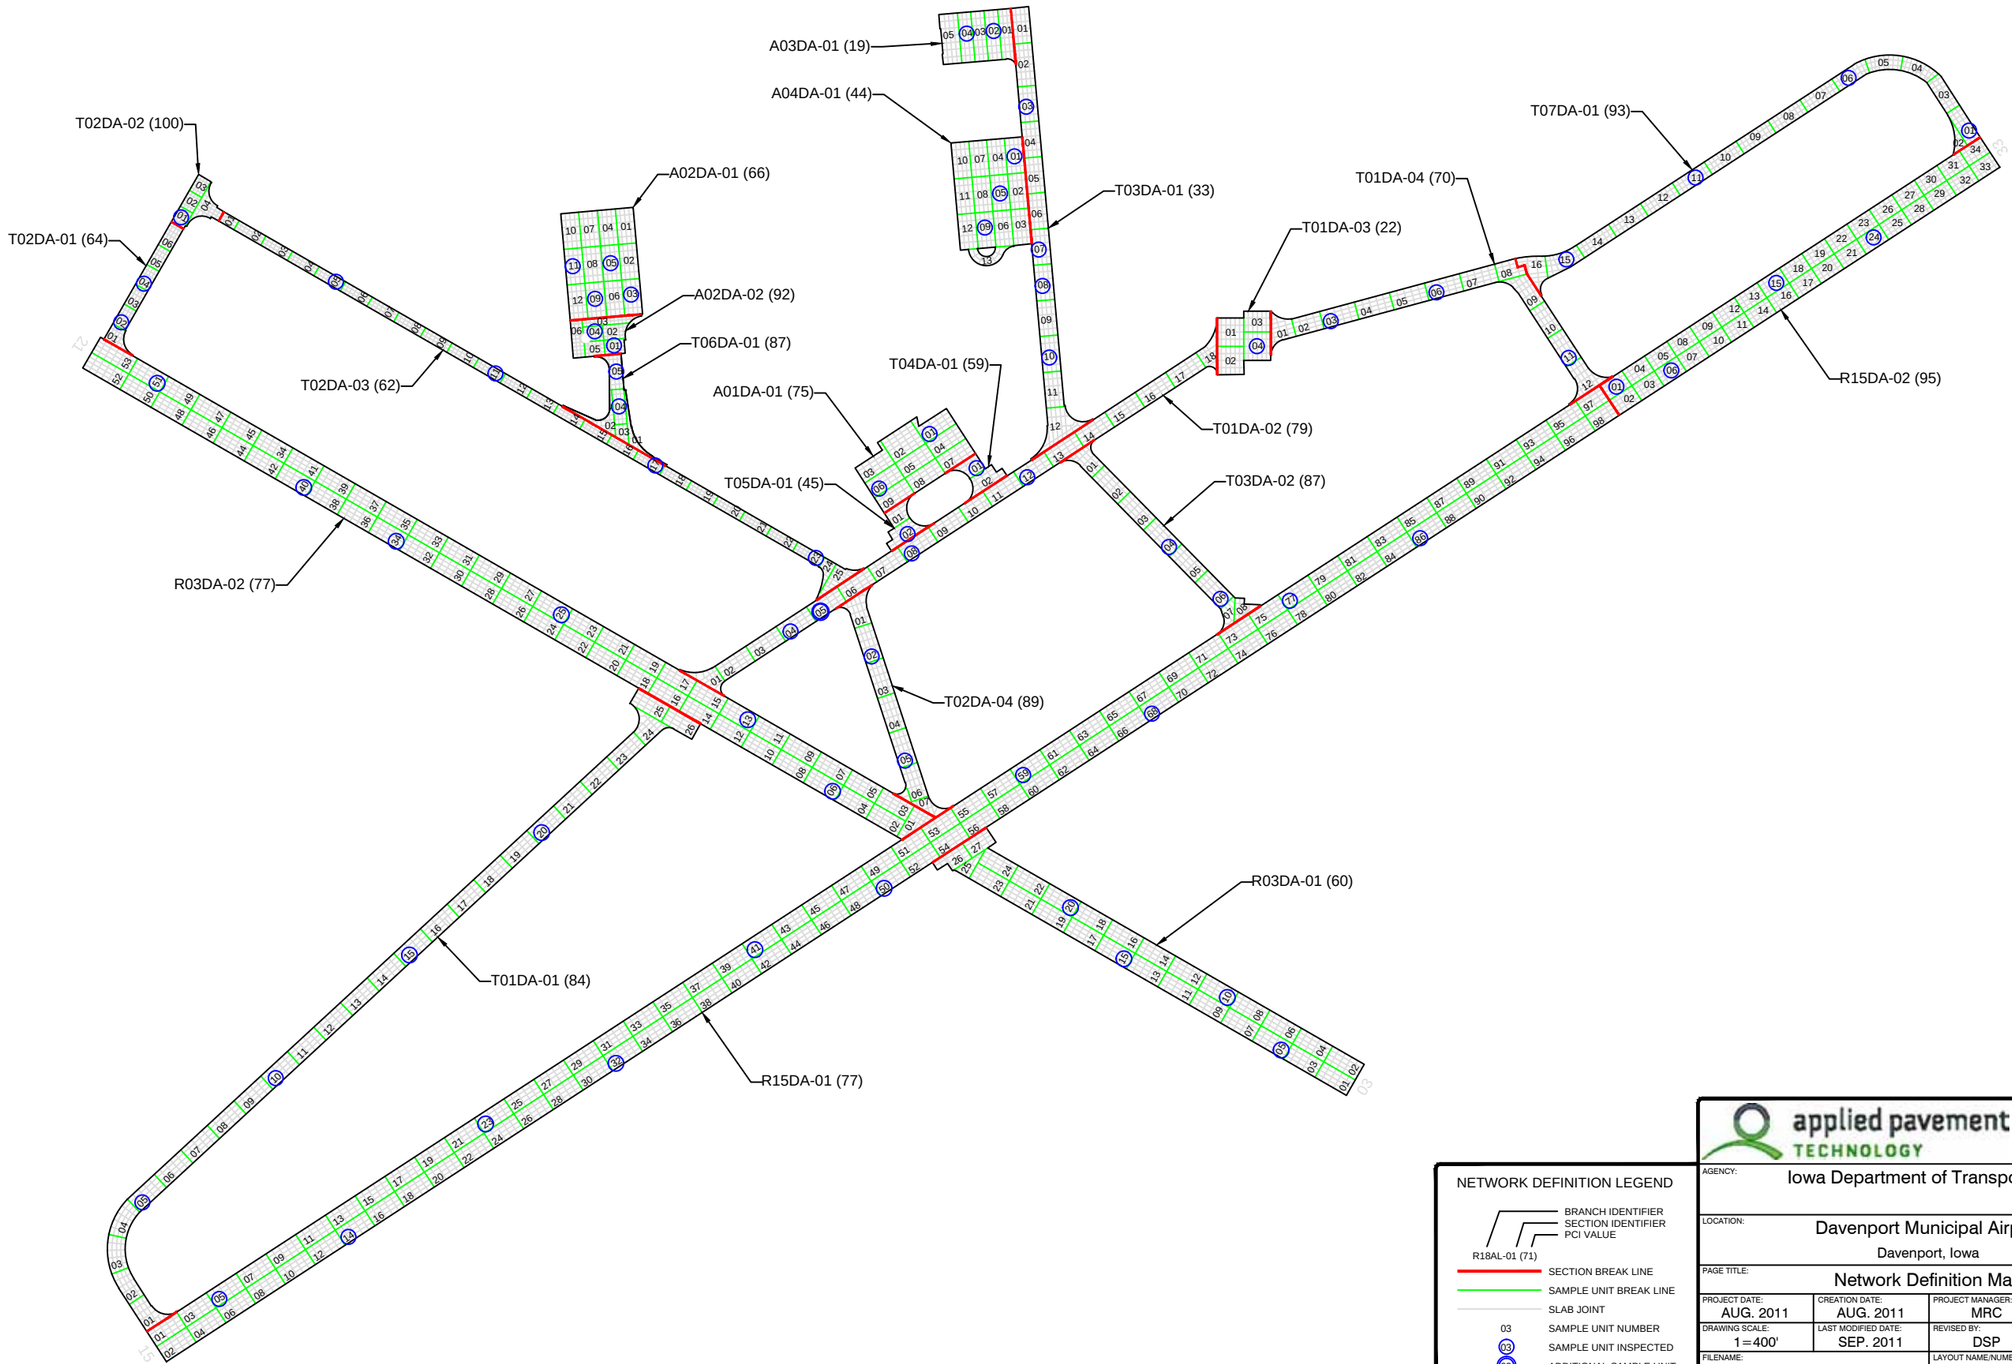
FIGURE 3. NETWORK DEFINITION MAP.

Figure 3 is a network definition map that identifies the pavements at Davenport Municipal Airport that were evaluated during this project. This map shows how the pavement network was divided into branches, sections, and sample units for pavement management purposes. It also shows the nomenclature used in the MicroPAVER pavement management database to identify the different pavement areas.

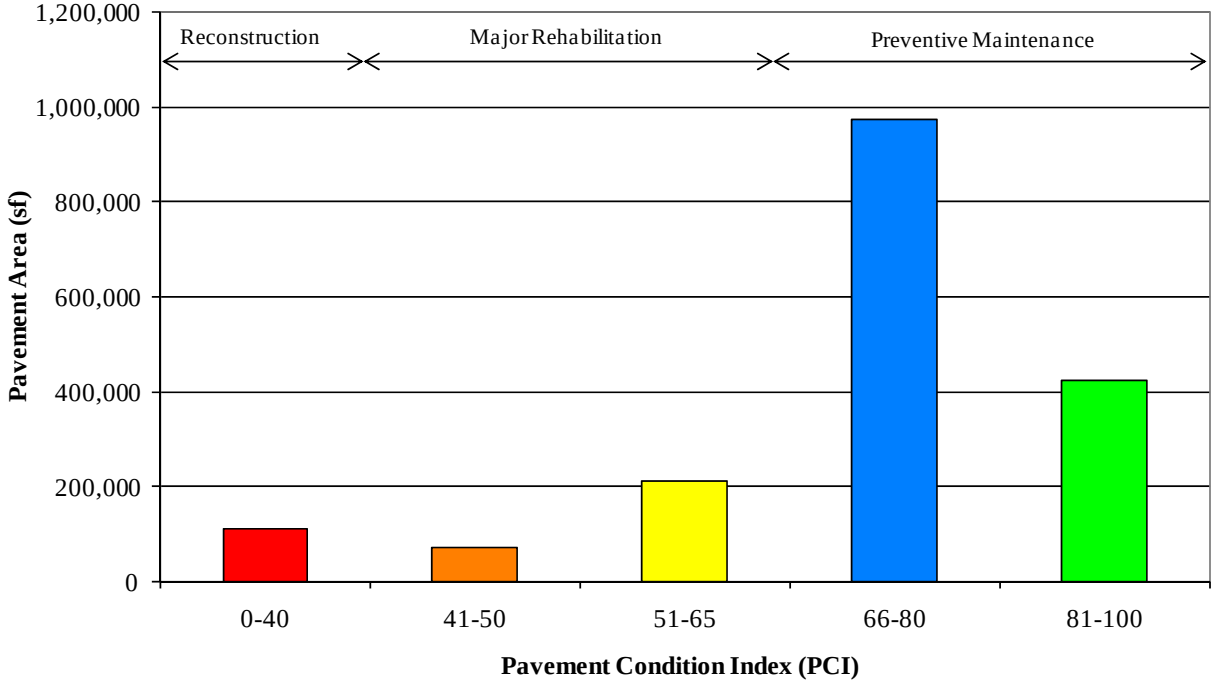
Figure 6. Overall condition.

The pavements at Davenport Municipal Airport were inspected on September 7, 2011. The 2011 area-weighted condition of Davenport Municipal Airport is 73, with conditions ranging from 19 to 100 (on a scale of 0 [failed] to 100 [excellent]). During the previous pavement inspection in 2008, the area-weighted PCI of the airport was 76.

Figures 6 and 7 provide graphs summarizing the overall condition of the pavements at Davenport Municipal Airport. Figure 8 is a map that displays the condition of the pavements evaluated. Table 1 summarizes the results of the pavement evaluation. Appendix C presents photographs taken during the PCI inspection, and Appendix D contains detailed information on the distresses observed during the visual survey. Appendix E includes detailed work history information that
