EAGLE GROVE MUNICIPAL AIRPORT
PAVEMENT MANAGEMENT REPORT

Prepared For:
Iowa Department of Transportation
Office of Aviation

Prepared By:
Applied Pavement Technology, Inc.

November 2003

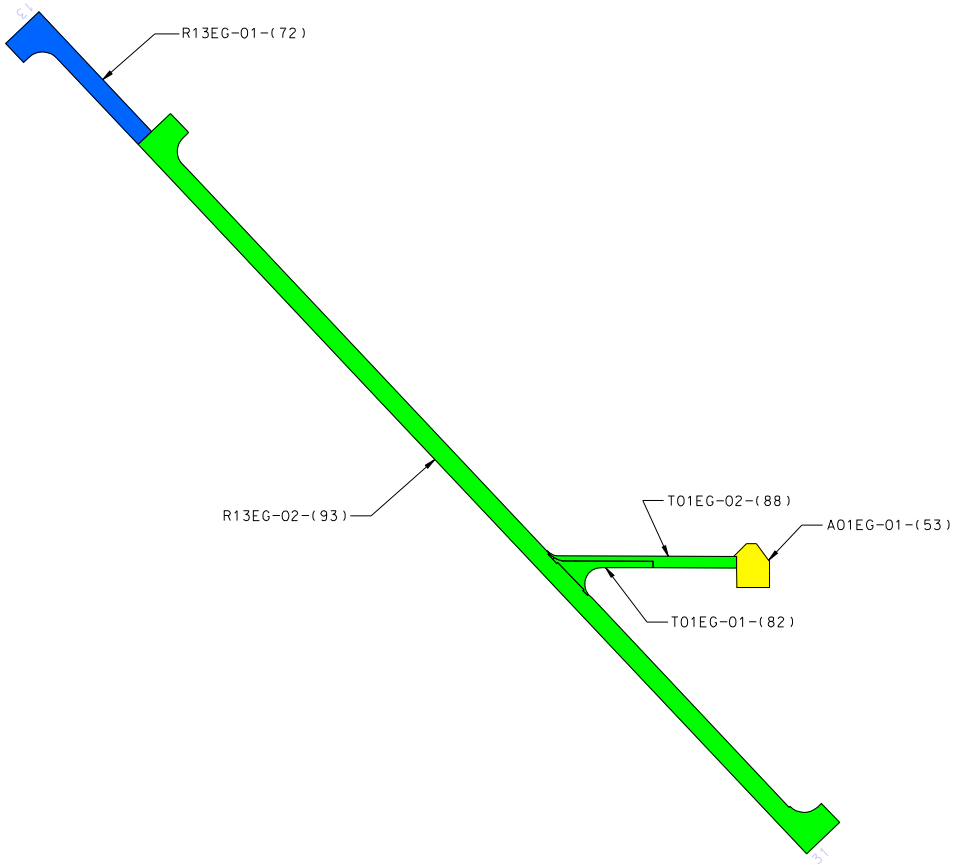
PAVEMENT CONDITION INDEX MAP

The pavements at Eagle Grove Municipal Airport were inspected on November 20, 2003. The 2003 area-weighted condition of Eagle Grove Municipal Airport is 87, with conditions ranging from 53 to 93 (on a scale of 0 [failed] to 100 [excellent]).

Eagle Grove Municipal Airport								
Branch[1]	**Section**	**Surface Type [2]**	**Section Area, sf**	**LCD [3]**	**2003 PCI**	**% Distress Due to:**		**Distress Types**
						Load [4]	**Climate or Durability [5]**	
A01EG	01	AAC	12,200	7/8/1989	53	0	100	Longitudinal and transverse cracking, Raveling and weathering, Depression
R13EG	01	PCC	36,420	7/1/1988	72	100	0	Corner break, Linear Cracking, Shattered slab
R13EG	02	PCC	187,540	6/1/1981	93	75	0	Linear Cracking, Joint spalling, Shrinkage cracks, Small patch, Corner break
T01EG	01	PCC	9,160	6/1/1981	82	66	0	Corner spalling, Joint spalling, Linear Cracking
T01EG	02	PCC	13,600	6/1/1988	88	73	0	Linear Cracking, Large patch

Year	Branch[1]	Section	Type of Repair[2]	Estimated Cost[3]
2004	A01EG	01	Major Rehabilitation	$33,550
	R13EG	01	Localized Maintenance	$550
		02	Localized Maintenance	$452
	T01EG	01	Localized Maintenance	$49
