WEBSTER CITY MUNICIPAL AIRPORT PAVEMENT MANAGEMENT REPORT

Prepared By:
Applied Pavement Technology, Inc.

January 2010

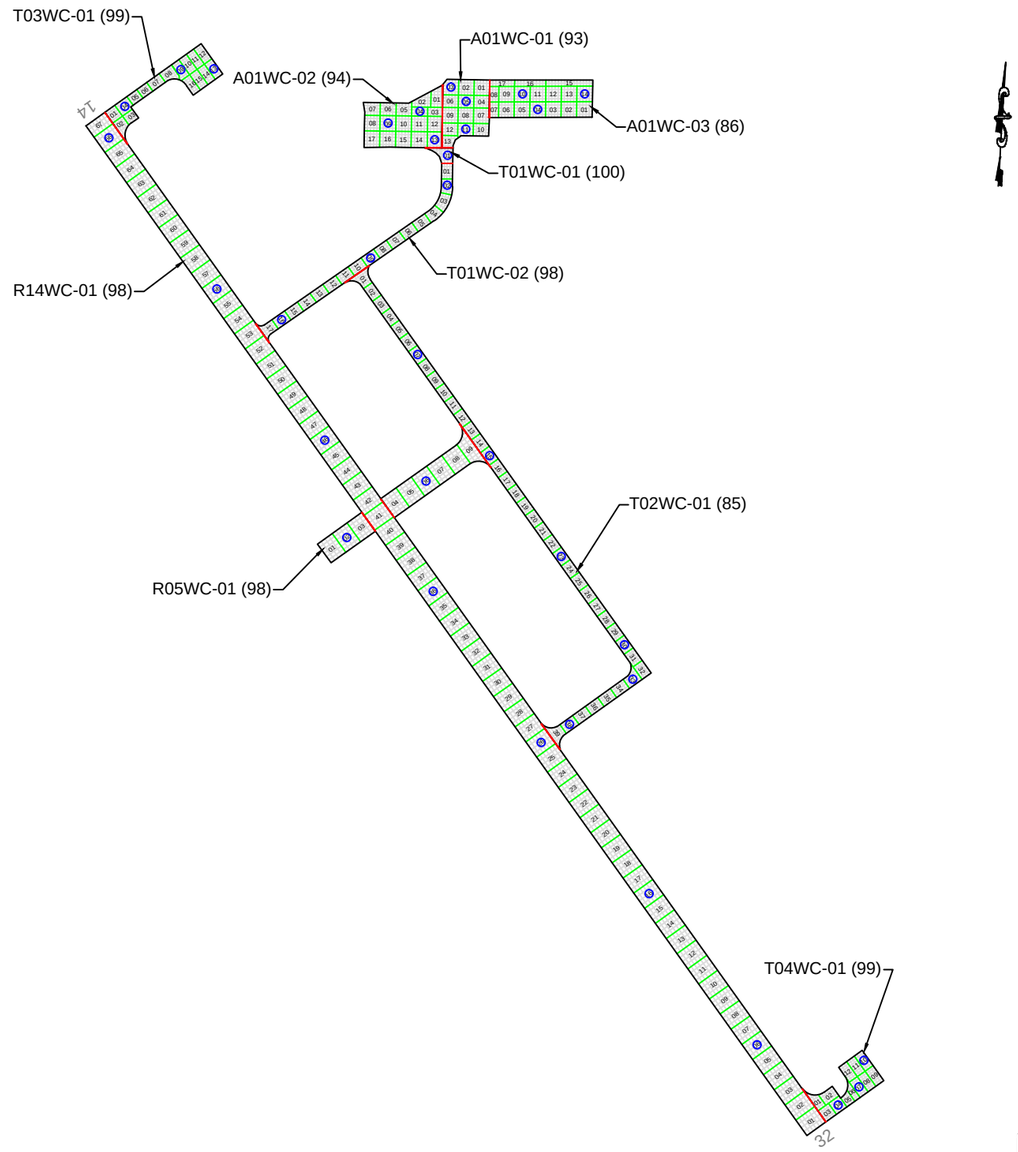
FIGURE 3. NETWORK DEFINITION MAP.

Figure 3 is a network definition map that identifies the pavements at Webster City Municipal Airport that were evaluated during this project. This map shows how the pavement network was divided into branches, sections, and sample units for pavement management purposes. It also shows the nomenclature used in the MicroPAVER pavement management database to identify the different pavement areas.

The network definition map provided in Figure 3 of this report shows the location of all runways, taxiways, and aprons at Webster City Municipal Airport. If any new pavements are constructed or any pavement areas are permanently closed, this map must be updated. Updates can be done by submitting your project plans to the Iowa DOT after project completion.

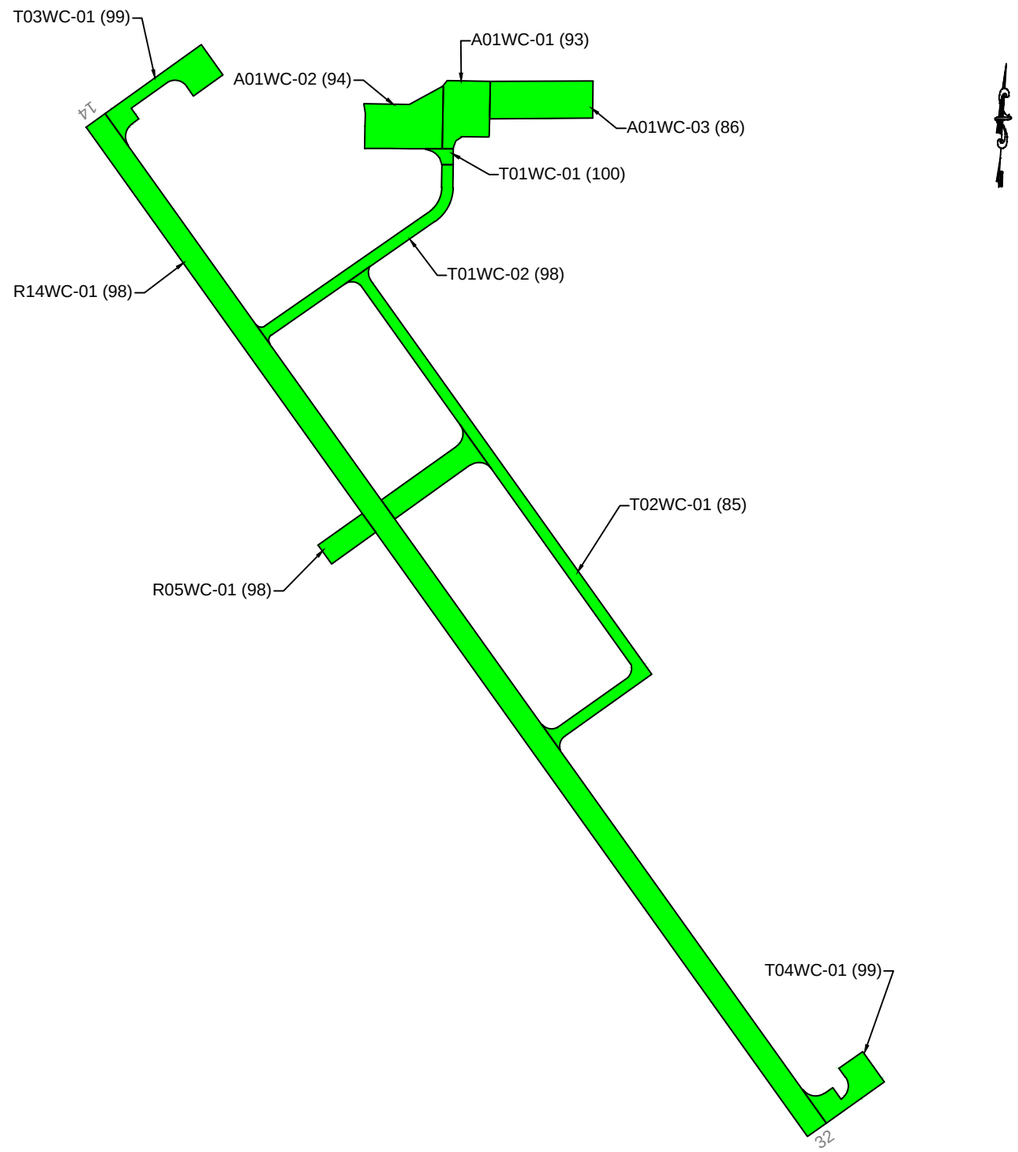
FIGURE 8. PCI MAP.

The pavements at Webster City Municipal Airport were inspected on September 19, 2009. The 2009 area-weighted condition of Webster City Municipal Airport is 95, with conditions ranging from 85 to 100 (on a scale of 0 [failed] to 100 [excellent]). During the previous pavement inspection in 2005, the area-weighted PCI of the airport was 96.

Runway 5-23 is defined by one section that is in excellent condition with low-severity joint seal damage recorded at the time of inspection.

Runway 14-32 also consists of one section that is in excellent condition with low-severity joint seal damage and small amounts of low-severity linear cracking and joint spalling observed.

Taxiway 01 contains two sections that connect Runway 14-32 and the terminal apron. Section 01, located adjacent to the terminal apron, and Section 02, which comprises the majority of this taxiway, are both in excellent condition. Low-severity joint seal damage and isolated areas of medium-severity joint spalling were noted in Section 02 and no distresses were observed in Section 01 at the time of inspection.

Taxiway 02 is defined by one section that connects Taxiway 01 and both runways. Section 01 is in good condition with low-severity joint seal damage recorded. In addition, significant quantities of low- and medium-severity durability cracking and joint spalling and all severities of corner spalling were identified. Isolated areas of low-severity corner breaking were also observed.

Taxiway 03 contains one section that is located adjacent to the Runway 14 approach. Section 01 is in excellent condition with small amounts of low-severity joint seal damage and isolated areas of low-severity joint spalling recorded.

Taxiway 04 consists of one section that is located adjacent to the Runway 32 approach. Section 01 is in excellent condition with small quantities of low-severity joint seal damage identified.

Three sections are defined in the terminal apron area. Section 01, which is comprised of the center portion of the terminal apron, is in good condition with small amounts of low-severity linear cracking observed. Section 02, the western portion of the terminal apron, is in good condition with small amounts of low-severity linear cracking, corner breaking, patching, joint spalling, and corner spalling recorded. Section 03, the eastern portion of the terminal apron, is in good condition. Moderate amounts of low-severity linear cracking and small quantities of low-severity joint seal damage, low- and medium-severity corner breaking, and low-severity joint and corner spalling were identified.
