JEFFERSON MUNICIPAL AIRPORT PAVEMENT MANAGEMENT REPORT

Prepared By:
Applied Pavement Technology, Inc.

December 2011

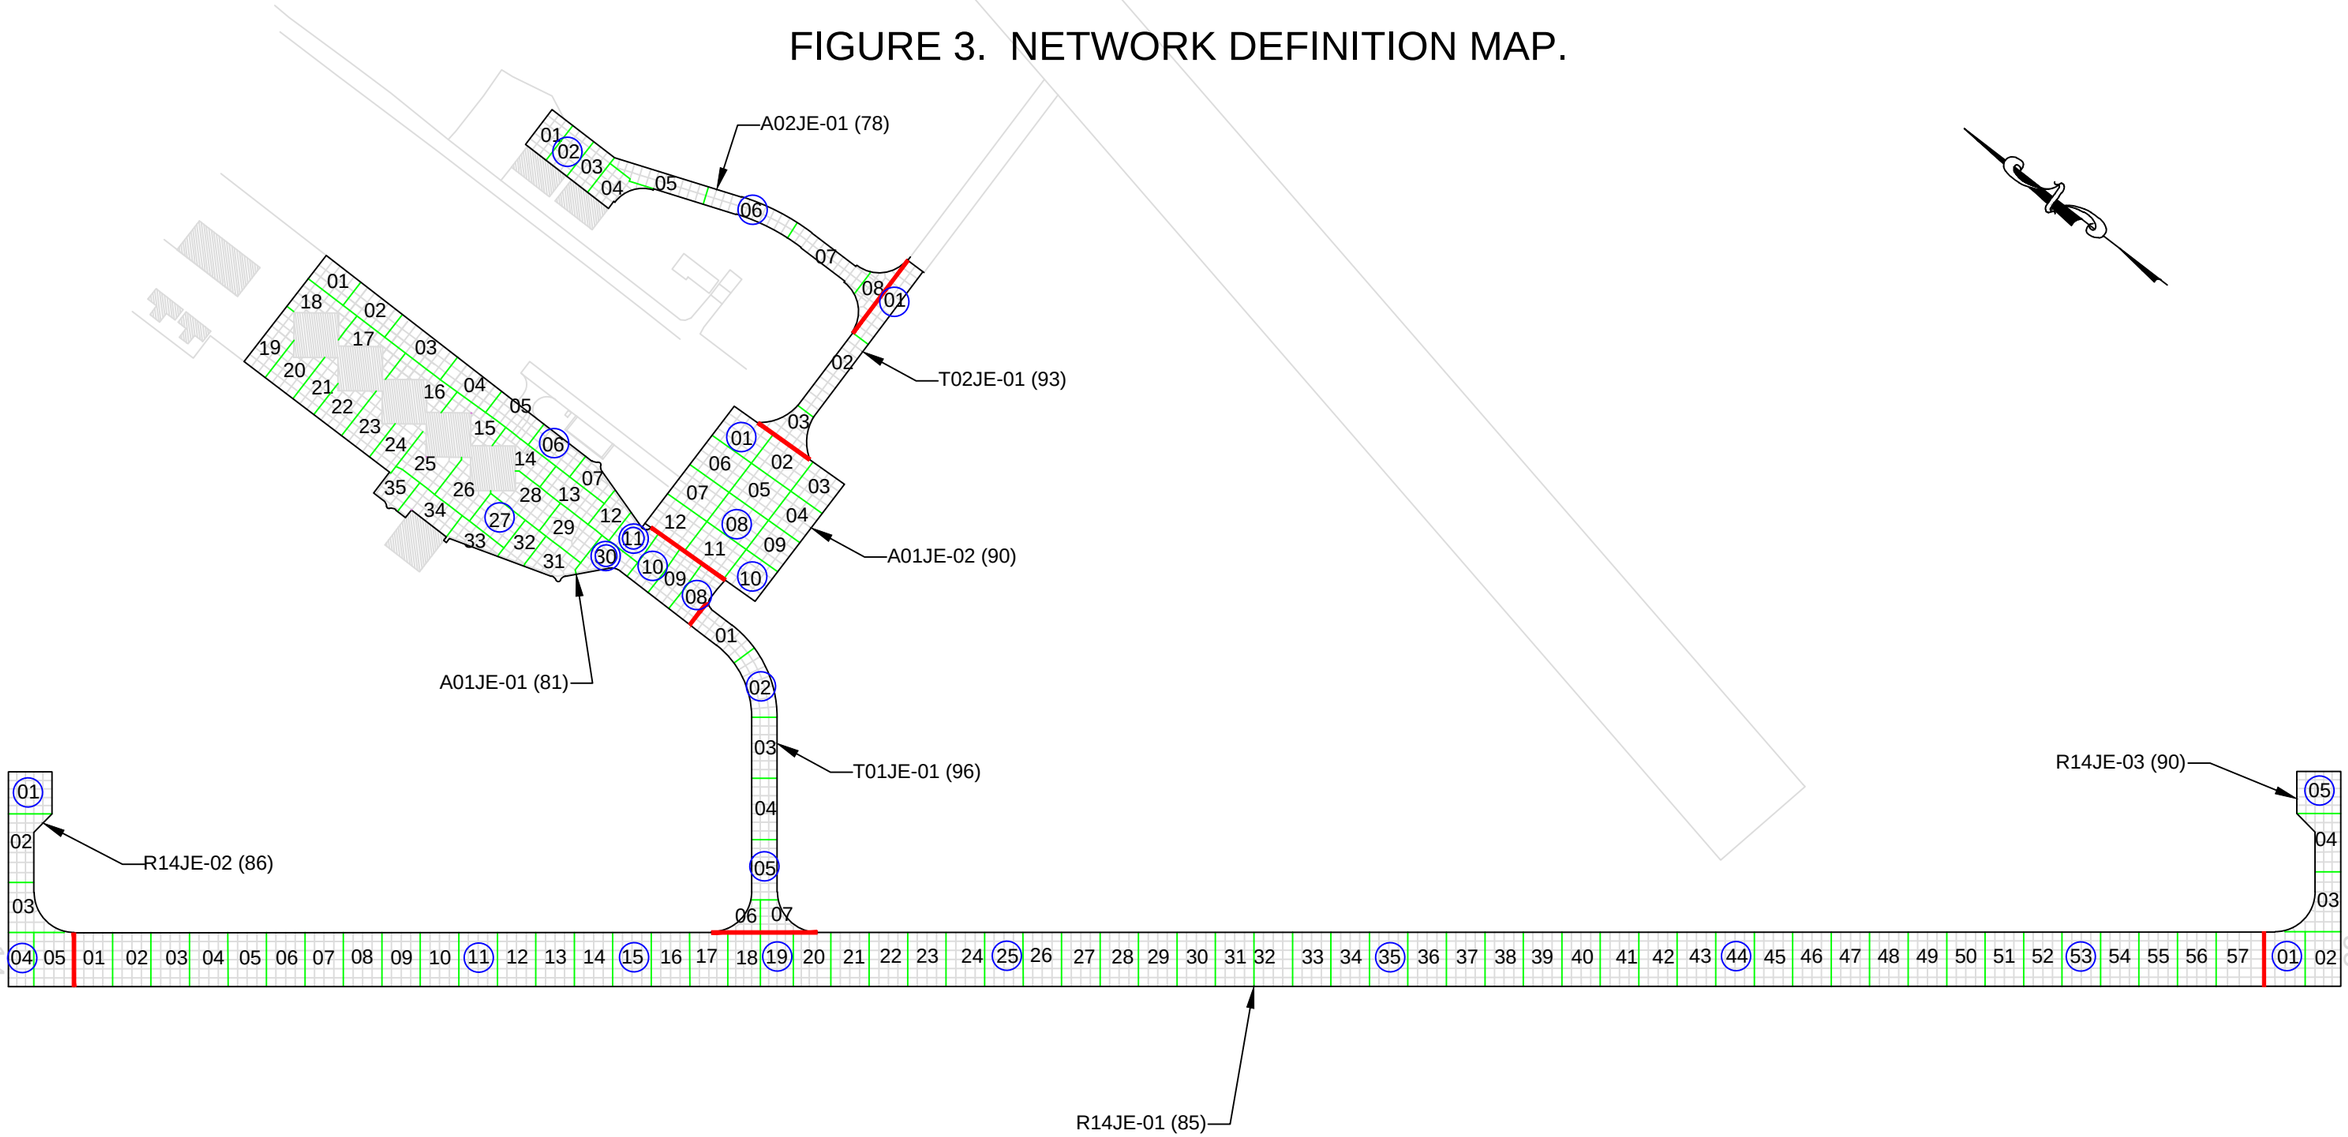
FIGURE 3. NETWORK DEFINITION MAP.

Runway 14-32 consists of three sections. Section 01, the majority of the runway, is in good condition with medium- and high-severity joint seal damage recorded. Additionally, small amounts of low- and medium-severity longitudinal, transverse, and diagonal (LTD) cracking and low-severity faulting were noted. Section 02, a turnaround located at the Runway 14 approach, is in good condition with medium-severity joint seal damage identified. Small quantities of low-severity LTD cracking and corner breaking and low- and medium-severity joint spalling were observed. Section 03, a turnaround located at the Runway 32 approach, is in good condition with medium-severity joint seal damage and low- and high-severity corner spalling noted.

Taxiway 01 connects Runway 14-32 with the main apron area and is defined by one section. Section 01 is in excellent condition with low- and medium-severity joint seal damage recorded.

Taxiway 02 connects the main apron with Apron 02 and is comprised of one section in excellent condition. Medium-severity joint seal damage was the only distress identified.

Apron 01, the main apron, consists of two sections. Section 01, the majority of the apron located near the T-Hangar buildings, is in good condition with low- and medium-severity joint seal damage observed. In addition, extensive amounts of all severities of joint spalling and low-severity LTD cracking and corner breaking were also noted. Small amounts of low-severity corner spalling, large patching, and small patching were also identified. Additional sample units were recorded where high-severity joint spalling was observed. Section 02, located to the east, is in good condition with medium- and high-severity joint seal damage recorded.

Apron 02 is located on the east side of the airfield and is comprised of one section in satisfactory condition. Low- and medium-severity joint spalling, medium-severity joint seal damage, and low-severity LTD cracking and corner breaking were observed.

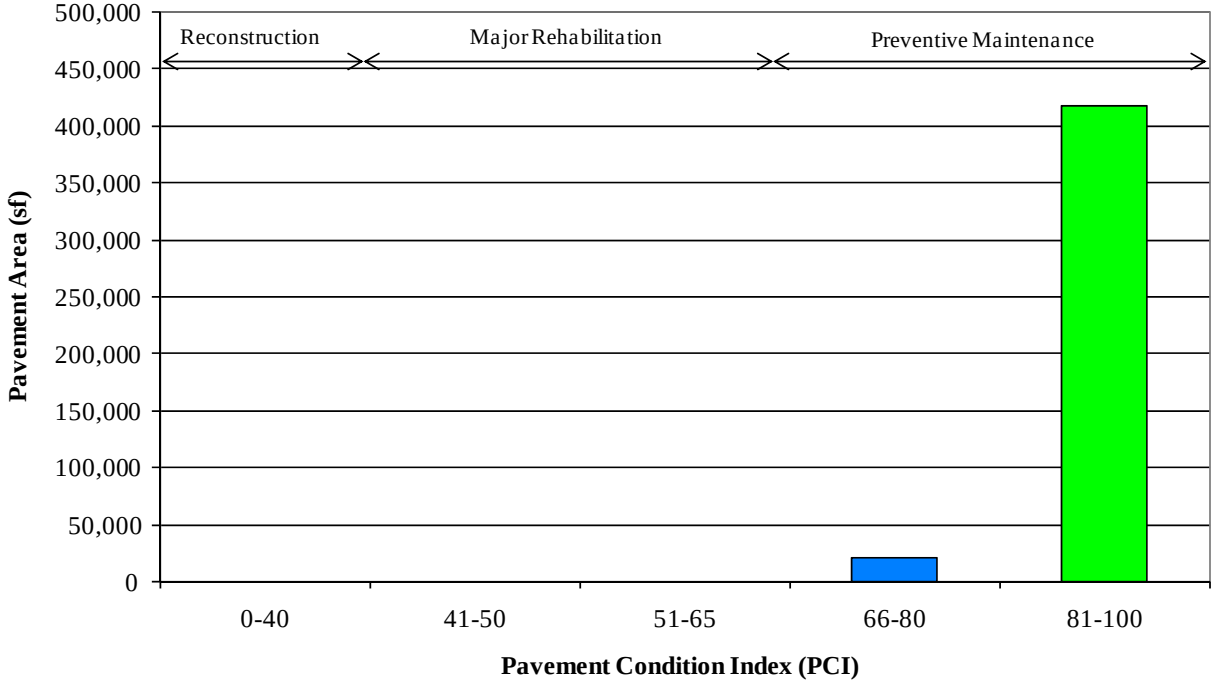
Figure 6. Overall condition.

The pavements at Jefferson Municipal Airport were inspected on September 13, 2011. The 2011 area-weighted condition of Jefferson Municipal Airport is 85, with conditions ranging from 78 to 96 (on a scale of 0 [failed] to 100 [excellent]). During the previous pavement inspection in 2008, the area-weighted PCI of the airport was 87.
