EMMETSBURG MUNICIPAL AIRPORT PAVEMENT MANAGEMENT REPORT

Prepared For:
Iowa Department of Transportation
Office of Aviation

Prepared By:
Applied Pavement Technology, Inc.

January 2010

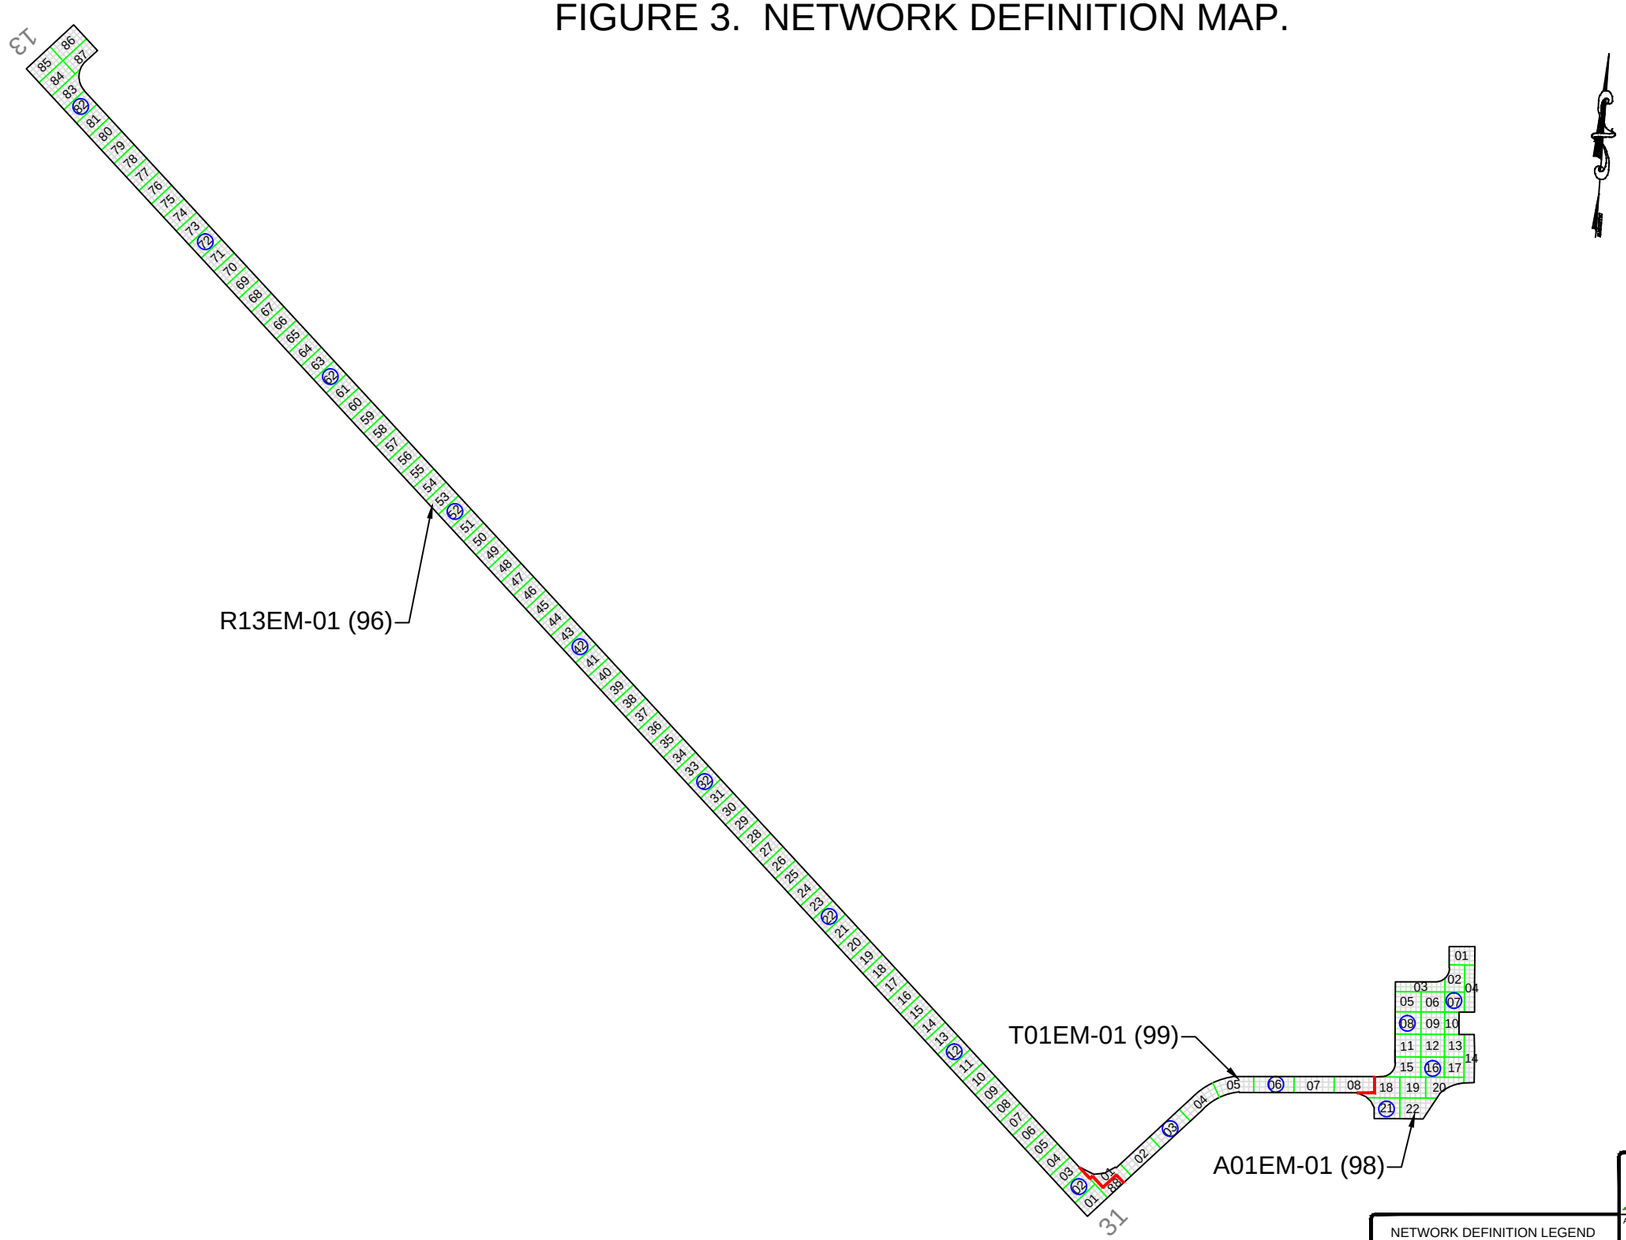
FIGURE 3. NETWORK DEFINITION MAP.

Runway 13-31 contains one section that is in excellent condition with low-severity joint seal damage and small amounts of low- and medium-severity linear cracking and joint spalling recorded.

Taxiway 01 was recently reconstructed and consists of one section in excellent condition with only low-severity joint seal damage observed at the time of inspection.

The terminal apron is defined by one recently reconstructed section that is in excellent condition. Moderate quantities of low-severity joint seal damage and small amounts of low-severity joint spalling were identified.

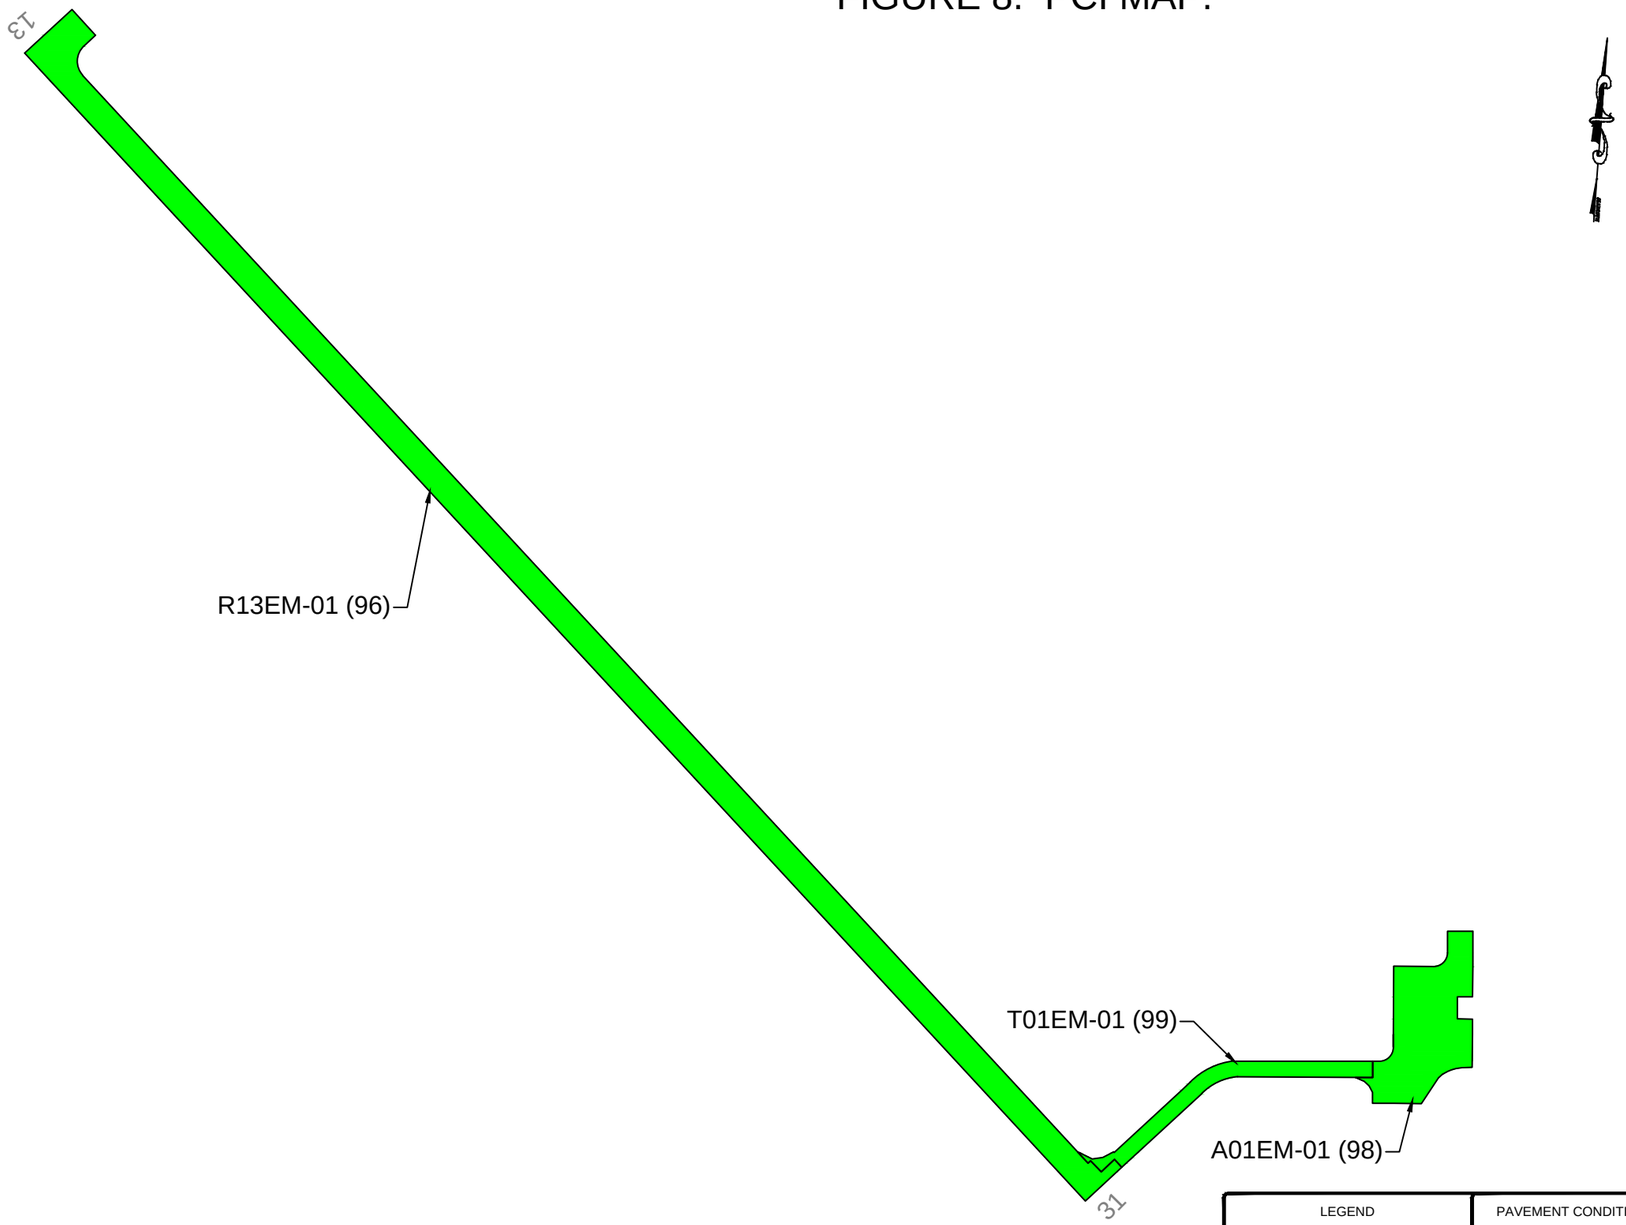
FIGURE 8. PCI MAP.

The pavements at Emmetsburg Municipal Airport were inspected on September 17, 2009. The 2009 area-weighted condition of Emmetsburg Municipal Airport is 97, with conditions ranging from 96 to 99 (on a scale of 0 [failed] to 100 [excellent]). During the previous pavement inspection in 2005, the area-weighted PCI of the airport was 85.
