KEOKUK MUNICIPAL AIRPORT
PAVEMENT MANAGEMENT REPORT

Prepared By:
Applied Pavement Technology, Inc.

December 2010

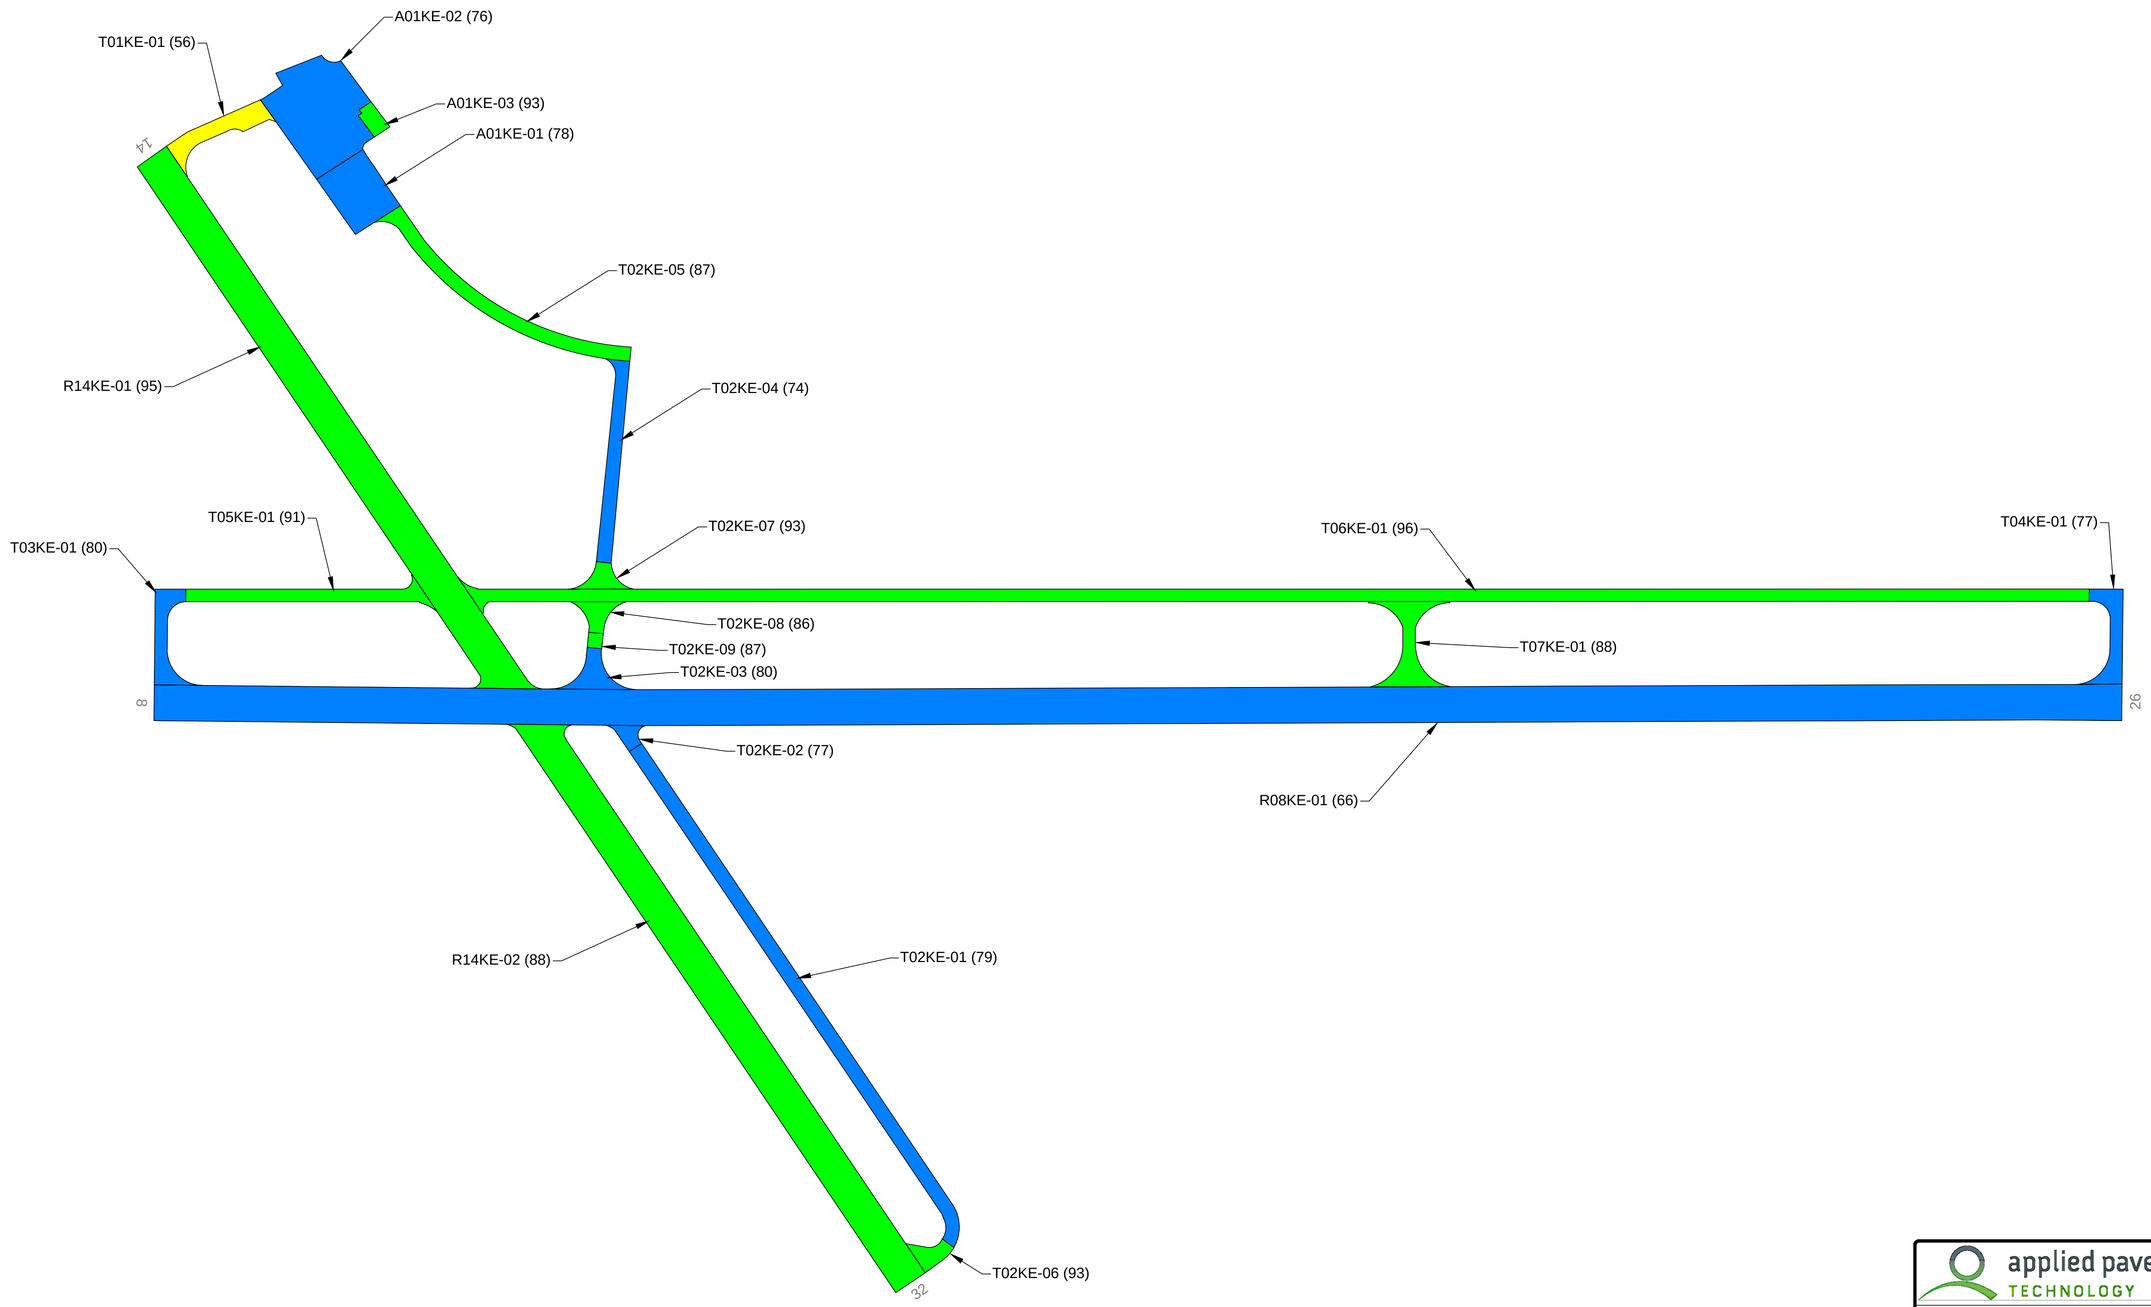
FIGURE 8. PCI MAP.

The pavements at Keokuk Municipal Airport were inspected on September 14-15, 2010. The 2010 area-weighted condition of Keokuk Municipal Airport is 79, with conditions ranging from 56 to 96 (on a scale of 0 [failed] to 100 [excellent]). During the previous pavement inspection in 2006, the area-weighted PCI of the airport was 85.

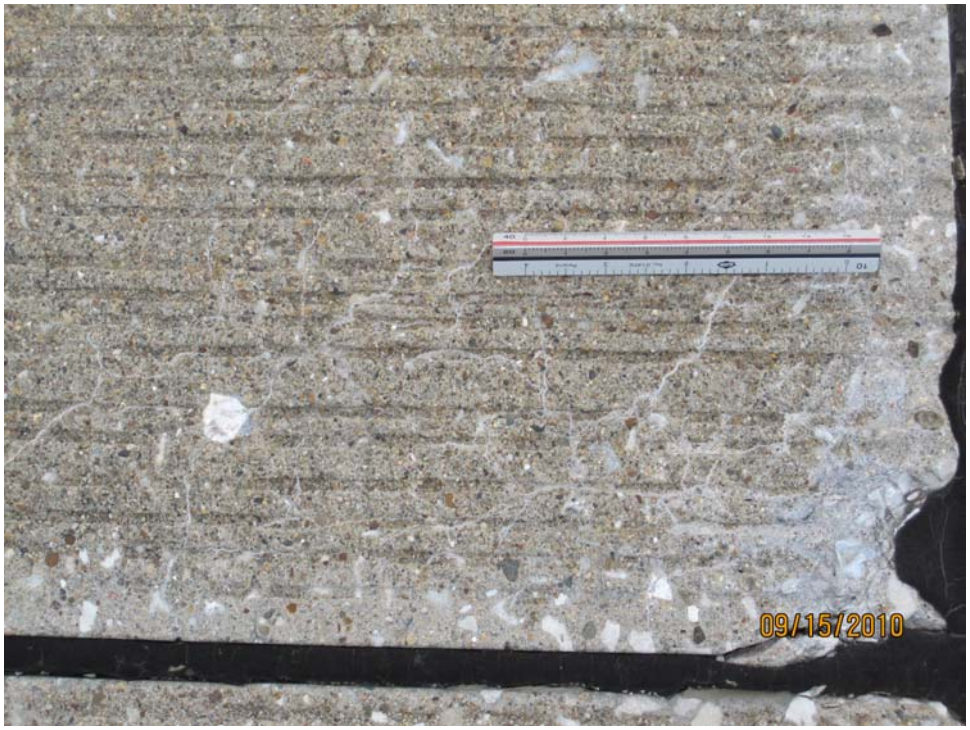
Runway 8-26 is comprised of one section that is in satisfactory condition with low-, medium-, and high-severity joint seal damage recorded throughout. Extensive quantities of low-severity durability cracking and popouts were identified. Isolated amounts of low- and medium-severity faulting and corner spalling and medium-severity linear cracking were also observed. This runway has been scheduled for a micro-surfacing project in 2011.

R08KE-01. Corner Spall.
