# FAIRFIELD MUNICIPAL AIRPORT PAVEMENT MANAGEMENT REPORT

**Prepared For:**
Iowa Department of Transportation
Office of Aviation

**Prepared By:**
Applied Pavement Technology, Inc.

December 2010

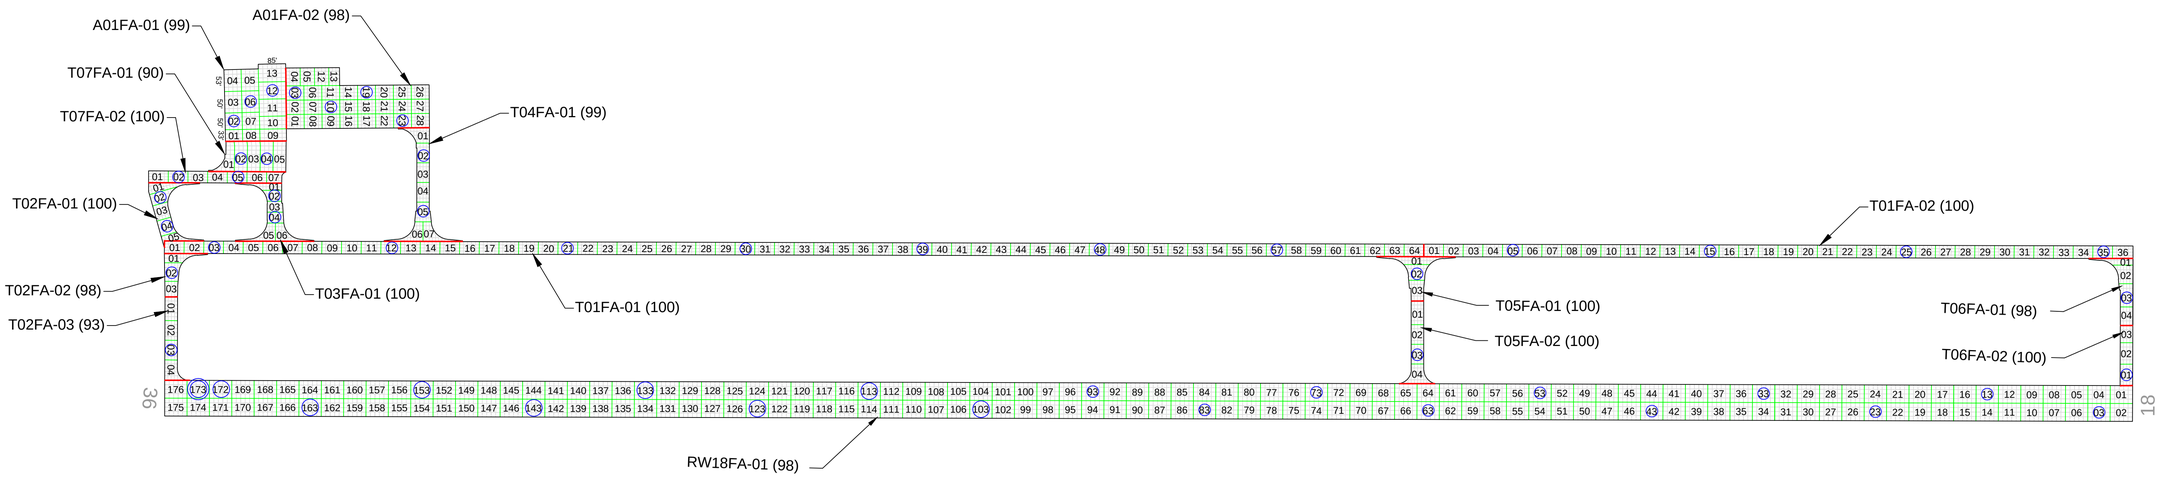
# FIGURE 3. NETWORK DEFINITION MAP.

Runway 18-36 is defined by one section that was recently reconstructed. Section 01 is in excellent condition with low-severity joint seal damage observed. Isolated quantities of low-severity corner breaks, medium-severity linear cracking, low- and high-severity joint spalling, and medium-severity corner spalling were also recorded.

Taxiway 01 is the parallel taxiway to Runway 18-36. This taxiway consists of two, recently reconstructed sections that are in excellent condition with no distresses identified during the inspection.

Taxiway 02 connects Taxiway 01 to the Runway 36 approach and contains three recently reconstructed sections. Section 01, located to the west of the parallel taxiway, is in excellent condition with no distresses observed. Section 02, located to the east to the parallel taxiway, is in excellent condition with only low-severity joint seal damage recorded. Section 03, located adjacent to the runway, is in good condition with medium-severity joint seal damage identified.

Taxiway 03 connects Taxiway 01 to the apron area and consists of one, recently reconstructed section in excellent condition with no distresses observed.

Taxiway 04 connects Taxiway 01 to the apron area and contains one, recently reconstructed section that is in excellent condition with only isolated areas of low-severity joint seal damage recorded.

Taxiway 05 connects Taxiway 01 to the runway midfield and is defined by two, recently reconstructed sections that are in excellent condition with no distresses identified during the inspection.

Taxiway 06 connects Taxiway 01 to the Runway 18 approach and contains two, recently reconstructed sections. Section 01, located adjacent to the taxiway, is in excellent condition with only low-severity joint seal damage recorded. Section 02, located adjacent to the runway, is also in excellent condition with no distresses observed.

Taxiway 07 connects Taxiway 01 to the apron area and consists of two sections. Section 01 is in good condition with small amounts of low-severity joint seal damage and isolated quantities of medium- and high-severity joint spalling recorded. Section 02, located adjacent to the apron area, was recently reconstructed and is in excellent condition with no distresses identified at the time of inspection.

Two sections are defined in the apron area (Apron 01). Section 01, the southern portion of the apron area, is in excellent condition with only low-severity joint seal damage recorded. Section

02, the northern portion of the apron area, is also in excellent condition with only isolated quantities of low-severity joint seal damage and joint spalling observed.

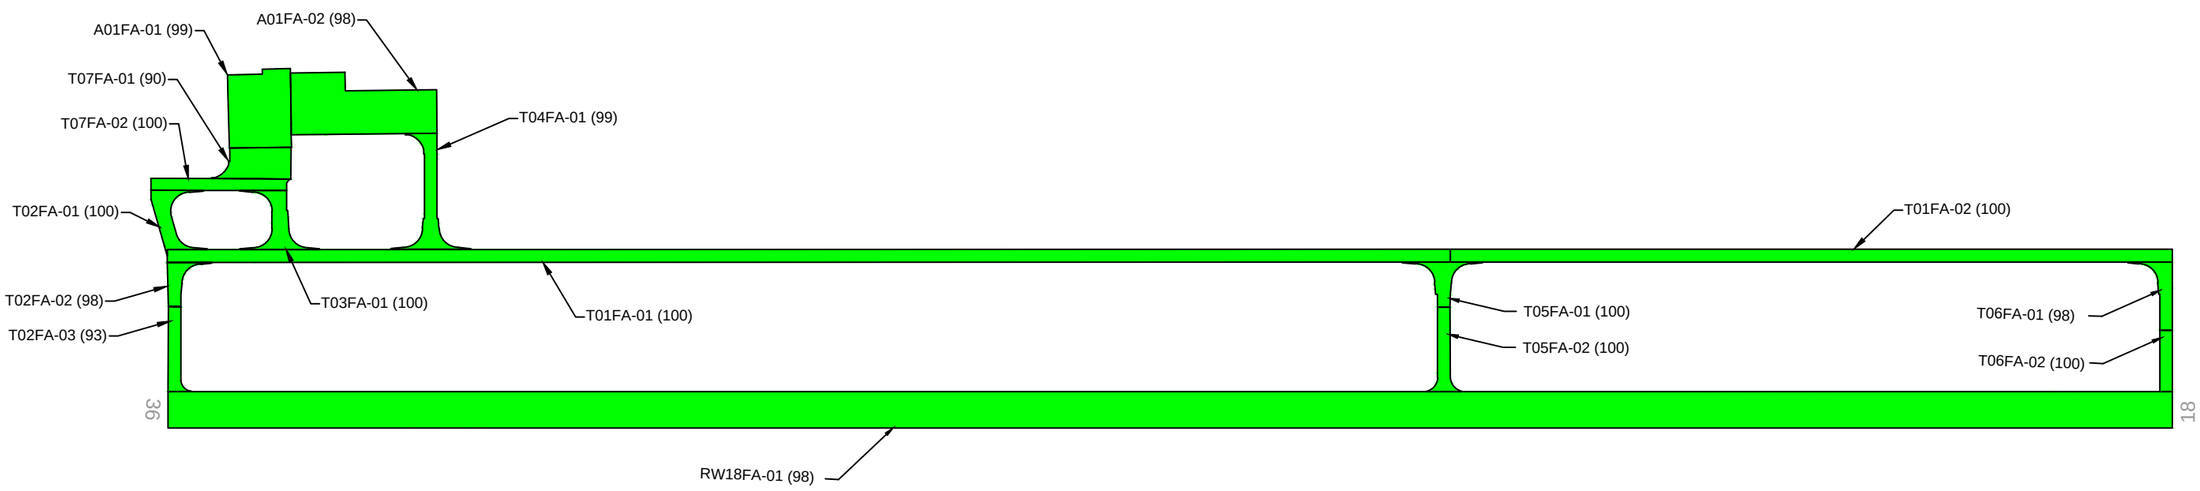
# FIGURE 8. PCI MAP.

The pavements at Fairfield Municipal Airport were inspected on September 15, 2010. The 2010 area-weighted condition of Fairfield Municipal Airport is 98, with conditions ranging from 90 to 100 (on a scale of 0 [failed] to 100 [excellent]). During the previous pavement inspection in 2006, the area-weighted PCI of the airport was 93.

Figures 6 and 7 provide graphs summarizing the overall condition of the pavements at the Fairfield Municipal Airport. Figure 8 is a map that displays the condition of the pavements evaluated. Table 1 summarizes the results of the pavement evaluation. Appendix C presents photographs taken during the PCI inspection, and Appendix D contains detailed information on the distresses observed during the visual survey. Appendix E includes detailed work history
