FORT DODGE REGIONAL AIRPORT PAVEMENT MANAGEMENT REPORT

Prepared For:
Iowa Department of Transportation
Office of Aviation

Prepared By:
Applied Pavement Technology, Inc.

January 2010

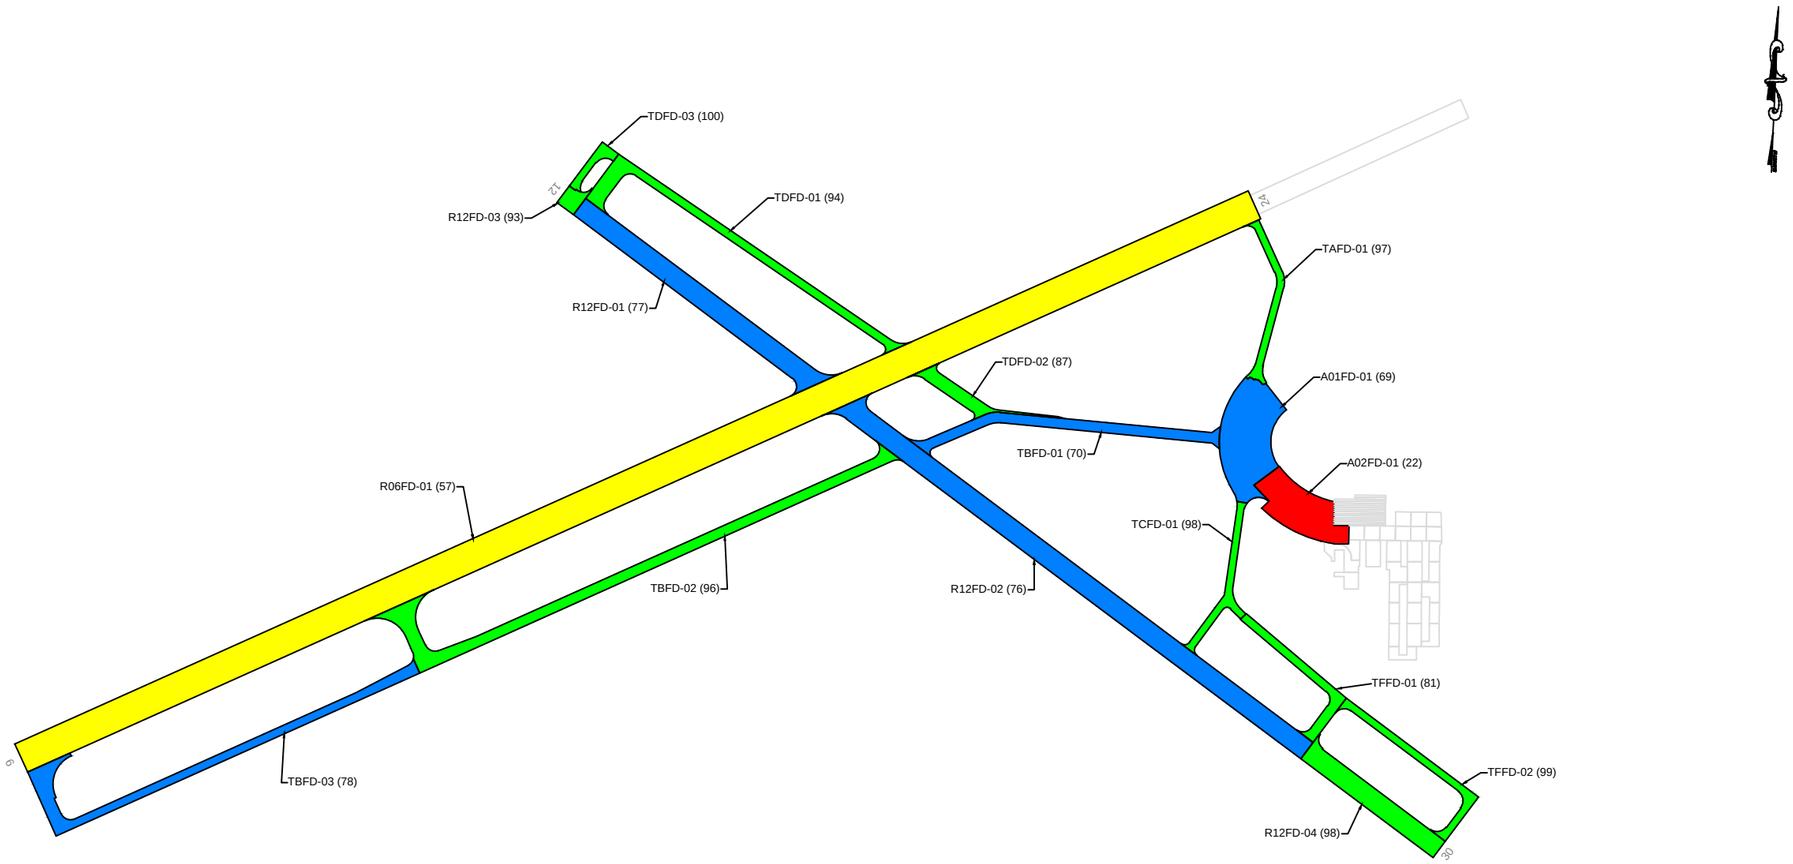
FIGURE 8. PCI MAP.

The pavements at Fort Dodge Regional Airport were inspected on September 18, 2009. The 2009 area-weighted condition of Fort Dodge Regional Airport is 70, with conditions ranging from 22 to 100 (on a scale of 0 [failed] to 100 [excellent]). During the previous pavement inspection in 2005, the area-weighted PCI of the airport was 71.

Figures 6 and 7 provide graphs summarizing the overall condition of the pavements at the Fort Dodge Regional Airport. Figure 8 is a map that displays the condition of the pavements evaluated. Table 1 summarizes the results of the pavement evaluation. Appendix C presents photographs taken during the PCI inspection, and Appendix D contains detailed information on the distresses observed during the visual survey. Appendix E includes detailed work history

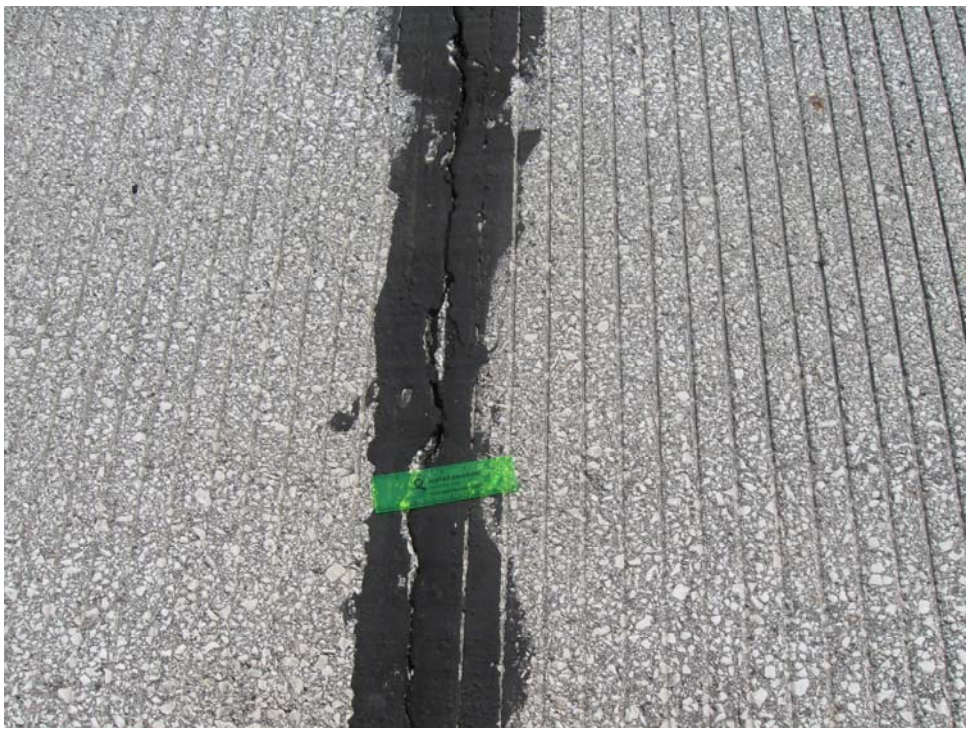
R06FD-01. Overview.

Runway 6-24 contains one section that is in fair condition with extensive amounts of low- and medium-severity longitudinal and transverse (L&T) cracking observed. In addition, small amounts of low- and medium-severity alligator cracking, medium-severity raveling and weathering, and high-severity L&T cracking were noted. The majority of the low-severity cracking was unsealed and the medium-severity cracking was due to failed crack sealant. The high-severity cracking had widths greater than 3 inches.

R06FD-01. Longitudinal and transverse cracking.
