FORT MADISON MUNICIPAL AIRPORT PAVEMENT MANAGEMENT REPORT

Prepared By:
Applied Pavement Technology, Inc.

January 2007

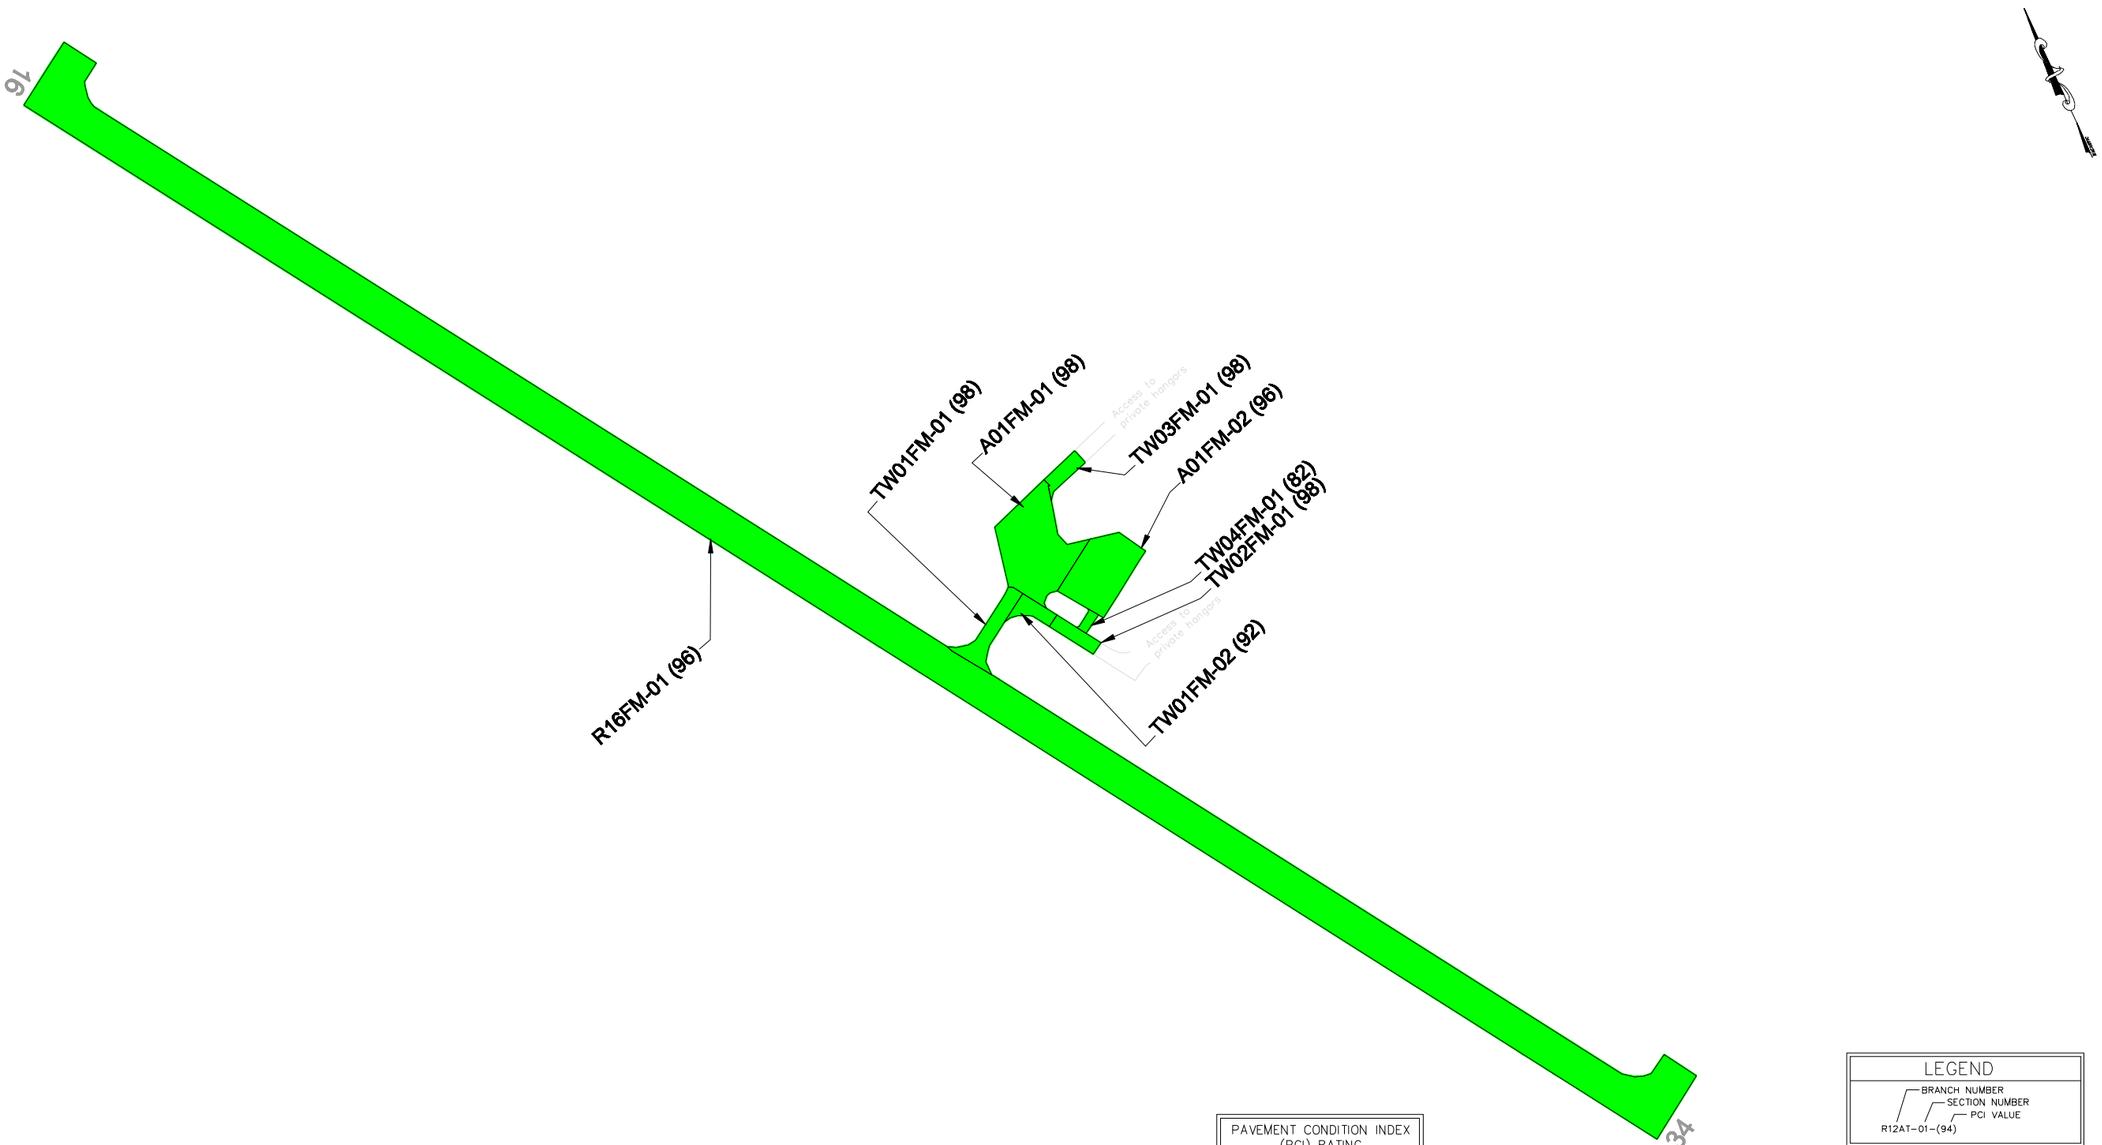
PAGE TITLE: Pavement Condition Index Map

The pavements at Fort Madison Municipal Airport were inspected on September 19, 2006. The 2006 area-weighted condition of Fort Madison Municipal Airport is 96, with conditions ranging from 82 to 98 (on a scale of 0 [failed] to 100 [excellent]). In 2003 the area-weighted PCI of the airport was 94.
