FORT MADISON MUNICIPAL AIRPORT PAVEMENT MANAGEMENT REPORT

Prepared By:
Applied Pavement Technology, Inc.

December 2010

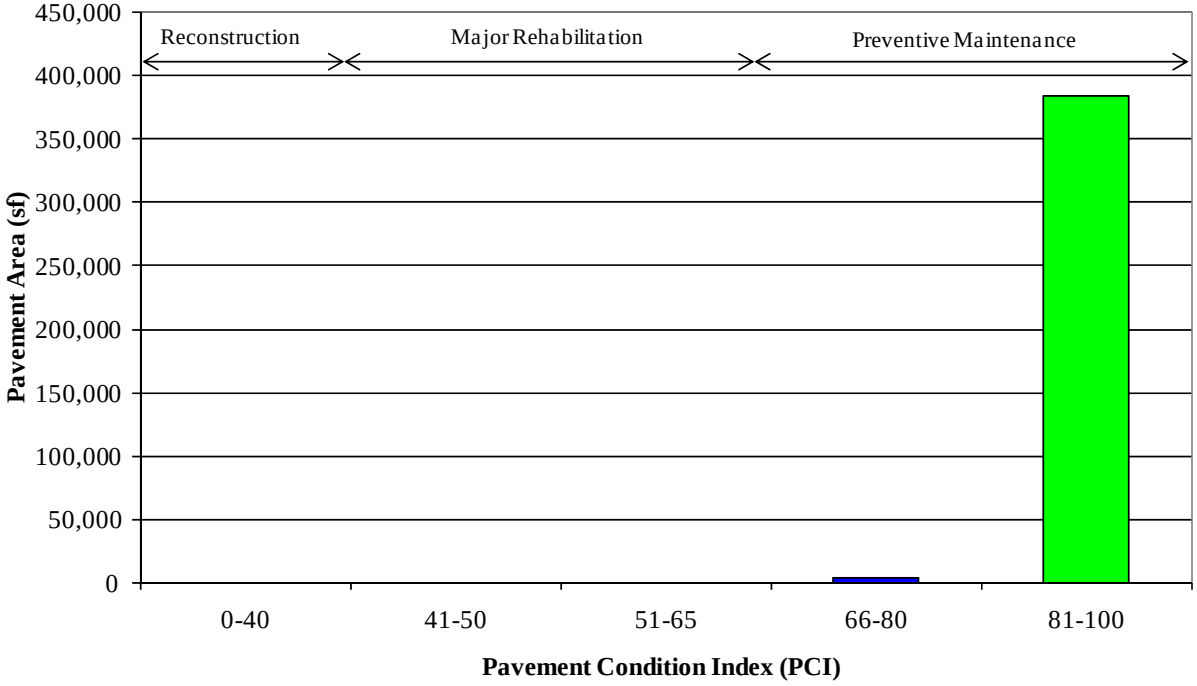
Figure 6. Overall condition.

The pavements at Fort Madison Municipal Airport were inspected on September 15, 2010. The 2010 area-weighted condition of Fort Madison Municipal Airport is 96, with conditions ranging from 80 to 100 (on a scale of 0 [failed] to 100 [excellent]). During the previous pavement inspection in 2006, the area-weighted PCI of the airport was 96.
