GUTHRIE COUNTY REGIONAL AIRPORT PAVEMENT MANAGEMENT REPORT

Prepared For:
Iowa Department of Transportation
Office of Aviation

Prepared By:
Applied Pavement Technology, Inc.

December 2010

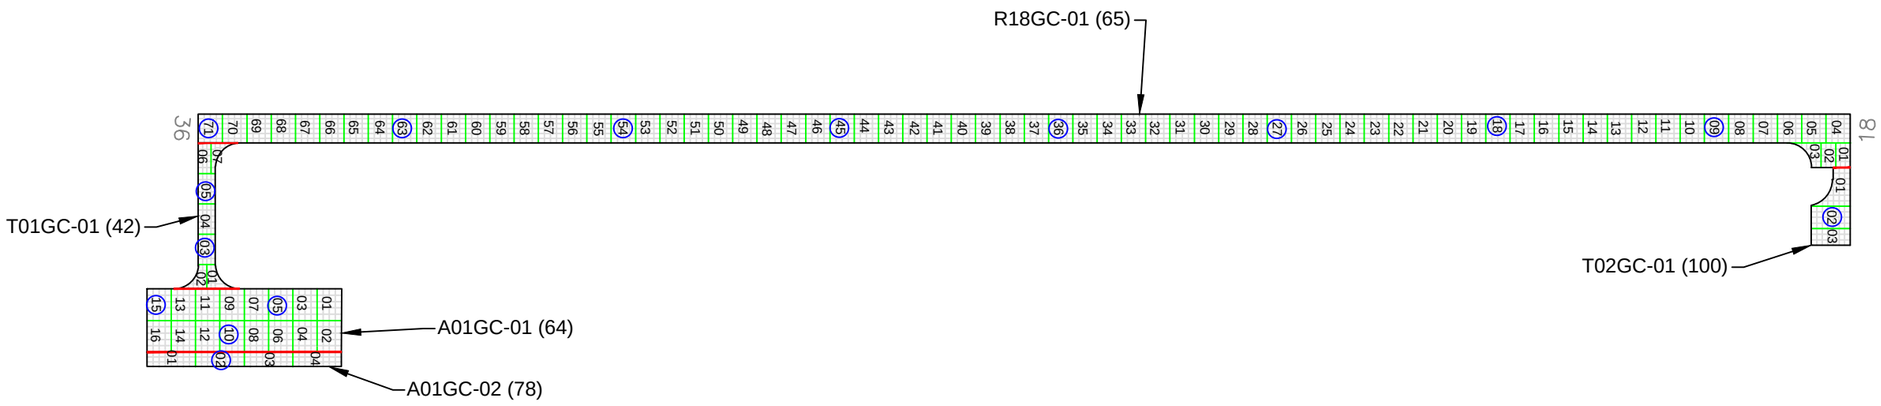
FIGURE 3. NETWORK DEFINITION MAP.

Runway 14-32 is defined by one section that is in fair condition with high-severity joint seal damage recorded throughout. Extensive quantities of low-severity durability cracking and popouts along with small quantities of low-severity corner breaking, linear cracking, and faulting were also observed. In addition, isolated amounts of high-severity joint spalling were noted.

Taxiway 01 connects the runway with the apron area and is in poor condition with high-severity joint seal damage and significant quantities of low- and medium-severity durability cracking and popouts observed.

Taxiway 02, located near the Runway 18 approach, was recently constructed and is in excellent condition with no distresses identified at the time of inspection.

Two sections are defined in the apron area (Apron 01). Section 01, the majority of the apron area, is in fair condition with high-severity joint seal damage and significant quantities of low- and medium-severity durability cracking and popouts recorded throughout. In addition, isolated quantities of low-severity linear cracking were observed. Section 02, the eastern portion of the apron area, is in satisfactory condition with high-severity joint seal damage and moderate quantities of low-severity durability cracking and popouts identified.

Year	Branch[1]	Section[1]	Type of Repair[2]	Estimated Cost[3]
2011	R18GC	01	Major Rehabilitation	$1,525,009
	T01GC	01	Major Rehabilitation	$177,173
2015	A01GC	01	Major Rehabilitation	$453,610
			Total:	**$2,155,792**

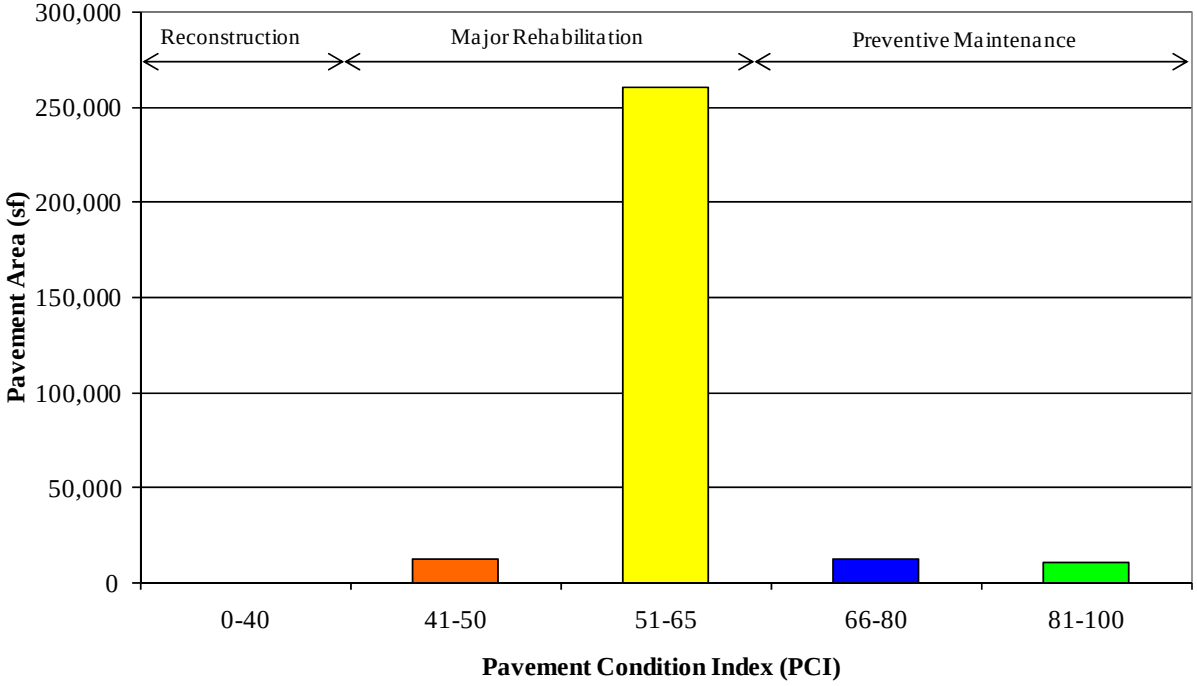
Figure 6. Overall condition.

The pavements at Guthrie County Regional Airport were inspected on September 17, 2010. The 2010 area-weighted condition of Guthrie County Regional Airport is 66, with conditions ranging from 42 to 100 (on a scale of 0 [failed] to 100 [excellent]). During the previous pavement inspection in 2006, the area-weighted PCI of the airport was 79.
