GRINNELL REGIONAL AIRPORT PAVEMENT MANAGEMENT REPORT

Prepared For:
Iowa Department of Transportation
Office of Aviation

Prepared By:
Applied Pavement Technology, Inc.

December 2011

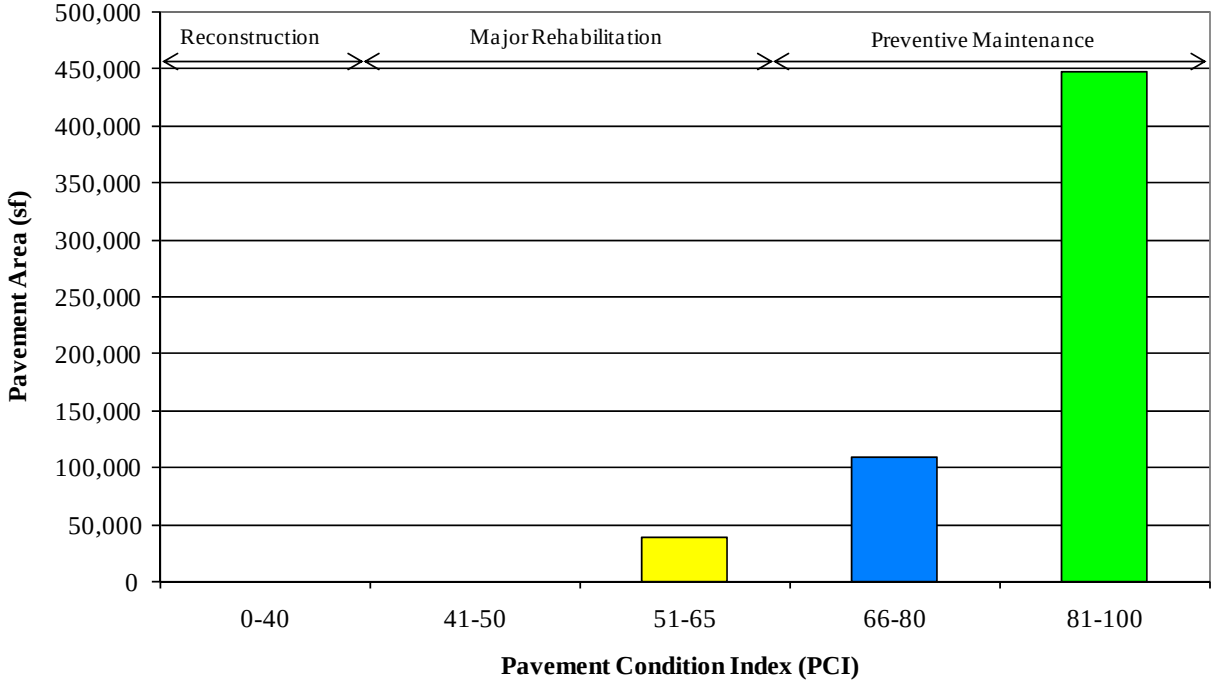
Figure 6. Overall condition.

The pavements at Grinnell Regional Airport were inspected on September 14, 2011. The 2011 area-weighted condition of Grinnell Regional Airport is 80, with conditions ranging from 55 to 98 (on a scale of 0 [failed] to 100 [excellent]). During the previous pavement inspection in 2008, the area-weighted PCI of the airport was 90.

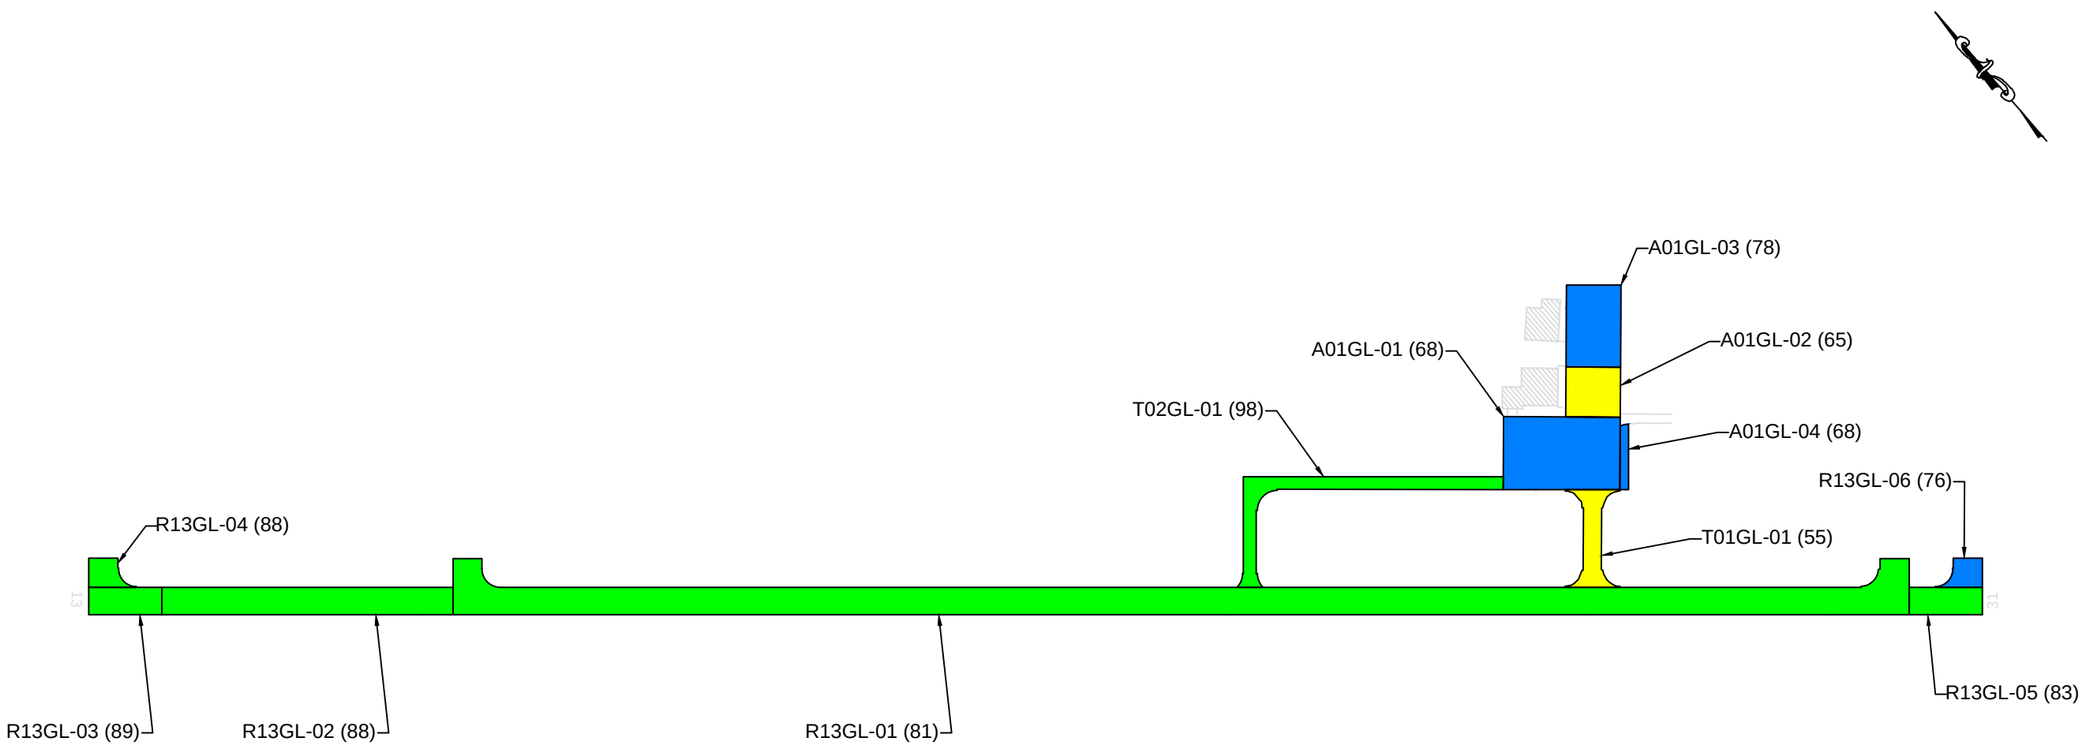
FIGURE 8. PCI MAP.

Runway 13-31 is defined by six sections. Section 01, which comprises the majority of the runway, is in good condition. Medium- and high-severity joint seal damage was observed. In addition, all severities of joint spalling and corner spalling and low- and medium-severity small patching were recorded. An additional sample unit was identified where extensive amounts of medium-severity faulting and large patching and low- and medium-severity small patching were identified. Section 02, the extension on the northwestern end of the runway, is in good condition with medium-severity joint seal damage recorded. Small quantities of low- and medium-severity joint spalling and corner spalling were also observed. Sections 03 and 04 are located at the Runway 13 approach. Both sections are in good condition with medium-severity joint seal damage and isolated quantities of low-severity longitudinal, transverse, and diagonal (LTD) cracking identified. In addition, isolated amounts of low-severity joint spalling and corner spalling were observed in Section 03 along with an additional sample unit where medium-severity LTD cracking was noted. Sections 05 and 06 are both located at the Runway 31 approach and are in good and satisfactory conditions, respectively. High-severity joint seal damage and low- and medium-severity corner spalling were recorded in both sections. Section 06 also had shrinkage cracking and medium-severity joint spalling identified.

Taxiway 01 connects Runway 13-31 with the western edge of the apron area and is in fair condition. Medium-severity joint seal damage was observed along with low- and medium-severity durability cracking, medium- and high-severity joint spalling, low- and high-severity corner spalling, and medium-severity faulting. In addition, small quantities of low-severity small patching, LTD cracking, and corner breaking were also identified.

Taxiway 02 connects Runway 13-31 with the northern edge of the apron area and is in excellent condition with only low-severity joint seal damage identified.

The apron area (Apron 01) is comprised of four sections. Section 01, the main portion the apron in front of the terminal building, is in satisfactory condition. Small patching and all severities of joint spalling were identified throughout. In addition, small quantities of low-severity durability cracking and faulting and medium-severity corner spalling and corner breaking were noted. Section 02 is located east of the main apron area and is also in satisfactory condition. Medium-severity joint seal damage and significant amounts of low- and medium-severity corner spalling were observed. Small quantities of low-severity joint spalling and high-severity large patching were also noted. Section 03 is also located on the eastern edge of the apron area. This section is in satisfactory condition with medium-severity joint seal damage identified. Moderate amounts of medium-severity corner spalling and joint spalling and low-severity LTD cracking and corner breaking were also recorded. Section 04, located on the southern edge of the apron area, is in satisfactory condition with high-severity joint seal damage and medium-severity LTD cracking observed.

Year	Branch[1]	Section[1]	Type of Repair[2]	Estimated Cost[3]
2012	T01GL	01	Major Rehabilitation	$123,562
			Total:	**$123,562**
