HARLAN MUNICIPAL AIRPORT
PAVEMENT MANAGEMENT REPORT

Prepared By:
Applied Pavement Technology, Inc.

December 2011

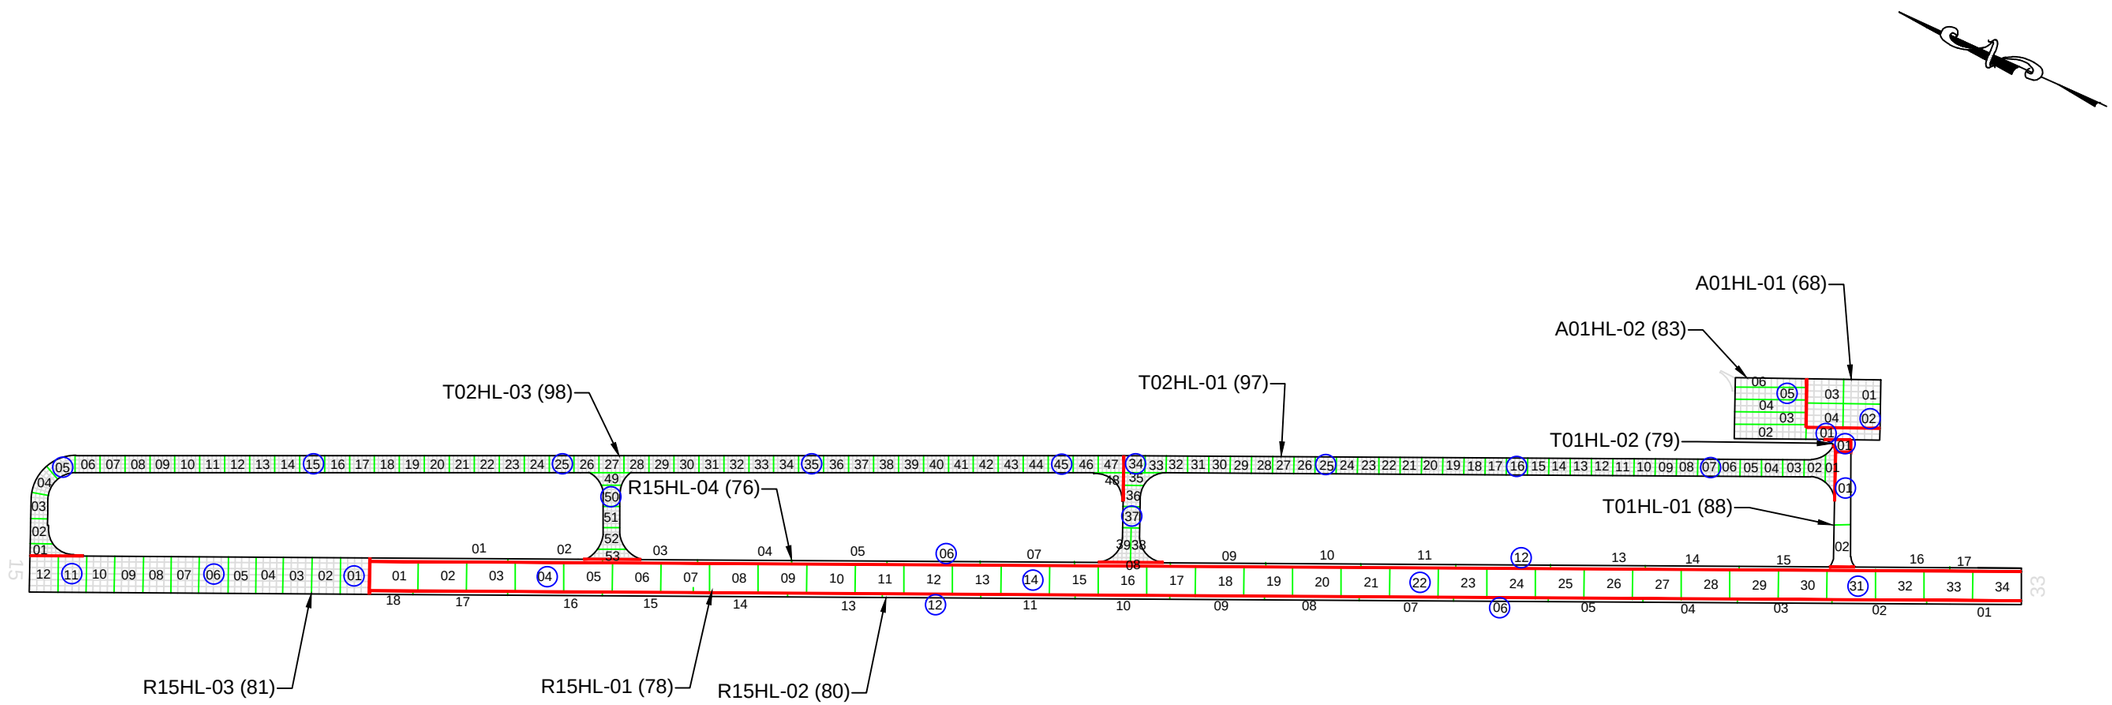
FIGURE 3. NETWORK DEFINITION MAP.

Runway 15-33 is defined by four sections. Section 01, the majority of the runway, is in satisfactory condition with extensive quantities of low-severity, mostly sealed, longitudinal and transverse (L&T) cracking recorded. Sections 02 and 04 comprise the east and west edges of the runway, respectively. They are both in satisfactory condition with moderate amounts of low-severity, mostly sealed, L&T cracking observed. Section 03, the extension on the north end of the runway, is in good condition with high-severity joint seal damage identified throughout. Additionally, small amounts of low-severity longitudinal, transverse, and diagonal (LTD) cracking, low- and medium-severity faulting; and high-severity joint spalling were noted.

Taxiway 01 connects the apron area with Runway 15-33 and is comprised of two sections. Section 01, the majority of the taxiway, is in good condition with small amounts of low-severity, mostly sealed, L&T cracking recorded. Section 02, adjacent to the apron area, is in satisfactory condition with medium-severity joint seal damage and low-severity LTD cracking identified.

Taxiway 02, the parallel taxiway, consists of two sections. Section 01, the southern portion of the parallel taxiway system, and Section 03, the northern portion, are both in excellent condition with low-severity joint seal damage recorded. Low-severity LTD cracking was also noted in Section 01.

The apron area (Apron 01) is defined by two sections. Section 01, the southern portion of the apron, is in satisfactory condition with medium-severity joint seal damage recorded. In addition, small amounts of low-severity joint spalling, LTD cracking, corner breaking, and small patching were noted. Section 02, the northern portion of the apron, is in good condition with low-severity joint seal damage identified throughout. Low-severity LTD cracking, corner spalling, and faulting were also recorded along with shrinkage cracking and low- and medium-severity joint spalling.

Year	Branch[1]	Section[1]	Type of Repair[2]	Estimated Cost[3]
2012	A01HL	01	Major Rehabilitation	$111,037
			Total:	**$111,037**

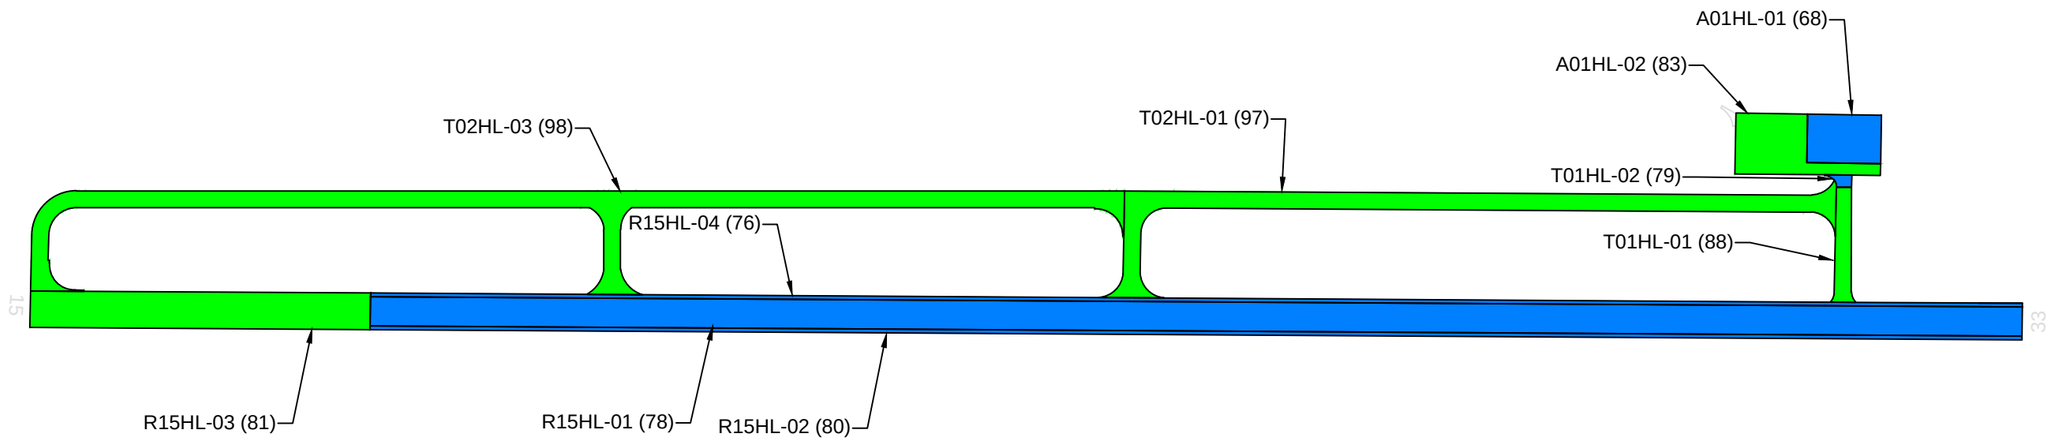
FIGURE 8. PCI MAP.

The pavements at Harlan Municipal Airport were inspected on September 12, 2011. The 2011 area-weighted condition of Harlan Municipal Airport is 84, with conditions ranging from 68 to 98 (on a scale of 0 [failed] to 100 [excellent]). During the previous pavement inspection in 2008, the area-weighted PCI of the airport was 82.
