HAMPTON MUNICIPAL AIRPORT PAVEMENT MANAGEMENT REPORT

Prepared By:
Applied Pavement Technology, Inc.

December 2010

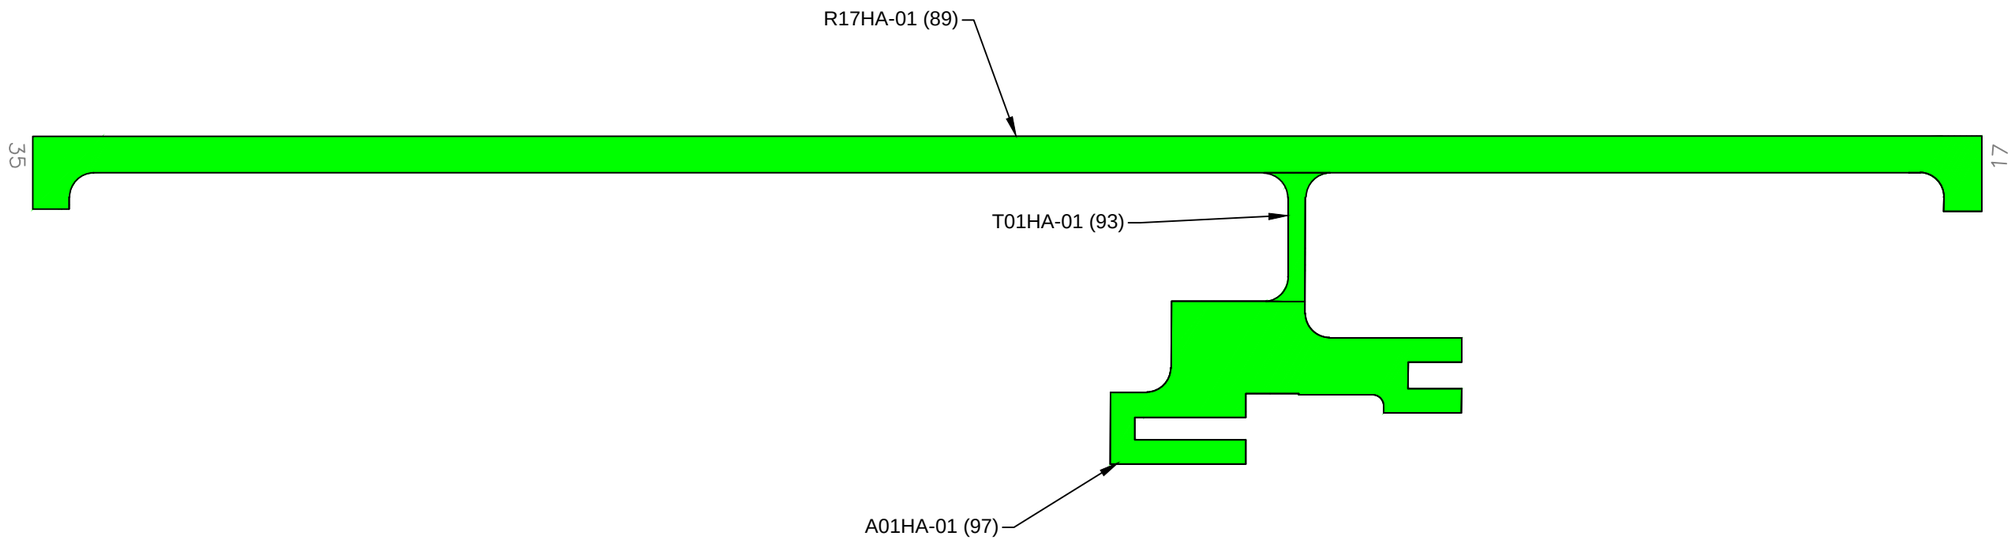
FIGURE 8. PCI MAP.

The pavements at Hampton Municipal Airport were inspected on September 19, 2010. The 2010 area-weighted condition of Hampton Municipal Airport is 91, with conditions ranging from 89 to 97 (on a scale of 0 [failed] to 100 [excellent]). During the previous pavement inspection in 2006, the area-weighted PCI of the airport was 89.

Runway 14-32 is defined by one section that is in good condition with low-severity joint seal damage recorded throughout. Moderate quantities of low-severity faulting and isolated amounts of high-severity small patching, low-severity corner breaking and corner spalling, and medium-severity joint spalling and faulting were also observed.

Taxiway 01 consists of one section. Section 01 is in good condition with low-severity joint seal damage and isolated quantities of medium-severity joint spalling recorded.

Apron 01 consists of one section that is in excellent condition with isolated areas of low-severity joint seal damage and faulting identified.
