HAMPTON MUNICIPAL AIRPORT
PAVEMENT MANAGEMENT REPORT

Prepared For:
Iowa Department of Transportation
Office of Aviation

Prepared By:
Applied Pavement Technology, Inc.

January 2007

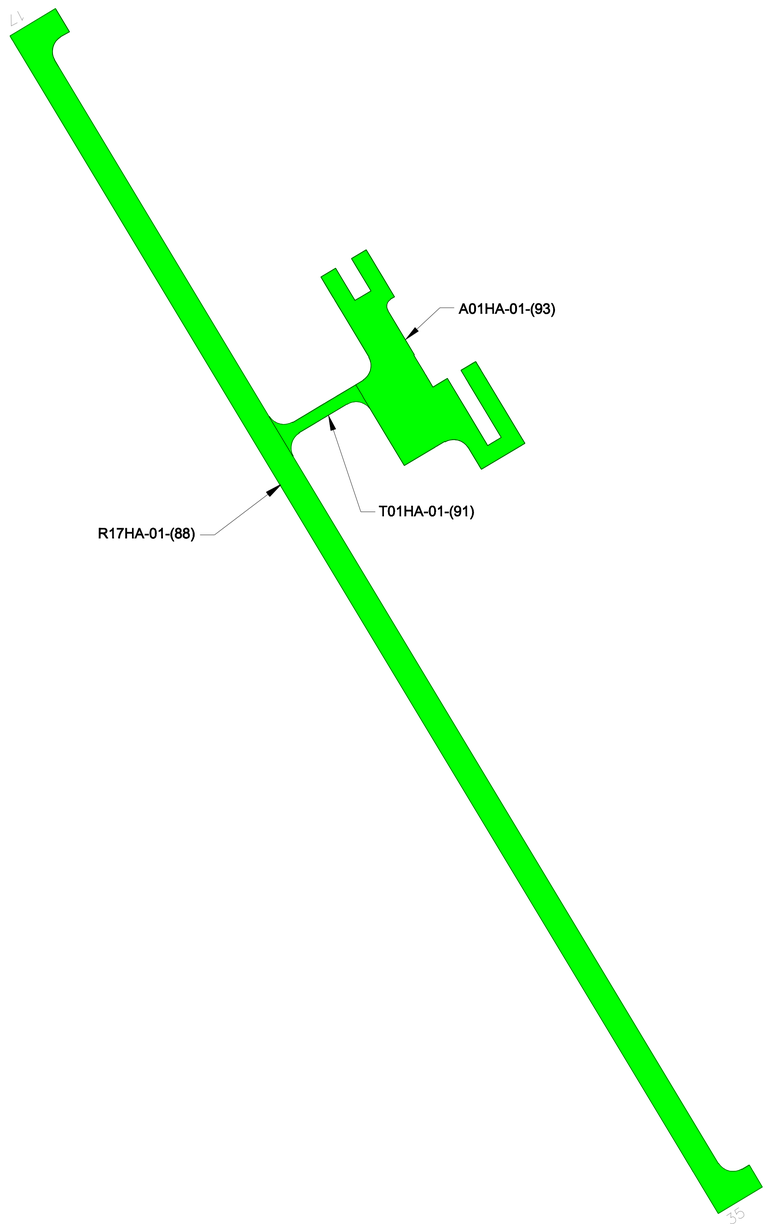
PAGE TITLE: Pavement Condition Index Map

The pavements at Hampton Municipal Airport were inspected on September 15, 2006. The 2006 area-weighted condition of Hampton Municipal Airport is 89, with conditions ranging from 88 to 93 (on a scale of 0 [failed] to 100 [excellent]). In 2003 the area-weighted PCI of the airport was 96.

Figures 6 and 7 provide graphs summarizing the overall condition of the pavements at the Hampton Municipal Airport. Figure 8 is a map that displays the condition of the pavements evaluated. Table 1 summarizes the results of the pavement evaluation. Appendix C presents photographs taken during the PCI inspection, and Appendix D contains detailed information on the distresses observed during the visual survey. Appendix E includes detailed work history
