OSCEOLA MUNICIPAL AIRPORT PAVEMENT MANAGEMENT REPORT

Prepared By:
Applied Pavement Technology, Inc.

December 2011

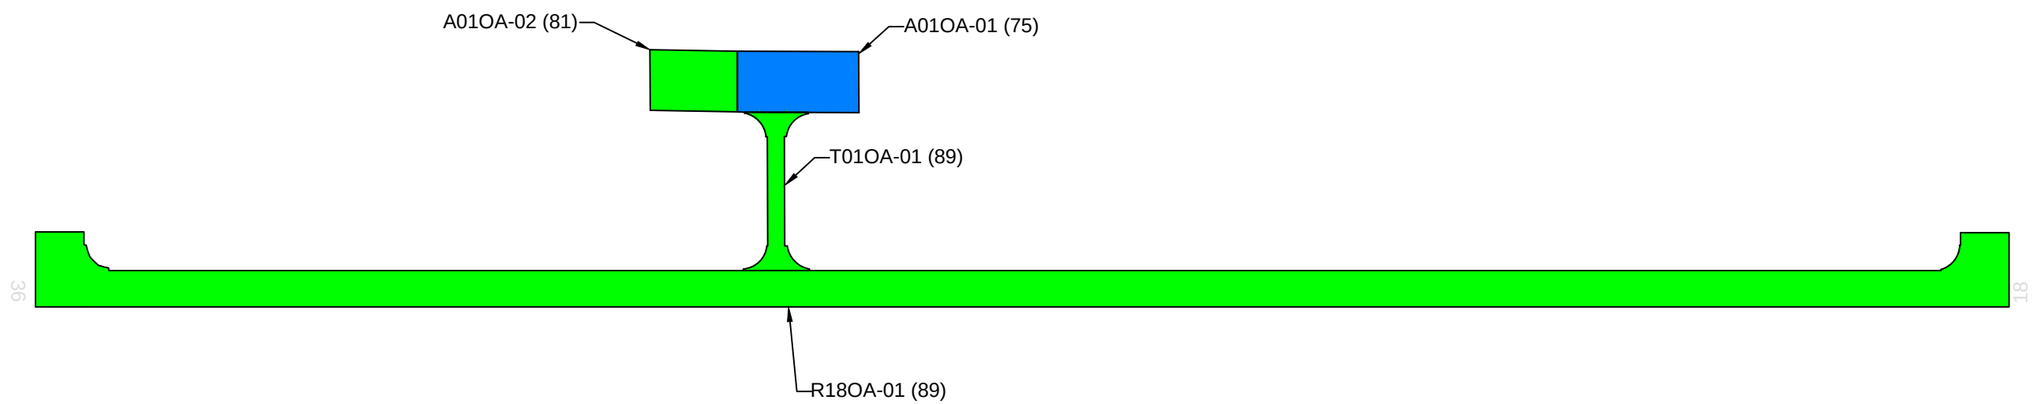
FIGURE 8. PCI MAP.

The pavements at Osceola Municipal Airport were inspected on September 11, 2011. The 2011 area-weighted condition of Osceola Municipal Airport is 87, with conditions ranging from 75 to 89 (on a scale of 0 [failed] to 100 [excellent]). During the previous pavement inspection in 2008, the area-weighted PCI of the airport was 87.

Runway 18-36 is defined by one section in good condition. Medium-severity joint seal damage was observed throughout Section 01. In addition, moderate amounts of low-severity faulting along with isolated quantities of low- and medium-severity corner spalling, medium-severity durability cracking, and shrinkage cracking were recorded.

Taxiway 01 connects Runway 18-36 with the apron area. This taxiway consists of one section in good condition with medium- and high-severity joint seal damage and isolated amounts of medium-severity corner spalling identified.

The apron area (Apron 01) is comprised of two sections. Section 01, the northern portion of the apron, is in satisfactory condition with high-severity joint seal damage recorded throughout. Moderate amounts of low- and medium-severity joint spalling and low-severity corner spalling were also identified. Additionally, isolated quantities of low-severity corner breaking and medium-severity longitudinal, transverse, and diagonal (LTD) cracking were noted. Section 02, the southern portion of the apron, is in good condition with medium- and high-severity joint seal damage recorded. Isolated quantities of low-severity corner spalling, joint spalling, and LTD cracking were identified. An additional sample unit was recorded due to the presence of medium-severity LTD cracking and corner spalling and low-severity corner breaking.
