CLARINDA MUNICIPAL - SCHENCK FIELD AIRPORT PAVEMENT MANAGEMENT REPORT

Prepared For:
Iowa Department of Transportation
Office of Aviation

Prepared By:
Applied Pavement Technology, Inc.

December 2011

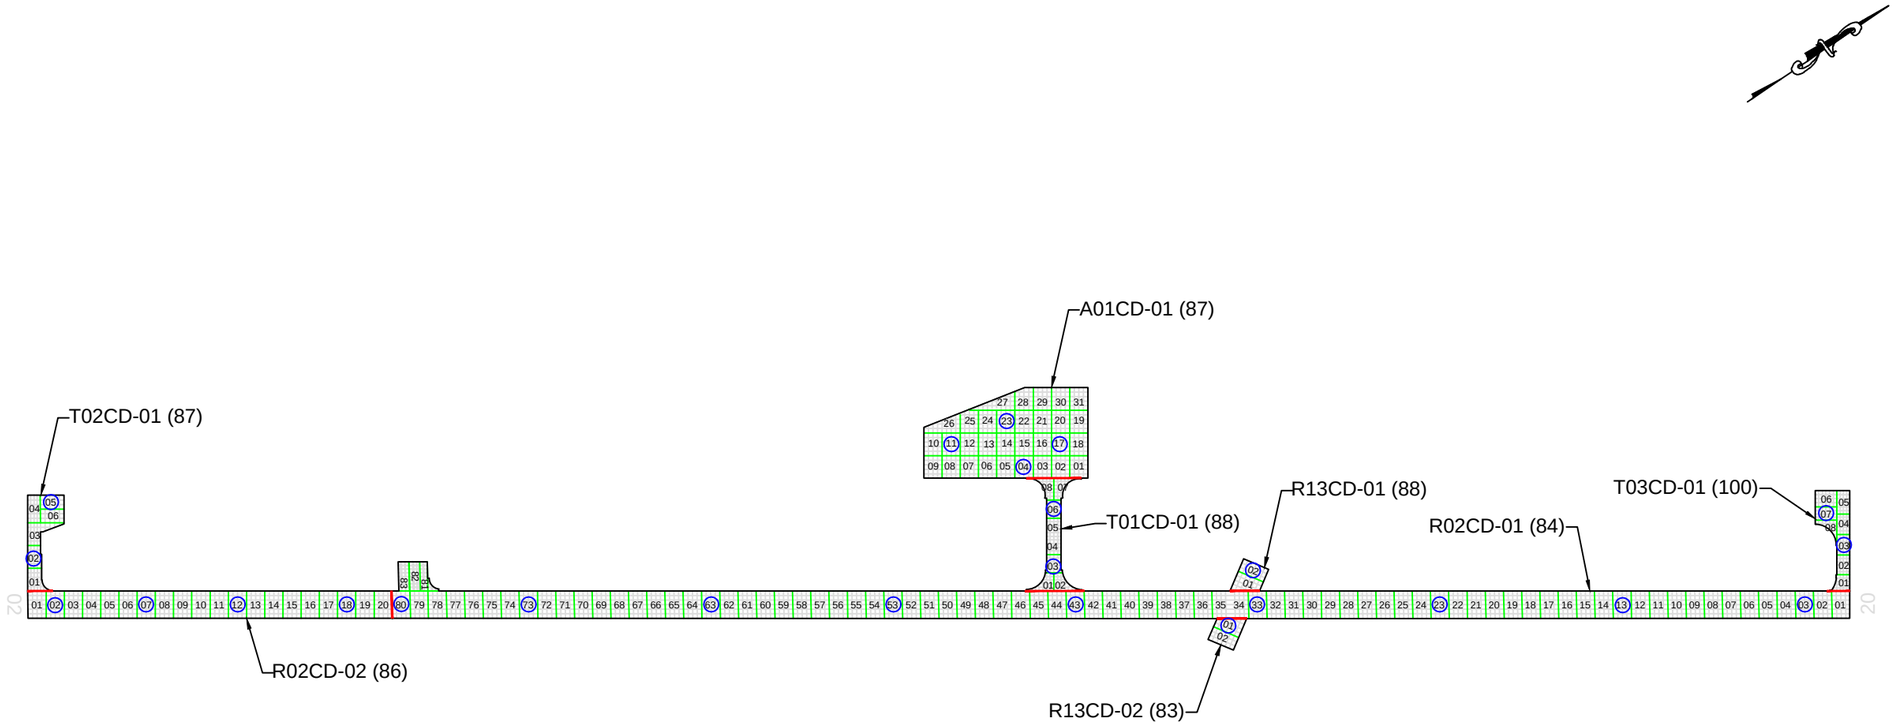
FIGURE 3. NETWORK DEFINITION MAP.

Figure 3 is a network definition map that identifies the pavements at Clarinda Municipal - Schenck Field Airport that were evaluated during this project. This map shows how the pavement network was divided into branches, sections, and sample units for pavement management purposes. It also shows the nomenclature used in the MicroPAVER pavement management database to identify the different pavement areas.

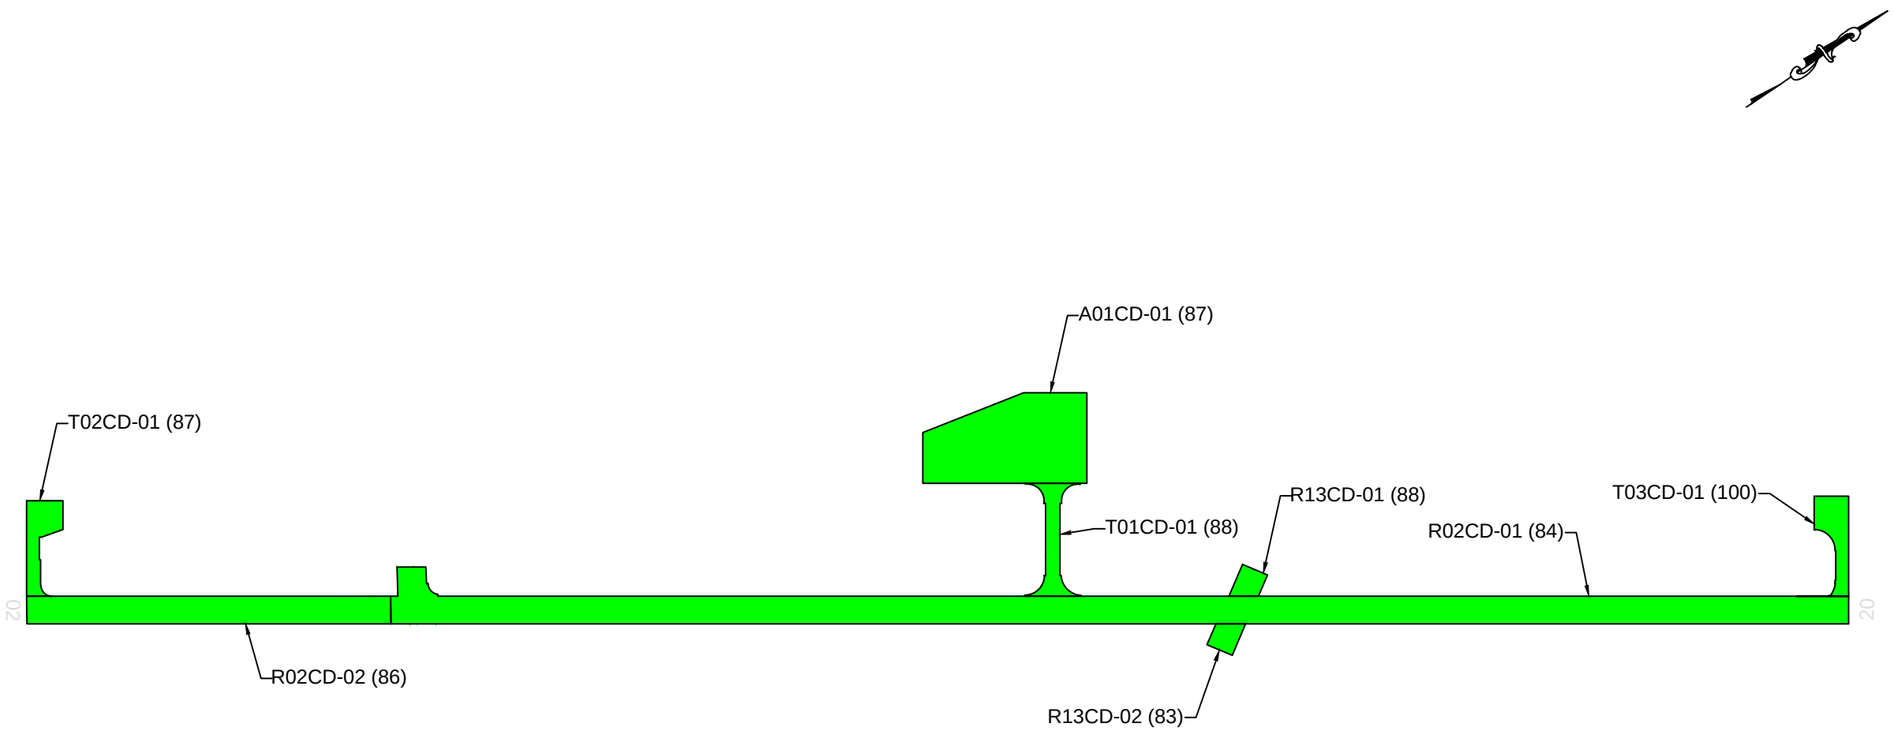
FIGURE 8. PCI MAP.

The pavements at Clarinda Municipal - Schenck Field Airport were inspected on September 12, 2011. The 2011 area-weighted condition of Clarinda Municipal - Schenck Field Airport is 86, with conditions ranging from 83 to 100 (on a scale of 0 [failed] to 100 [excellent]). During the previous pavement inspection in 2008, the area-weighted PCI of the airport was 84.

Runway 02-20 is comprised of two sections. Section 01, the majority of the pavement, is in good condition with medium-severity joint seal damage observed. In addition, small amounts of low-severity durability cracking and longitudinal, transverse, and diagonal (LTD) cracking; low- and medium-severity corner spalling; and all severities of joint spalling were recorded. Isolated quantities of low-severity corner breaking, shrinkage cracking, and medium- and high-severity small patching were also noted. Section 02, the southern portion of the runway located at the Runway 02 approach, is also in good condition with all severities of joint seal damage identified. Small quantities of low- and medium-severity LTD cracking and joint spalling were recorded. Isolated areas of low-severity durability cracking were also observed.

Runway 13-31 is defined by two small sections that tie in the turf runway with the Runway 02-20 pavement. Section 01, located west of Runway 02-20, is in good condition. Only high-severity joint seal damage was observed at the time of inspection. Section 02, located east of Runway 02-20, is also in good condition. High-severity joint seal damage was identified in Section 02 along with low-severity LTD cracking.

Taxiway 01 connects Runway 02-20 with the apron area and consists of one section. Section 01 is in good condition with only high-severity joint seal damage observed.

Taxiway 02, a turnaround located at the Runway 02 approach, is defined by one section. Section 01 is in good condition with high-severity joint seal damage and low-severity joint spalling identified.

The apron area (Apron 01) is comprised of one section. Section 01 is in good condition with high-severity joint seal damage recorded throughout along with small amounts of low-severity faulting.
