IDA GROVE MUNICIPAL AIRPORT PAVEMENT MANAGEMENT REPORT

Prepared By:
Applied Pavement Technology, Inc.

December 2010

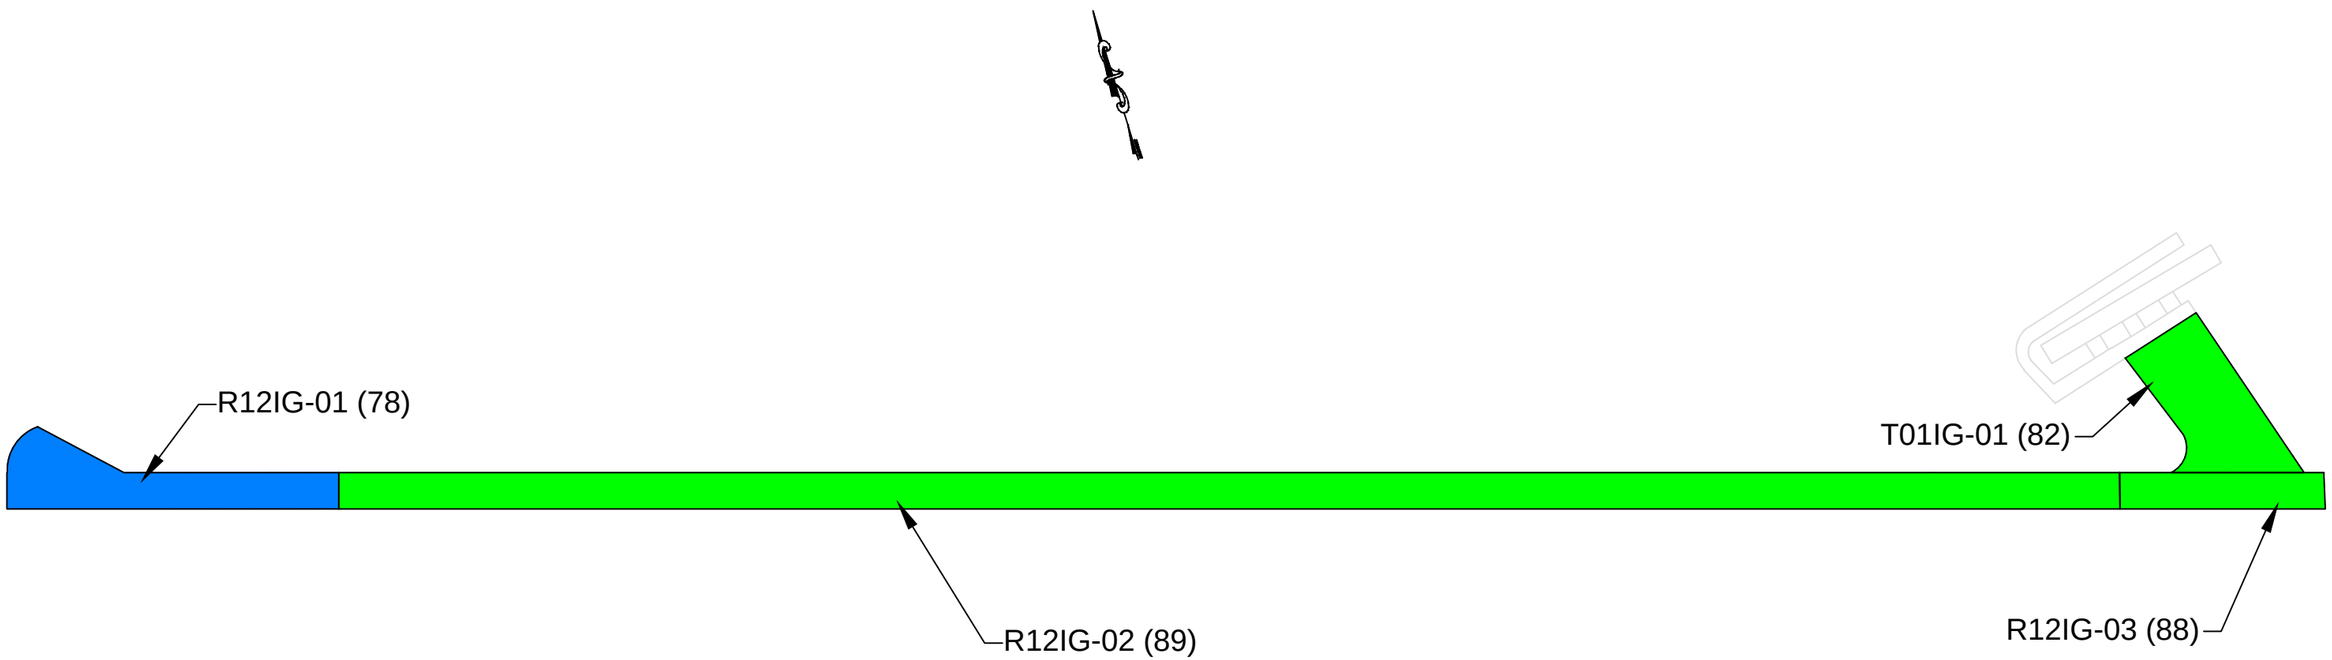
FIGURE 8. PCI MAP.

Runway 12-30 is defined by three sections. Section 01, the western portion of the runway, is in satisfactory condition with low- and medium-severity longitudinal and transverse (L&T) cracking recorded throughout. All of the low-severity cracking was unsealed, and the medium-severity cracking was due to unsealed crack widths greater than ¼ inch. Section 02, the majority of the runway, and Section 03, the eastern end of the runway, are in good condition with low- and medium-severity L&T cracking observed. Most of the low-severity cracking was sealed, and the medium-severity cracking was identified where the crack sealant was no longer performing satisfactorily.

Taxiway 01 consists of one section that is in good condition with low-severity, sealed L&T cracking recorded.
