IOWA FALLS MUNICIPAL AIRPORT PAVEMENT MANAGEMENT REPORT

Prepared By:
Applied Pavement Technology, Inc.

December 2010

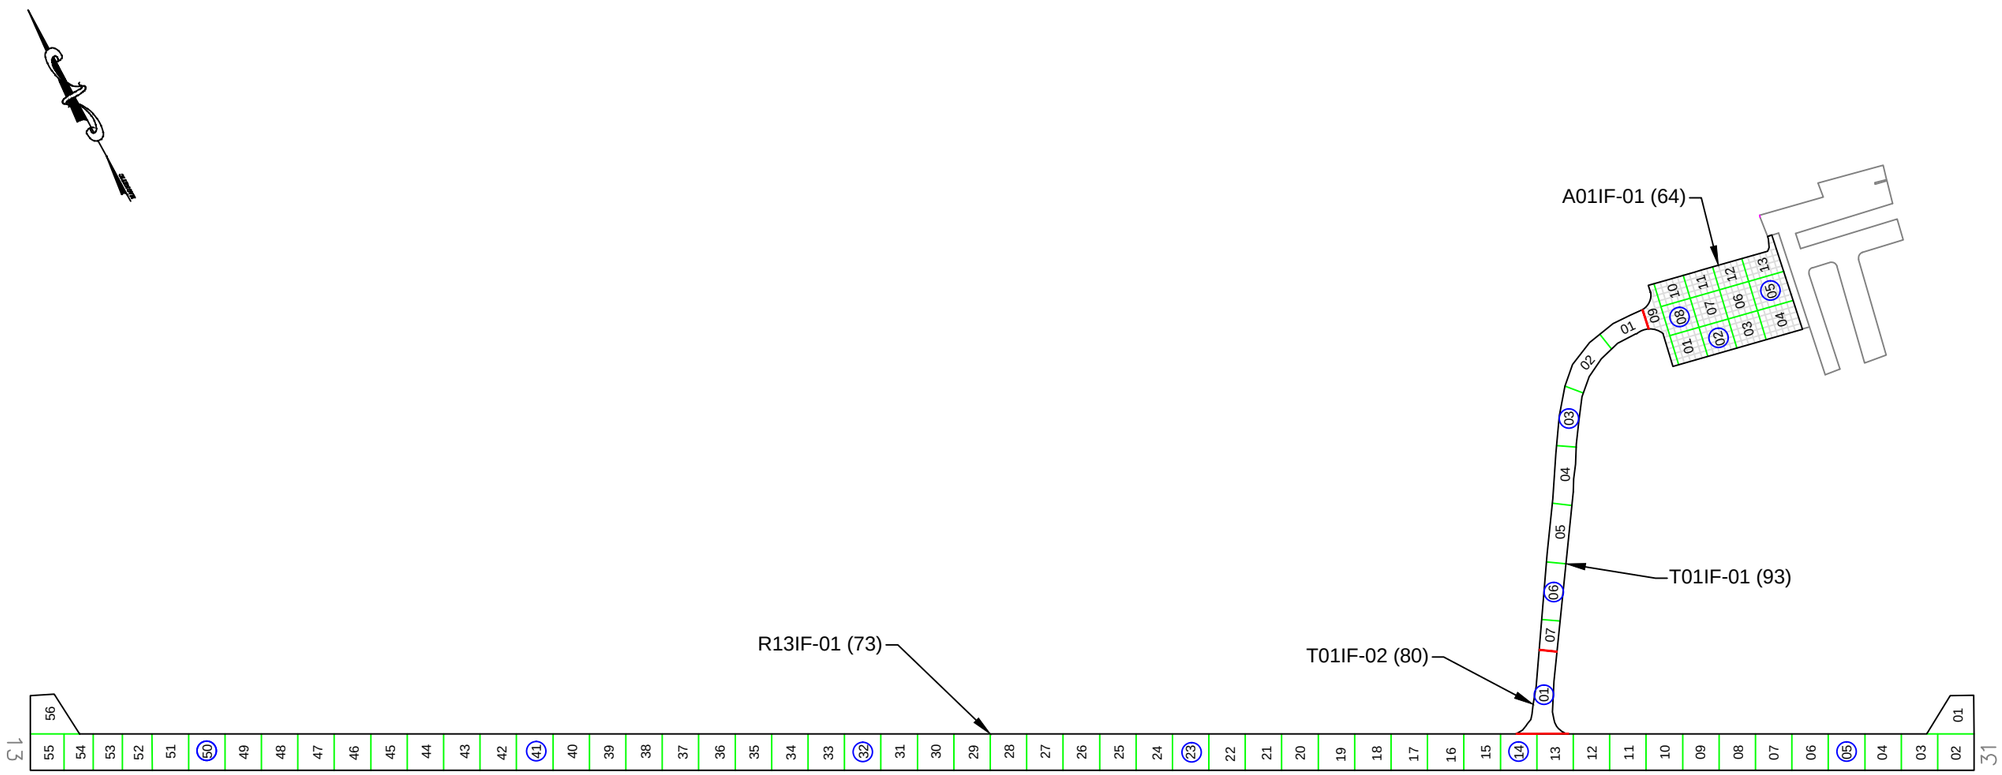
FIGURE 3. NETWORK DEFINITION MAP.

Runway 13-31 is defined by one section that is in satisfactory condition with low- and medium-severity longitudinal and transverse (L&T) cracking recorded throughout. All of the low-severity cracking was unsealed, and the medium-severity cracking was due to unsealed crack widths greater than ¼ inch.

Taxiway 01 consists of two sections. Section 01 is in good condition with low- and medium-severity L&T cracking recorded throughout. Section 02, located adjacent to the runway, is in satisfactory condition with low- and medium-severity L&T cracking observed. All of the low-severity cracking was unsealed, and the medium-severity cracking was due to unsealed crack widths greater than ¼ inch.

Apron 01 contains one section that is in fair condition with high-severity joint seal damage recorded throughout. In addition, moderate quantities of low- and medium-severity linear cracking and medium-severity shattered slabs were observed.

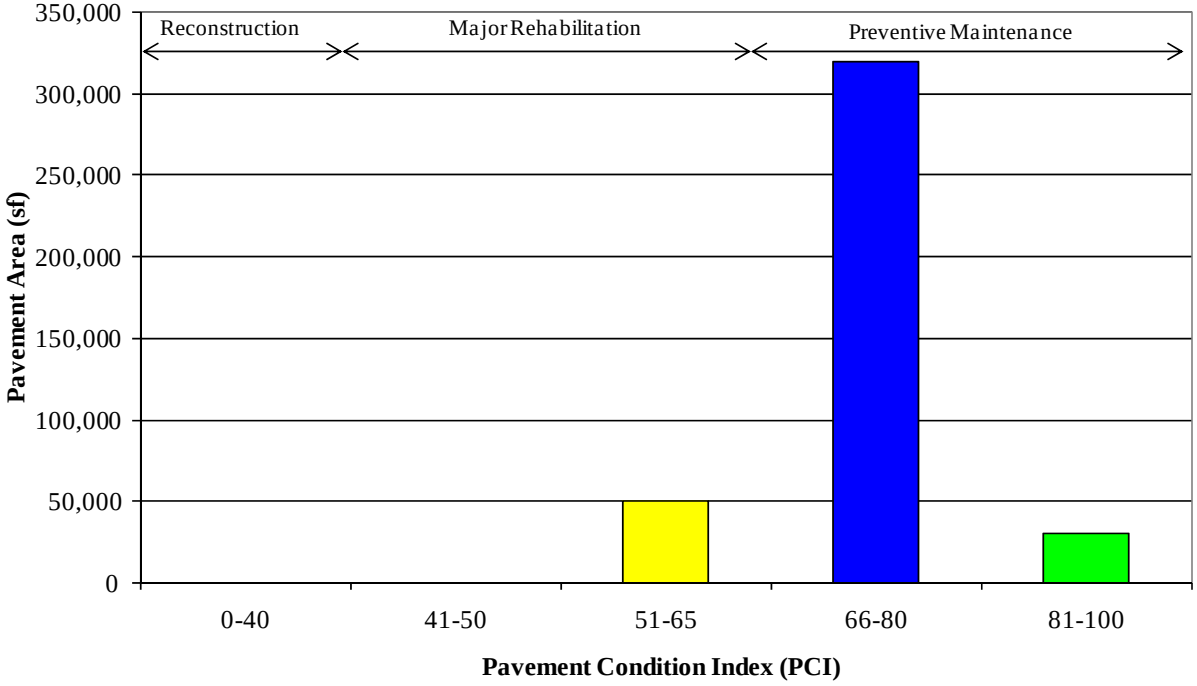
Figure 6. Overall condition.

The pavements at Iowa Falls Municipal Airport were inspected on September 19, 2010. The 2010 area-weighted condition of Iowa Falls Municipal Airport is 74, with conditions ranging from 64 to 93 (on a scale of 0 [failed] to 100 [excellent]). During the previous pavement inspection in 2006, the area-weighted PCI of the airport was 79.
