INDEPENDENCE MUNICIPAL AIRPORT PAVEMENT MANAGEMENT REPORT

Prepared By:
Applied Pavement Technology, Inc.

January 2010

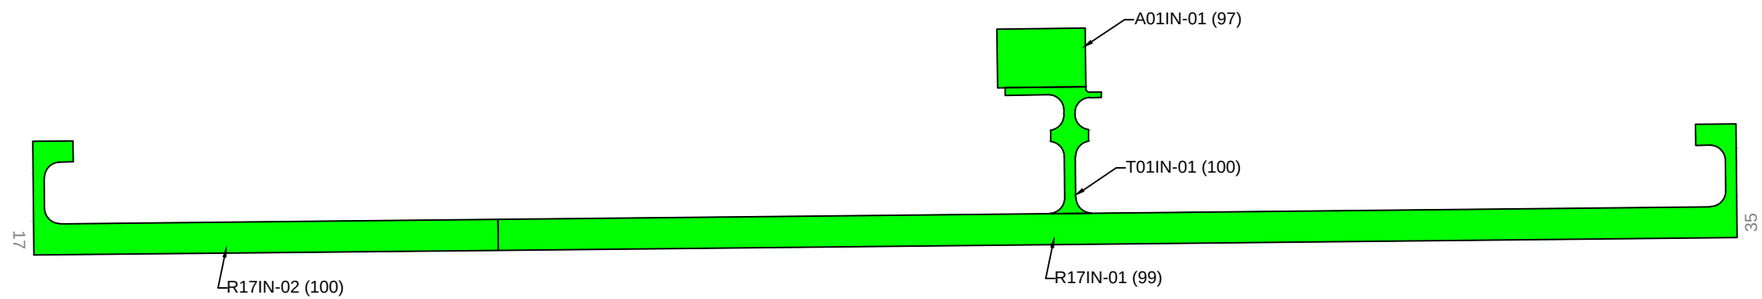
FIGURE 8. PCI MAP.

Runway 17-35 is defined by two sections that were recently reconstructed or constructed. Section 01 consists of the majority of the runway and was recently reconstructed. This section is in excellent condition with isolated amounts of low-severity patching and joint spalling recorded. Section 02, the northern portion of the runway, was recently constructed and is in excellent condition with no distresses observed at the time of inspection.

Taxiway 01 was recently reconstructed and consists of one section in excellent condition with no distresses identified at the time of inspection.

The terminal apron also was recently reconstructed and contains one section in excellent condition with only isolated amounts of low-severity corner breaking and joint spalling recorded.
