ANKENY REGIONAL AIRPORT PAVEMENT MANAGEMENT REPORT

Prepared For:
Iowa Department of Transportation
Office of Aviation

Prepared By:
Applied Pavement Technology, Inc.

December 2011

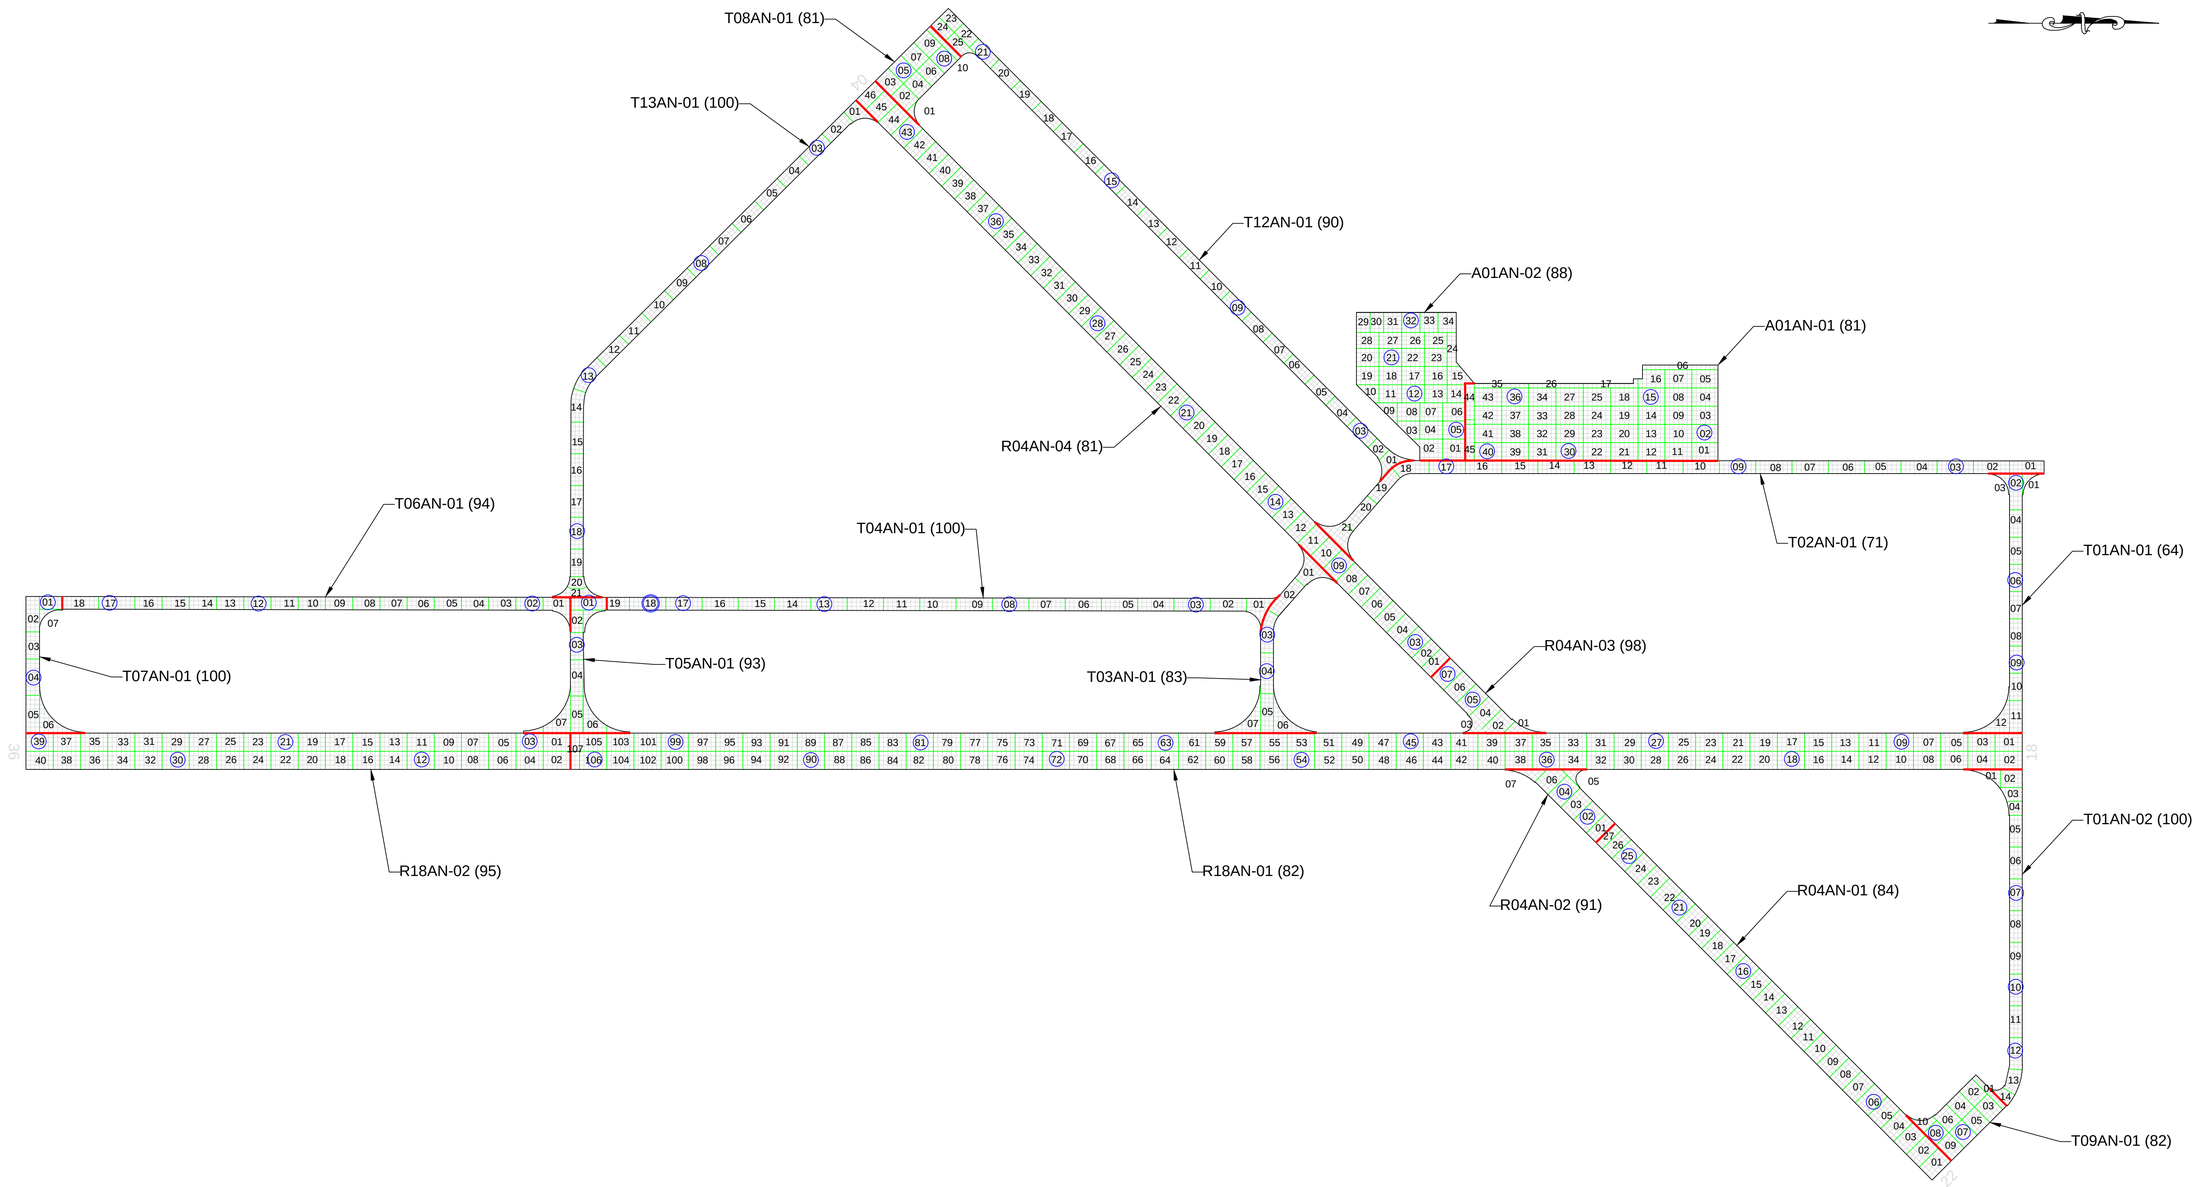
FIGURE 3. NETWORK DEFINITION MAP.

Figure 3 is a network definition map that identifies the pavements at Ankeny Regional Airport that were evaluated during this project. This map shows how the pavement network was divided into branches, sections, and sample units for pavement management purposes. It also shows the nomenclature used in the MicroPAVER pavement management database to identify the different pavement areas.

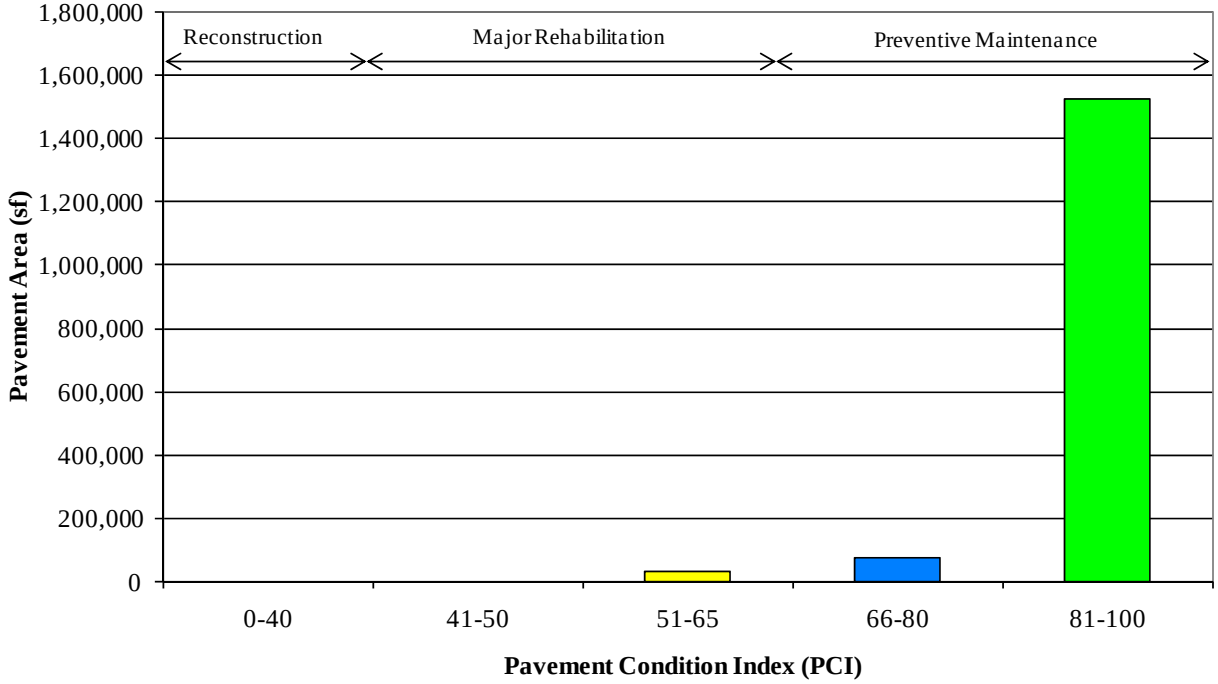
Figure 6. Overall condition.

The pavements at Ankeny Regional Airport were inspected on September 13, 2011. The 2011 area-weighted condition of Ankeny Regional Airport is 86, with conditions ranging from 64 to 100 (on a scale of 0 [failed] to 100 [excellent]). During the previous pavement inspection in 2008, the area-weighted PCI of the airport was 83.

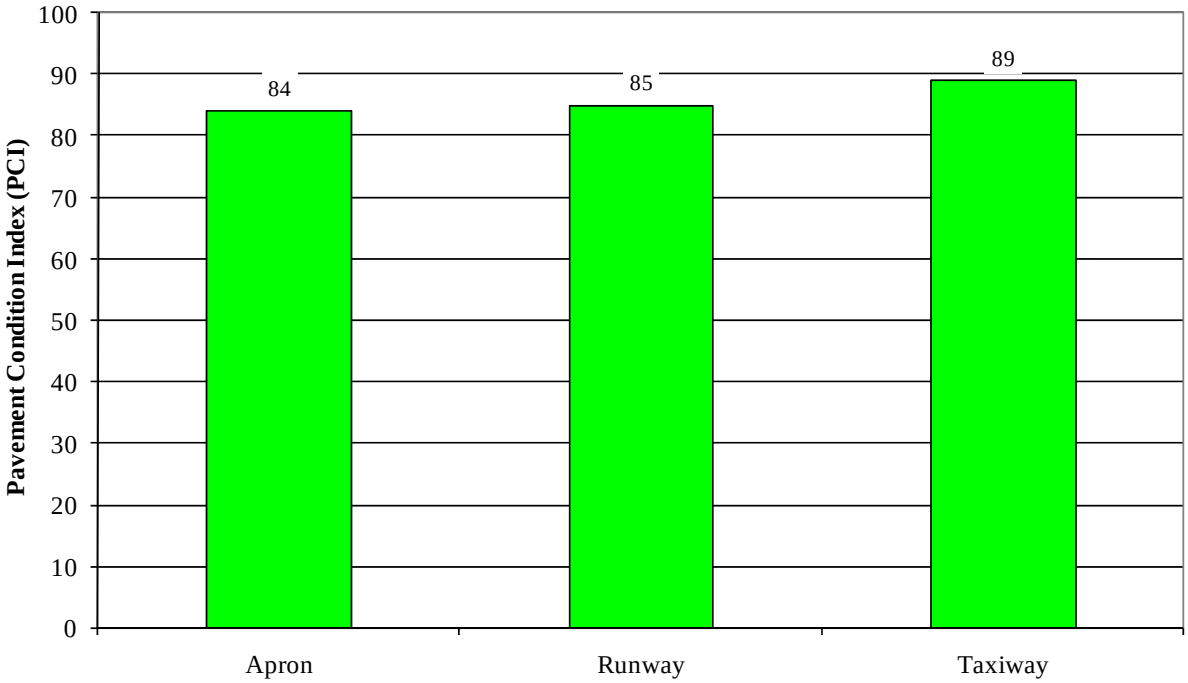
Figure 7. Condition by use.

Figures 6 and 7 provide graphs summarizing the overall condition of the pavements at Ankeny Regional Airport. Figure 8 is a map that displays the condition of the pavements evaluated. Table 1 summarizes the results of the pavement evaluation. Appendix C presents photographs taken during the PCI inspection, and Appendix D contains detailed information on the distresses observed during the visual survey. Appendix E includes detailed work history information that
