IOWA CITY MUNICIPAL AIRPORT PAVEMENT MANAGEMENT REPORT

Prepared For:
Iowa Department of Transportation
Office of Aviation

Prepared By:
Applied Pavement Technology, Inc.

December 2011

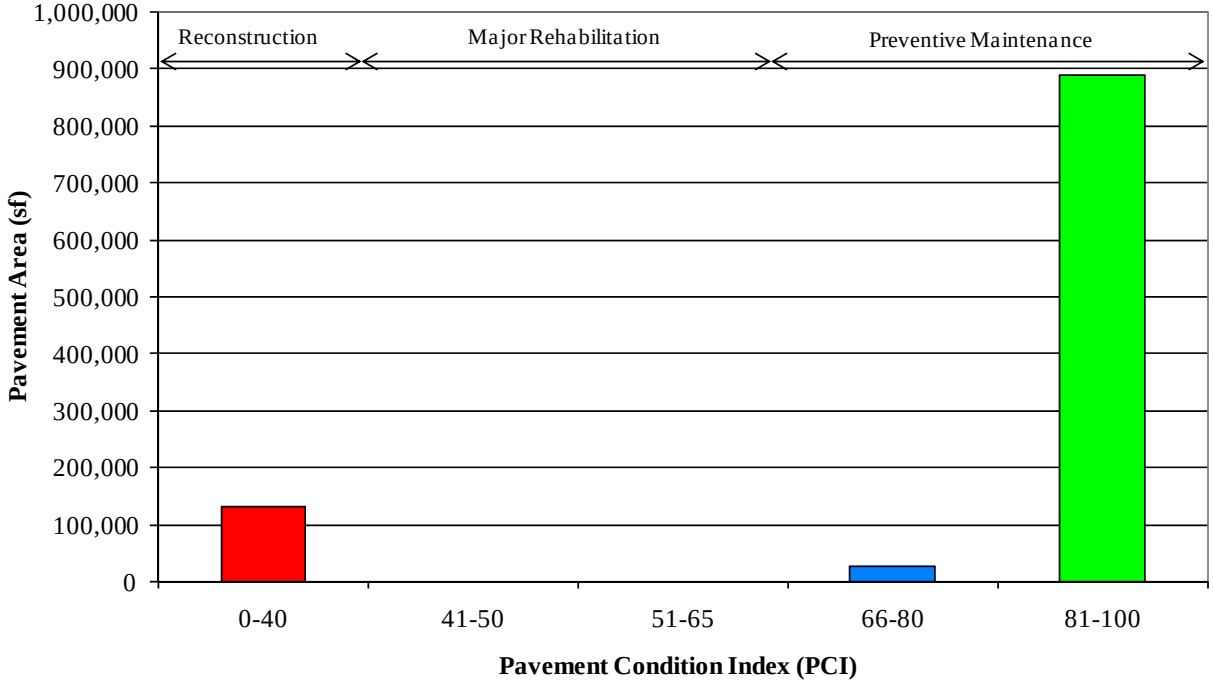
Figure 6. Overall condition.

Figures 6 and 7 provide graphs summarizing the overall condition of the pavements at Iowa City Municipal Airport. Figure 8 is a map that displays the condition of the pavements evaluated. Table 1 summarizes the results of the pavement evaluation. Appendix C presents photographs taken during the PCI inspection, and Appendix D contains detailed information on the distresses observed during the visual survey. Appendix E includes detailed work history information that

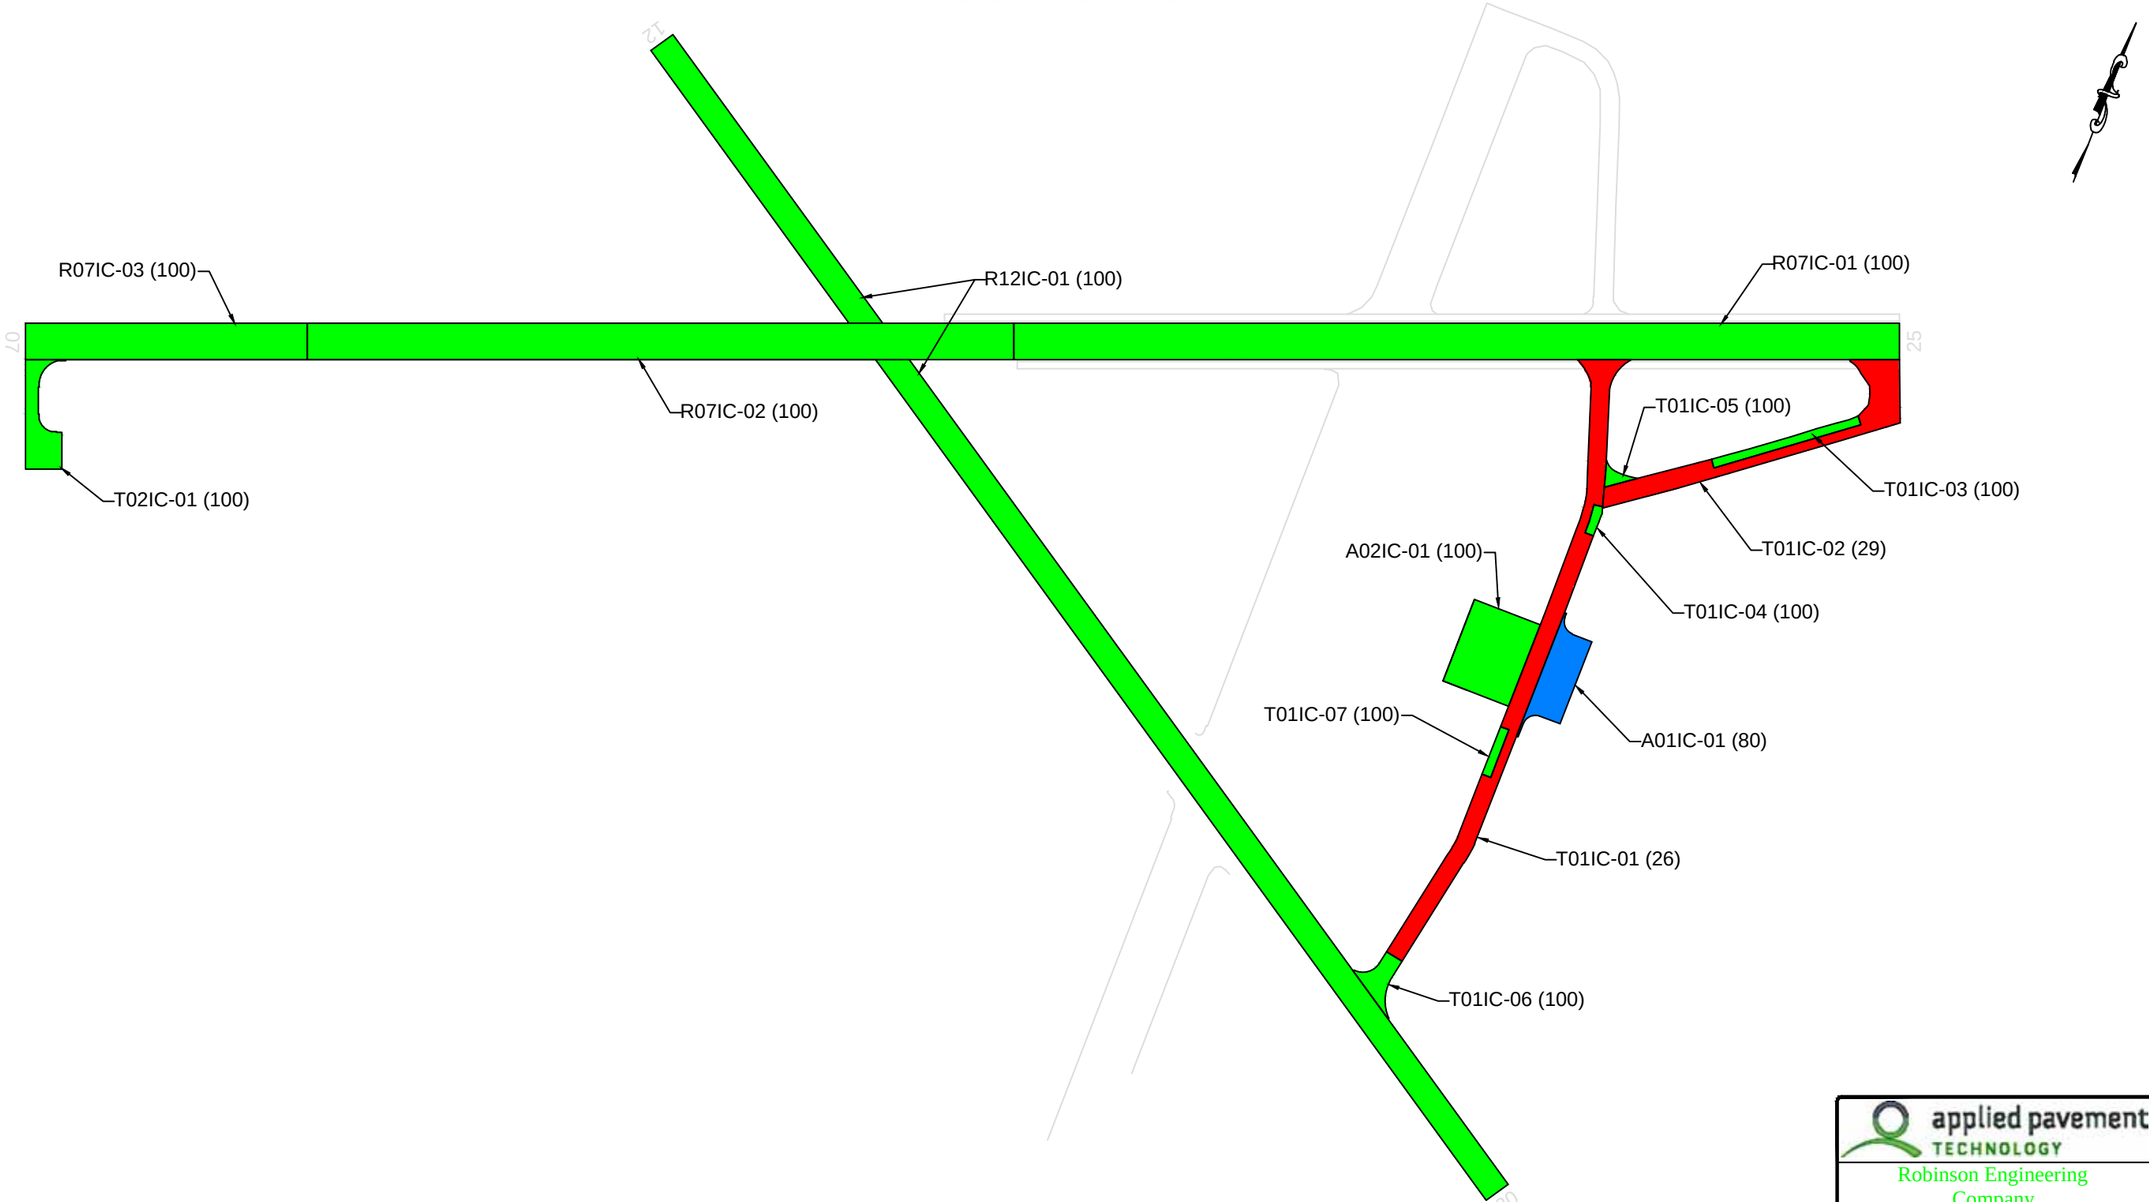
FIGURE 8. PCI MAP.

The pavements at Iowa City Municipal Airport were inspected on September 8, 2011. The 2011 area-weighted condition of Iowa City Municipal Airport is 90, with conditions ranging from 26 to 100 (on a scale of 0 [failed] to 100 [excellent]). During the previous pavement inspection in 2008, the area-weighted PCI of the airport was 81.
