MAPLETON MUNICIPAL AIRPORT
PAVEMENT MANAGEMENT REPORT

Prepared By:
Applied Pavement Technology, Inc.

January 2007

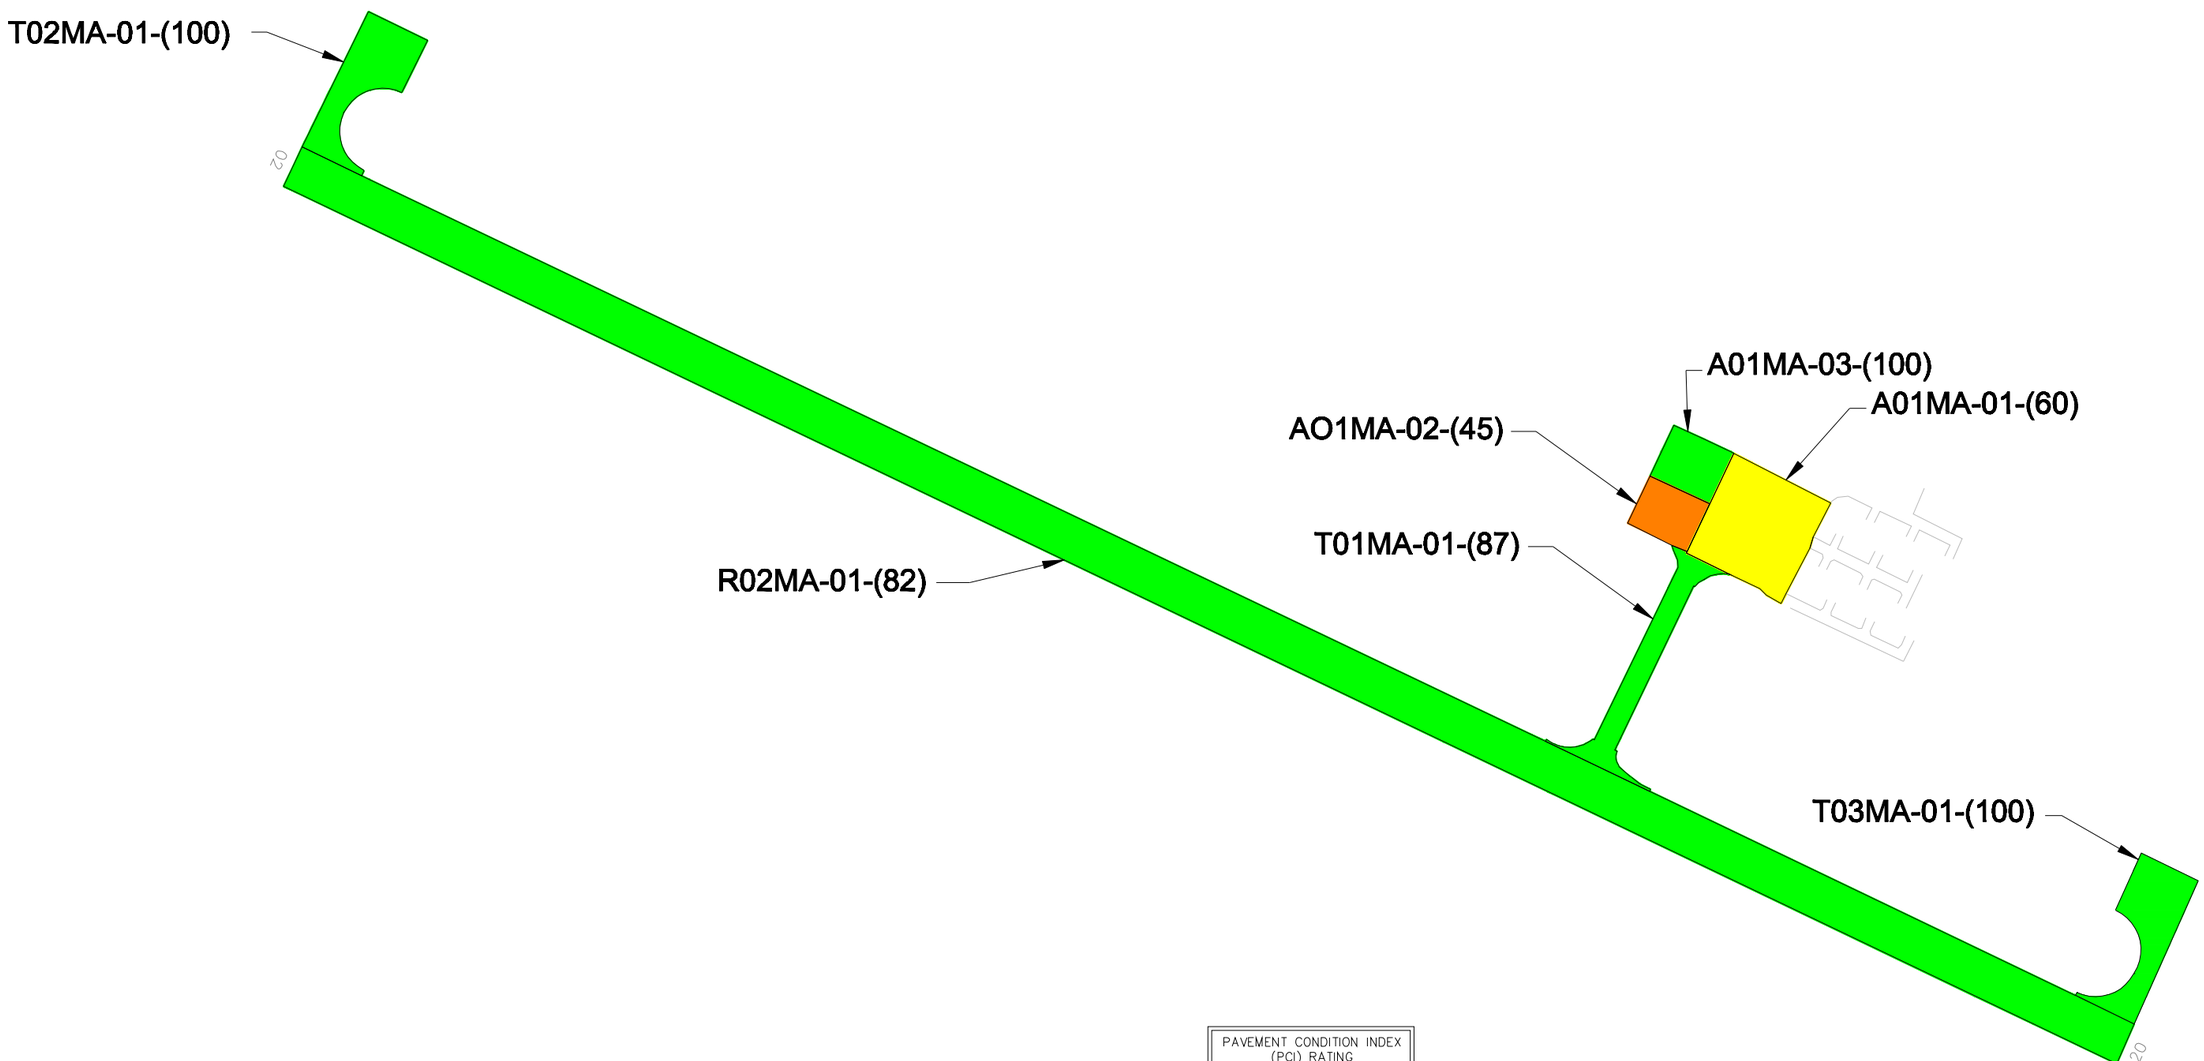
PAGE TITLE: Pavement Condition Index Map

The pavements at Mapleton Municipal Airport were inspected on September 13, 2006. The 2006 area-weighted condition of Mapleton Municipal Airport is 82, with conditions ranging from 45 to 100 (on a scale of 0 [failed] to 100 [excellent]). In 2003 the area-weighted PCI of the airport was 73.

Mapleton Municipal Airport								
Branch[1]	**Section**	**Surface Type[2]**	**Section Area (sf)**	**LCD[3]**	**2006 PCI**	**% Distress due to:**		**Distress Types**
						Load[4]	**Climate or Durability[5]**	
A01MA	01	PCC	22,500	6/1/1966	60	73	4	Corner Break, Shattered Slab, Linear Cracking, Joint Seal Damage, Joint Spall, Shrinkage Cracking
A01MA	02	PCC	6,640	7/19/1973	45	99	0	Shattered Slab, Shrinkage Cracking, Linear Cracking
A01MA	03	PCC	7,040	5/1/2005	100	0	0	No Distress
R02MA	01	PCC	168,060	6/1/1966	82	80	8	Linear Cracking, Small Patch, Joint Seal Damage, Corner Break, Joint Spall, Large Patch
T01MA	01	PCC	11,722	6/1/1966	87	47	0	Shrinkage Cracking, Corner Break, Joint Spall
T02MA	01	PCC	13,127	10/1/2006	100	0	0	No Distress
T03MA	01	PCC	12,993	10/1/2006	100	0	0	No Distress

Year	Branch[1]	Section	Type of Repair[2]	Estimated Cost[3]
2007	A01MA	01	Major Rehabilitation	$80,574
		02	Major Rehabilitation	$23,778
			Total	**$104,352**
