MARSHALLTOWN MUNICIPAL AIRPORT PAVEMENT MANAGEMENT REPORT

Prepared For:
Iowa Department of Transportation
Office of Aviation

Prepared By:
Applied Pavement Technology, Inc.

December 2011

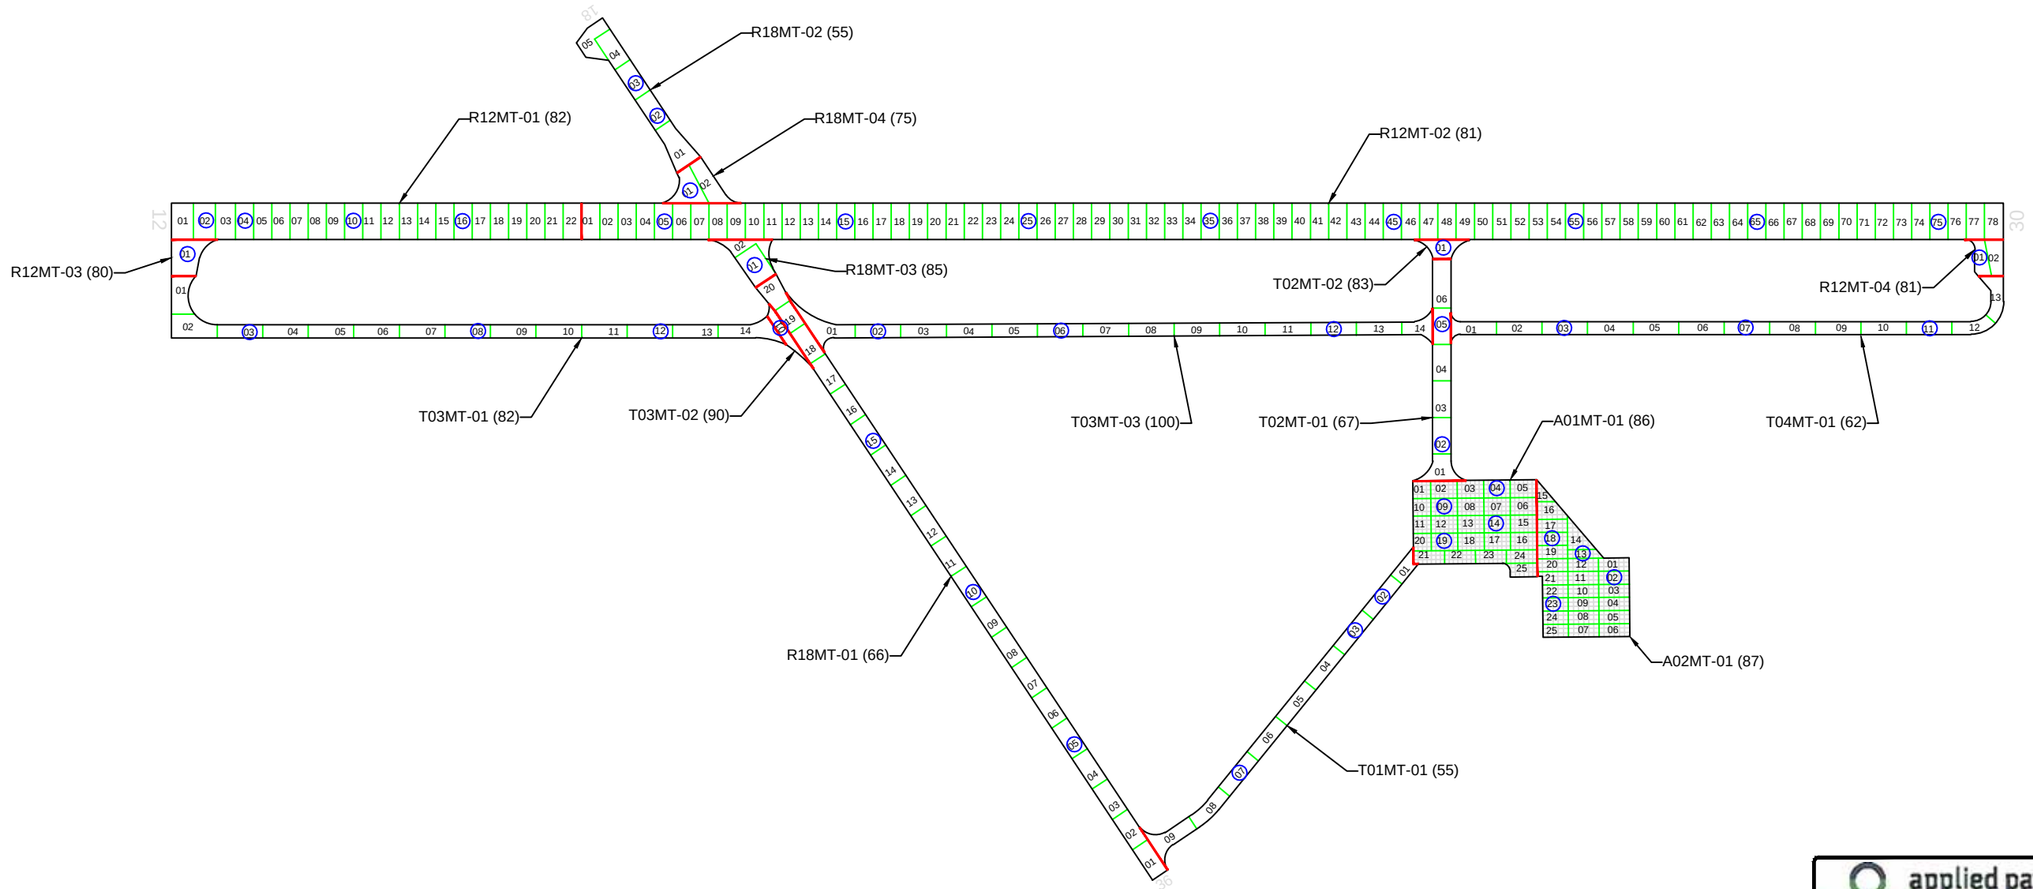
FIGURE 3. NETWORK DEFINITION MAP.

Runway 12-30 is defined by four sections. Section 01, an extension on the north end of the runway, and Section 02, the majority of the runway, are both in good condition with extensive quantities of low-severity, sealed longitudinal and transverse (L&T) cracking recorded. Sections 03 and 04, the turnarounds located at either end of the runway, are both in good condition with moderate amounts of low- and medium-severity L&T cracking observed. Most of the low-severity cracking was unsealed, and the medium-severity cracking was recorded where unsealed crack widths exceeded ¼ inch. The cracking in all sections was either recently resealed or was scheduled to be resealed after the pavement inspection was completed.

Runway 18-36 is comprised of four sections. Section 01, the majority of the runway located southwest of Runway 12-30, is in satisfactory condition, and Section 02, an extension on the northern end of the runway, is in fair condition. Moderate quantities of low- and medium-severity L&T cracking and small quantities of medium-severity alligator cracking were observed. The low-severity cracking was unsealed, and the medium-severity cracking was recorded where unsealed crack widths were greater than ¼ inch. Sections 03 and 04 are located on either side and adjacent to Runway 12-30. Section 03 is in good condition, and Section 04 is in satisfactory condition. Moderate amounts of low-severity, unsealed and medium-severity L&T cracking were recorded in both sections. The cracking in all sections was scheduled to be resealed after the pavement inspection was completed.

Taxiway 01 connects the apron area with the Runway 36 approach and consists of one section in fair condition. Extreme amounts of low- and medium-severity block cracking were identified in Section 01. In addition, moderate quantities of low- and medium-severity L&T cracking and alligator cracking along with low-severity patching were also noted. The low-severity cracking was unsealed and the medium-severity cracking was recorded where unsealed crack widths exceeded ¼ inch. The cracking was scheduled to be resealed after the pavement inspection was completed.

Taxiway 02 connects the apron area with Runway 12-30 and is comprised of two sections. Section 01 is in satisfactory condition with extensive quantities of low- and medium-severity L&T cracking observed, while Section 02 is in good condition with smaller amounts of low- and medium-severity L&T cracking recorded. All of the low-severity cracking was unsealed, and the medium-severity cracking was recorded where unsealed crack widths were greater than ¼ inch.

Taxiway 03, the parallel taxiway to Runway 12-30, is defined by three sections. Sections 01 and 02, located west of Runway 18-36, are both in good condition. Small quantities of low- and medium-severity L&T cracking were identified in Section 01 along with small amounts of medium-severity patching and low-severity rutting. Only medium-severity L&T cracking was observed in Section 02. All of the low-severity cracking was unsealed, and the medium-severity cracking was recorded where unsealed crack widths exceeded ¼ inch. The cracking in both Sections 01 and 02 was scheduled to be resealed after the pavement inspection was completed.

Section 03, located east of Runway 18-36, was recently constructed and is in excellent condition. No distresses were observed at the time of inspection.

Taxiway 04, a portion of the Runway 12-30 parallel taxiway located near the Runway 30 approach, is in fair condition with small quantities of low- and medium-severity L&T cracking and medium-severity alligator cracking and patching recorded. All of the low-severity cracking was unsealed, and the medium-severity cracking was recorded where unsealed crack widths were greater than ¼ inch or the cracks had developed secondary cracking. The cracking was scheduled to be resealed after the pavement inspection was completed.

Apron 01 is defined by one section in good condition with high-severity joint seal damage recorded throughout. In addition, isolated amounts of low-severity corner spalling and joint spalling were identified.

Apron 02 is also comprised of one section in good condition. High-severity joint-seal damage and low-severity corner spalling were observed in Section 01.

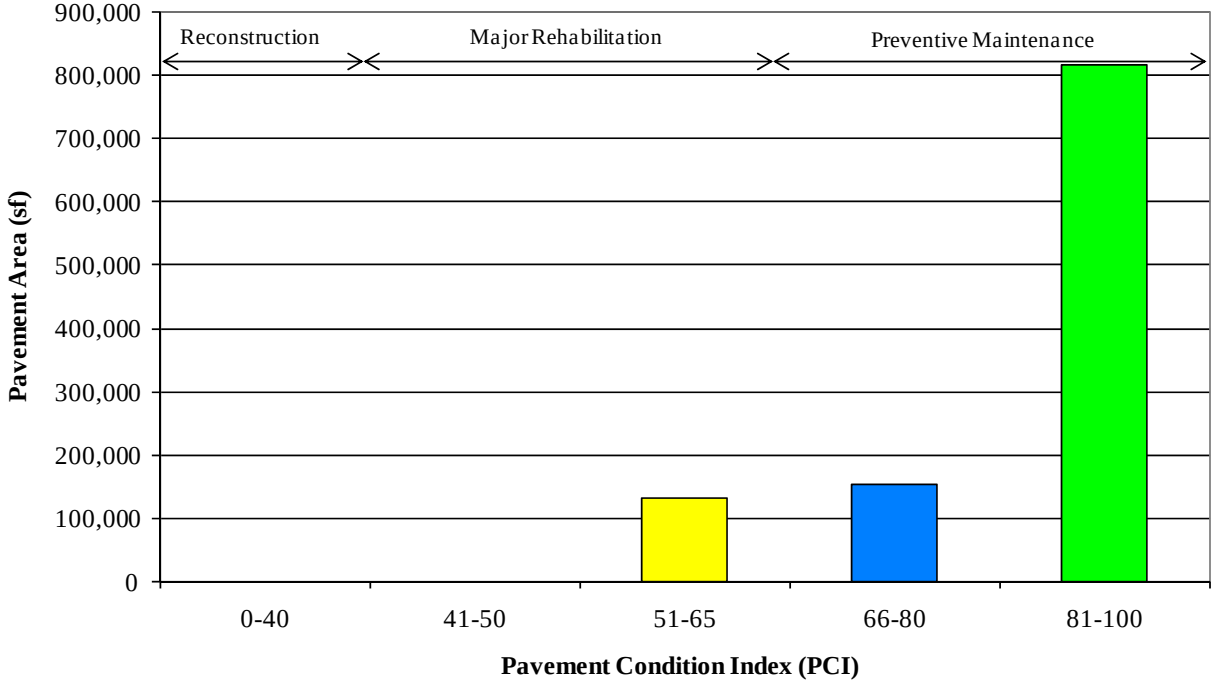
Figure 6. Overall condition.

The pavements at Marshalltown Municipal Airport were inspected on September 14, 2011. The 2011 area-weighted condition of Marshalltown Municipal Airport is 79, with conditions ranging from 55 to 100 (on a scale of 0 [failed] to 100 [excellent]). During the previous pavement inspection in 2008, the area-weighted PCI of the airport was 83.

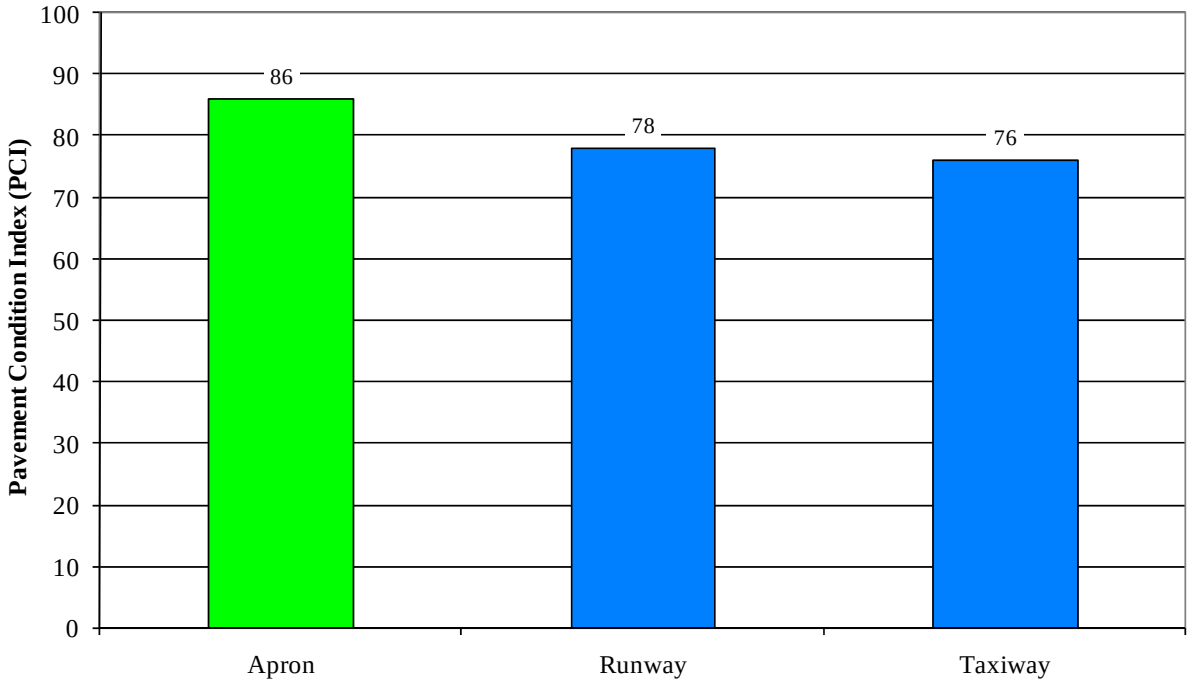
Figure 7. Condition by use.

Figures 6 and 7 provide graphs summarizing the overall condition of the pavements at Marshalltown Municipal Airport. Figure 8 is a map that displays the condition of the pavements evaluated. Table 1 summarizes the results of the pavement evaluation. Appendix C presents photographs taken during the PCI inspection, and Appendix D contains detailed information on the distresses observed during the visual survey. Appendix E includes detailed work history
