MOUNT PLEASANT MUNICIPAL AIRPORT PAVEMENT MANAGEMENT REPORT

Prepared By:
Applied Pavement Technology, Inc.

January 2007

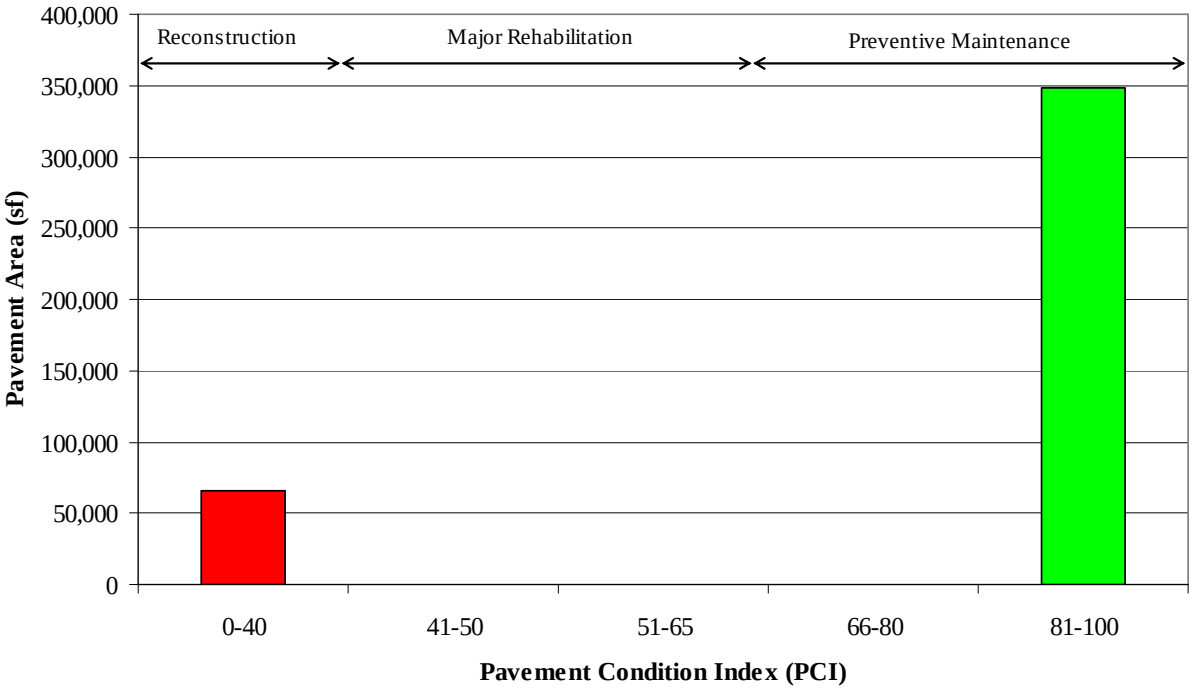
Figure 6. Overall condition.

The pavements at Mount Pleasant Municipal Airport were inspected on September 19, 2006. The 2006 area-weighted condition of Mount Pleasant Municipal Airport is 75, with conditions ranging from 37 to 97 (on a scale of 0 [failed] to 100 [excellent]). In 2003 the area-weighted PCI of the airport was 82.

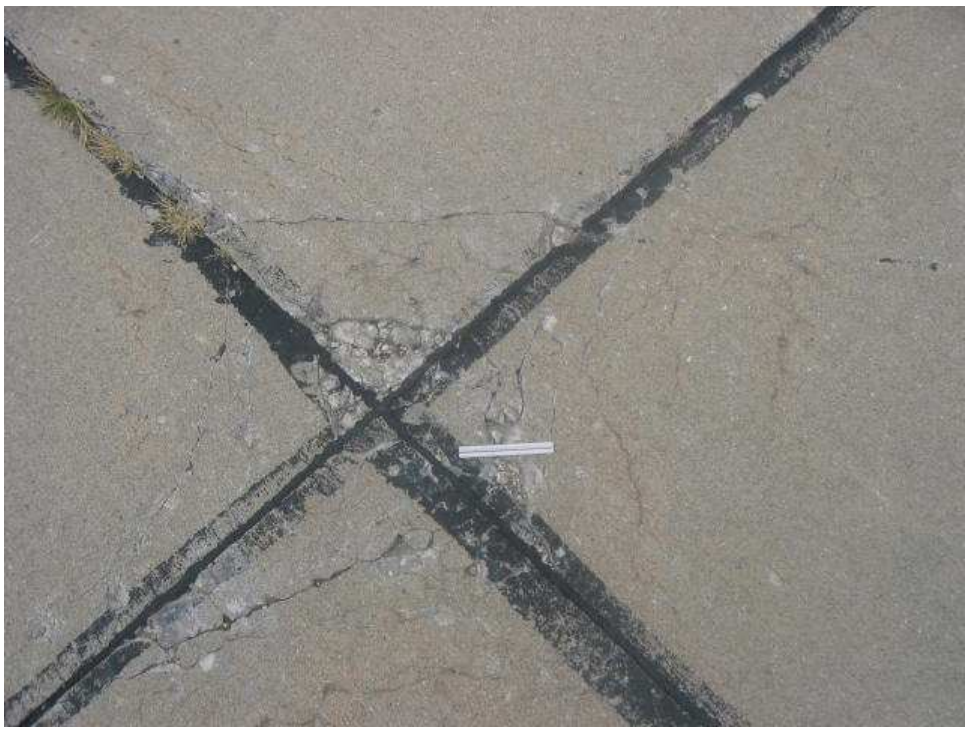
A02MP-01. Durability cracking.
