MOUNT PLEASANT MUNICIPAL AIRPORT PAVEMENT MANAGEMENT REPORT

Prepared By:
Applied Pavement Technology, Inc.

December 2010

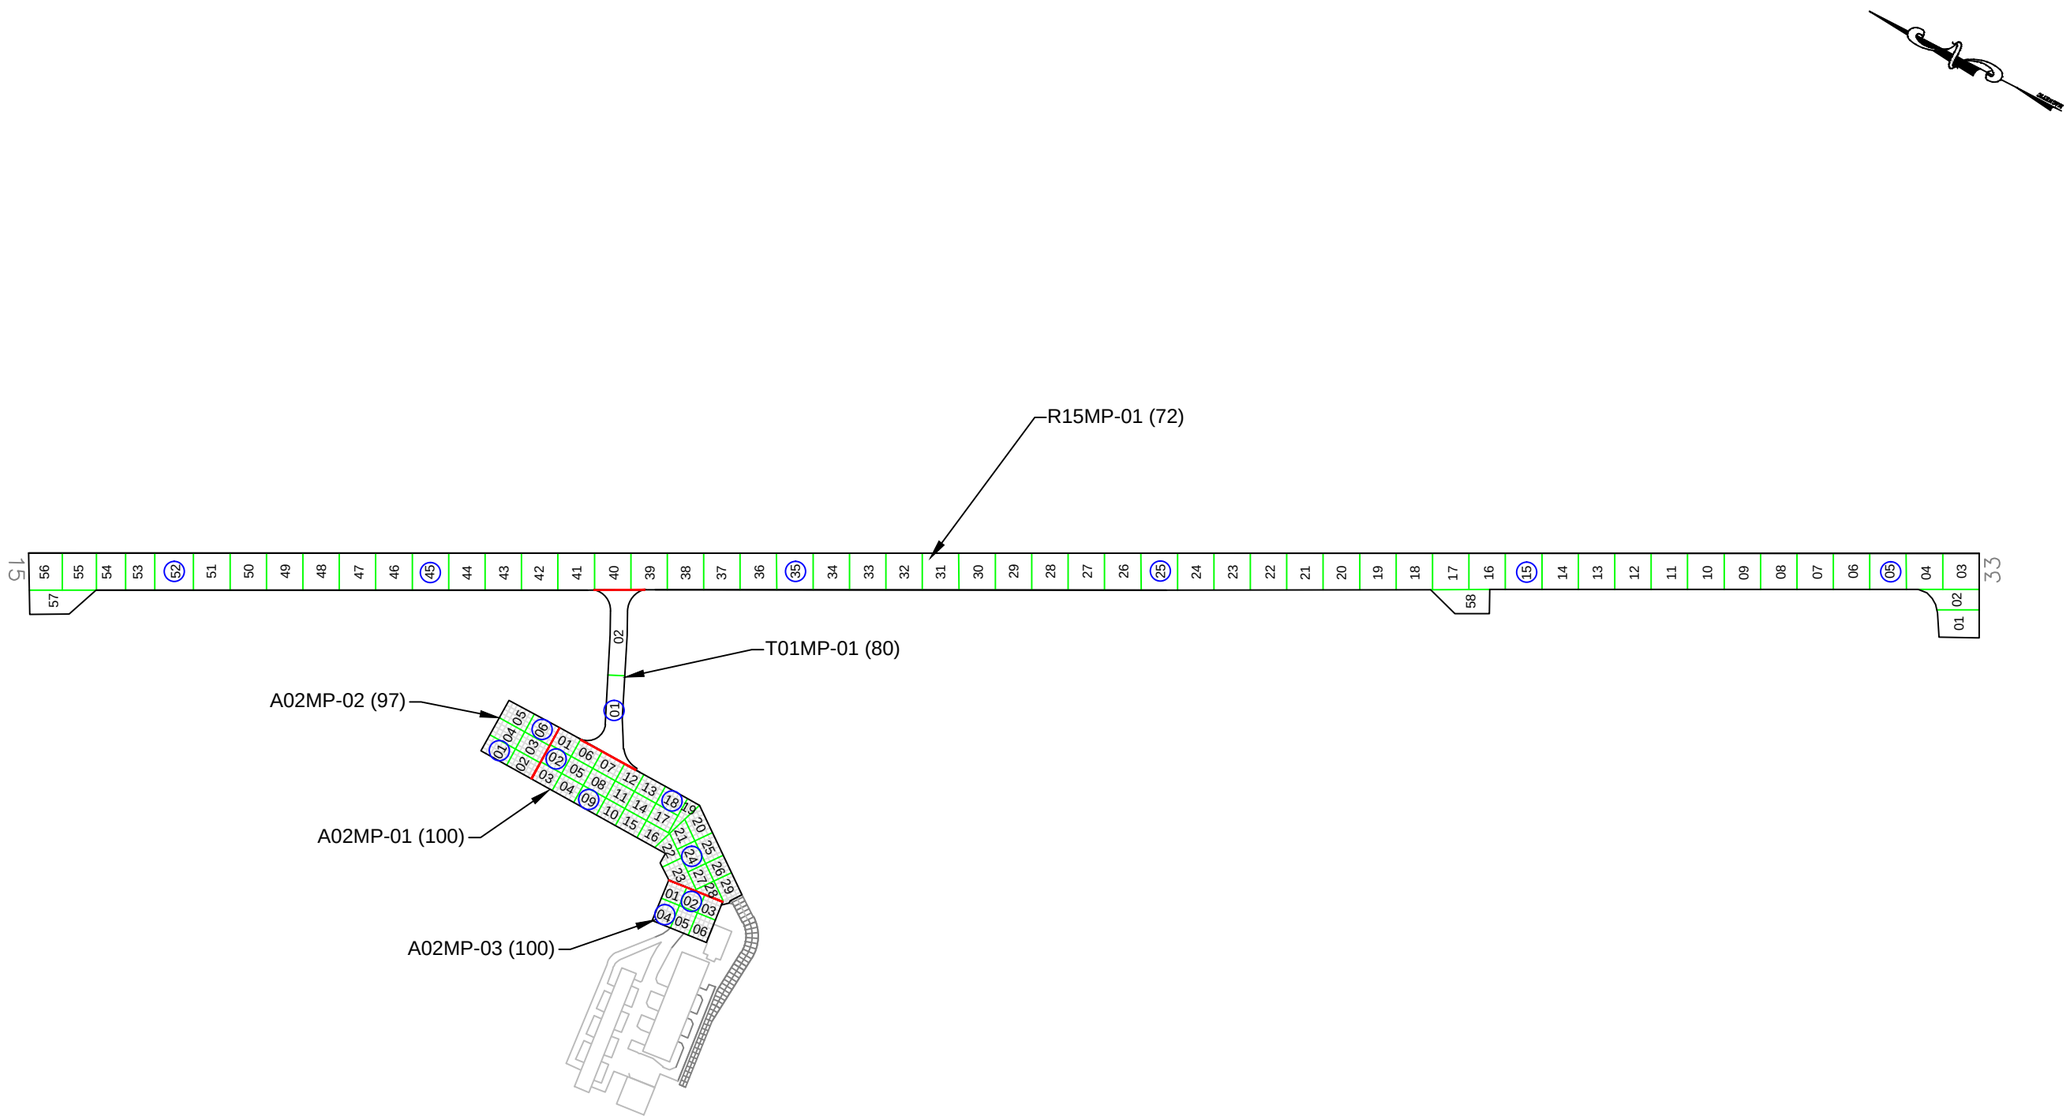
FIGURE 3. NETWORK DEFINITION MAP.

Runway 15-33 is defined by one section that is in satisfactory condition with moderate quantities of low- and medium-severity longitudinal and transverse (L&T) cracking observed throughout. The low-severity cracking was mostly unsealed, and the medium-severity cracking was due to unsealed crack widths greater than ¼ inch.

Taxiway 01 consists of one section that connects the runway and apron area. Section 01 is in satisfactory condition with moderate quantities of low- and medium-severity L&T cracking recorded. The low-severity cracking was mostly unsealed, and the medium-severity cracking was due to unsealed crack widths greater than ¼ inch.

Three sections are defined in the apron area (Apron 02). Section 01, the majority of the apron area, was under construction at the time of inspection. It is assumed that it will have no distresses upon completion of the construction. Section 02 is in excellent condition with low-severity joint seal damage and isolated quantities of low-severity corner spalling identified. Section 03, the southern portion of the apron area, was recently reconstructed and no distresses were observed at the time of inspection.

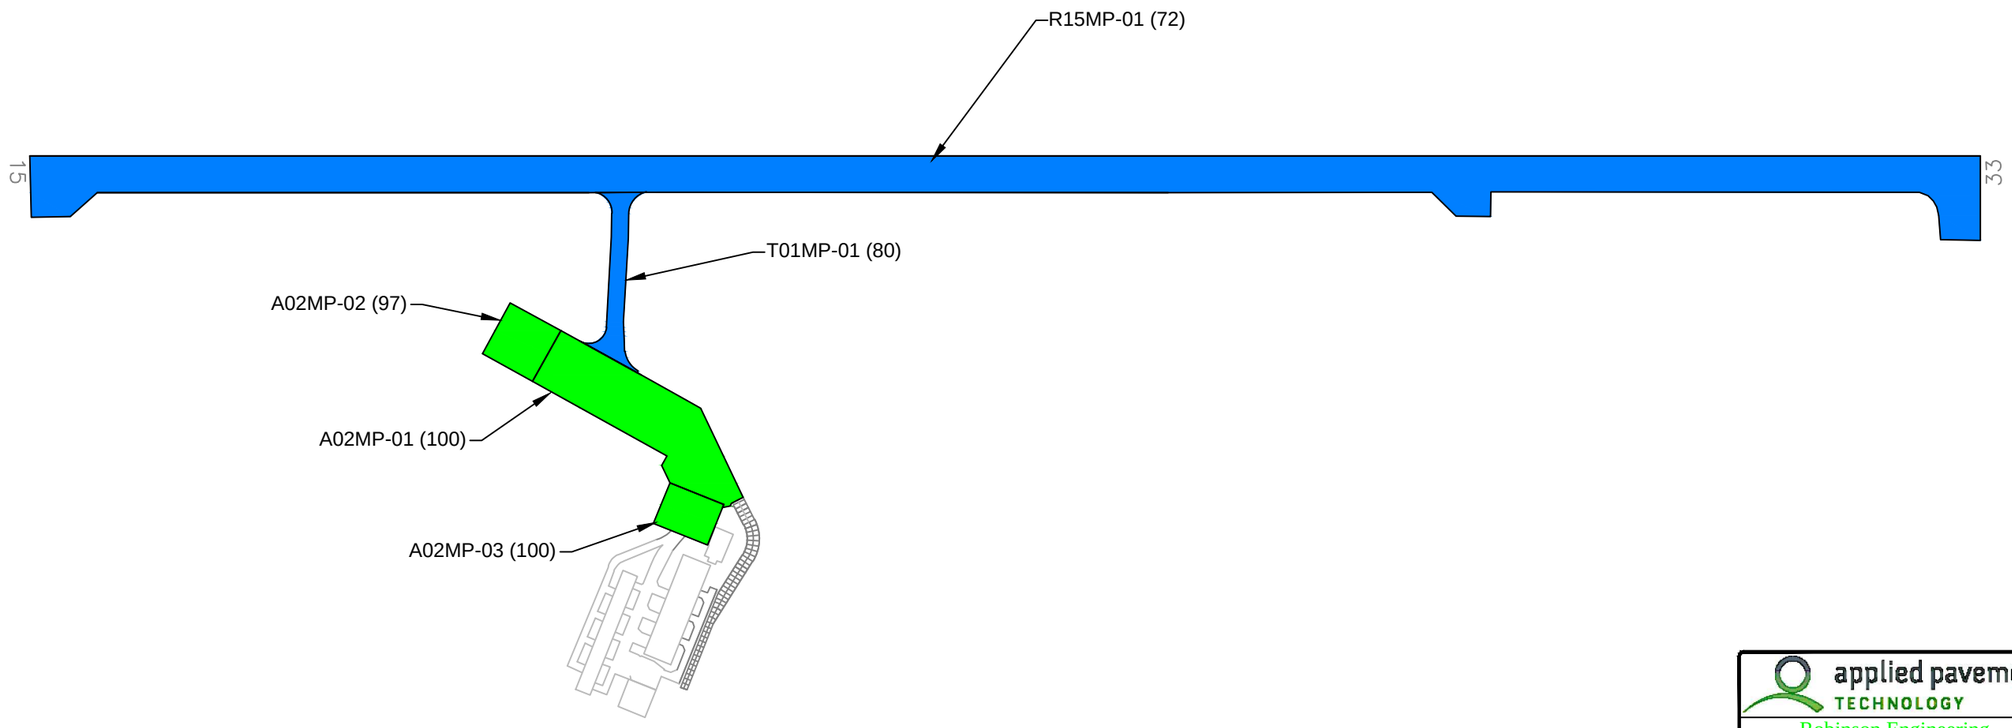
FIGURE 8. PCI MAP.

The pavements at Mount Pleasant Municipal Airport were inspected on September 15, 2010. The 2010 area-weighted condition of Mount Pleasant Municipal Airport is 78, with conditions ranging from 72 to 100 (on a scale of 0 [failed] to 100 [excellent]). During the previous pavement inspection in 2006, the area-weighted PCI of the airport was 75.
