MUSCATINE MUNICIPAL AIRPORT PAVEMENT MANAGEMENT REPORT

Prepared By:
Applied Pavement Technology, Inc.

December 2010

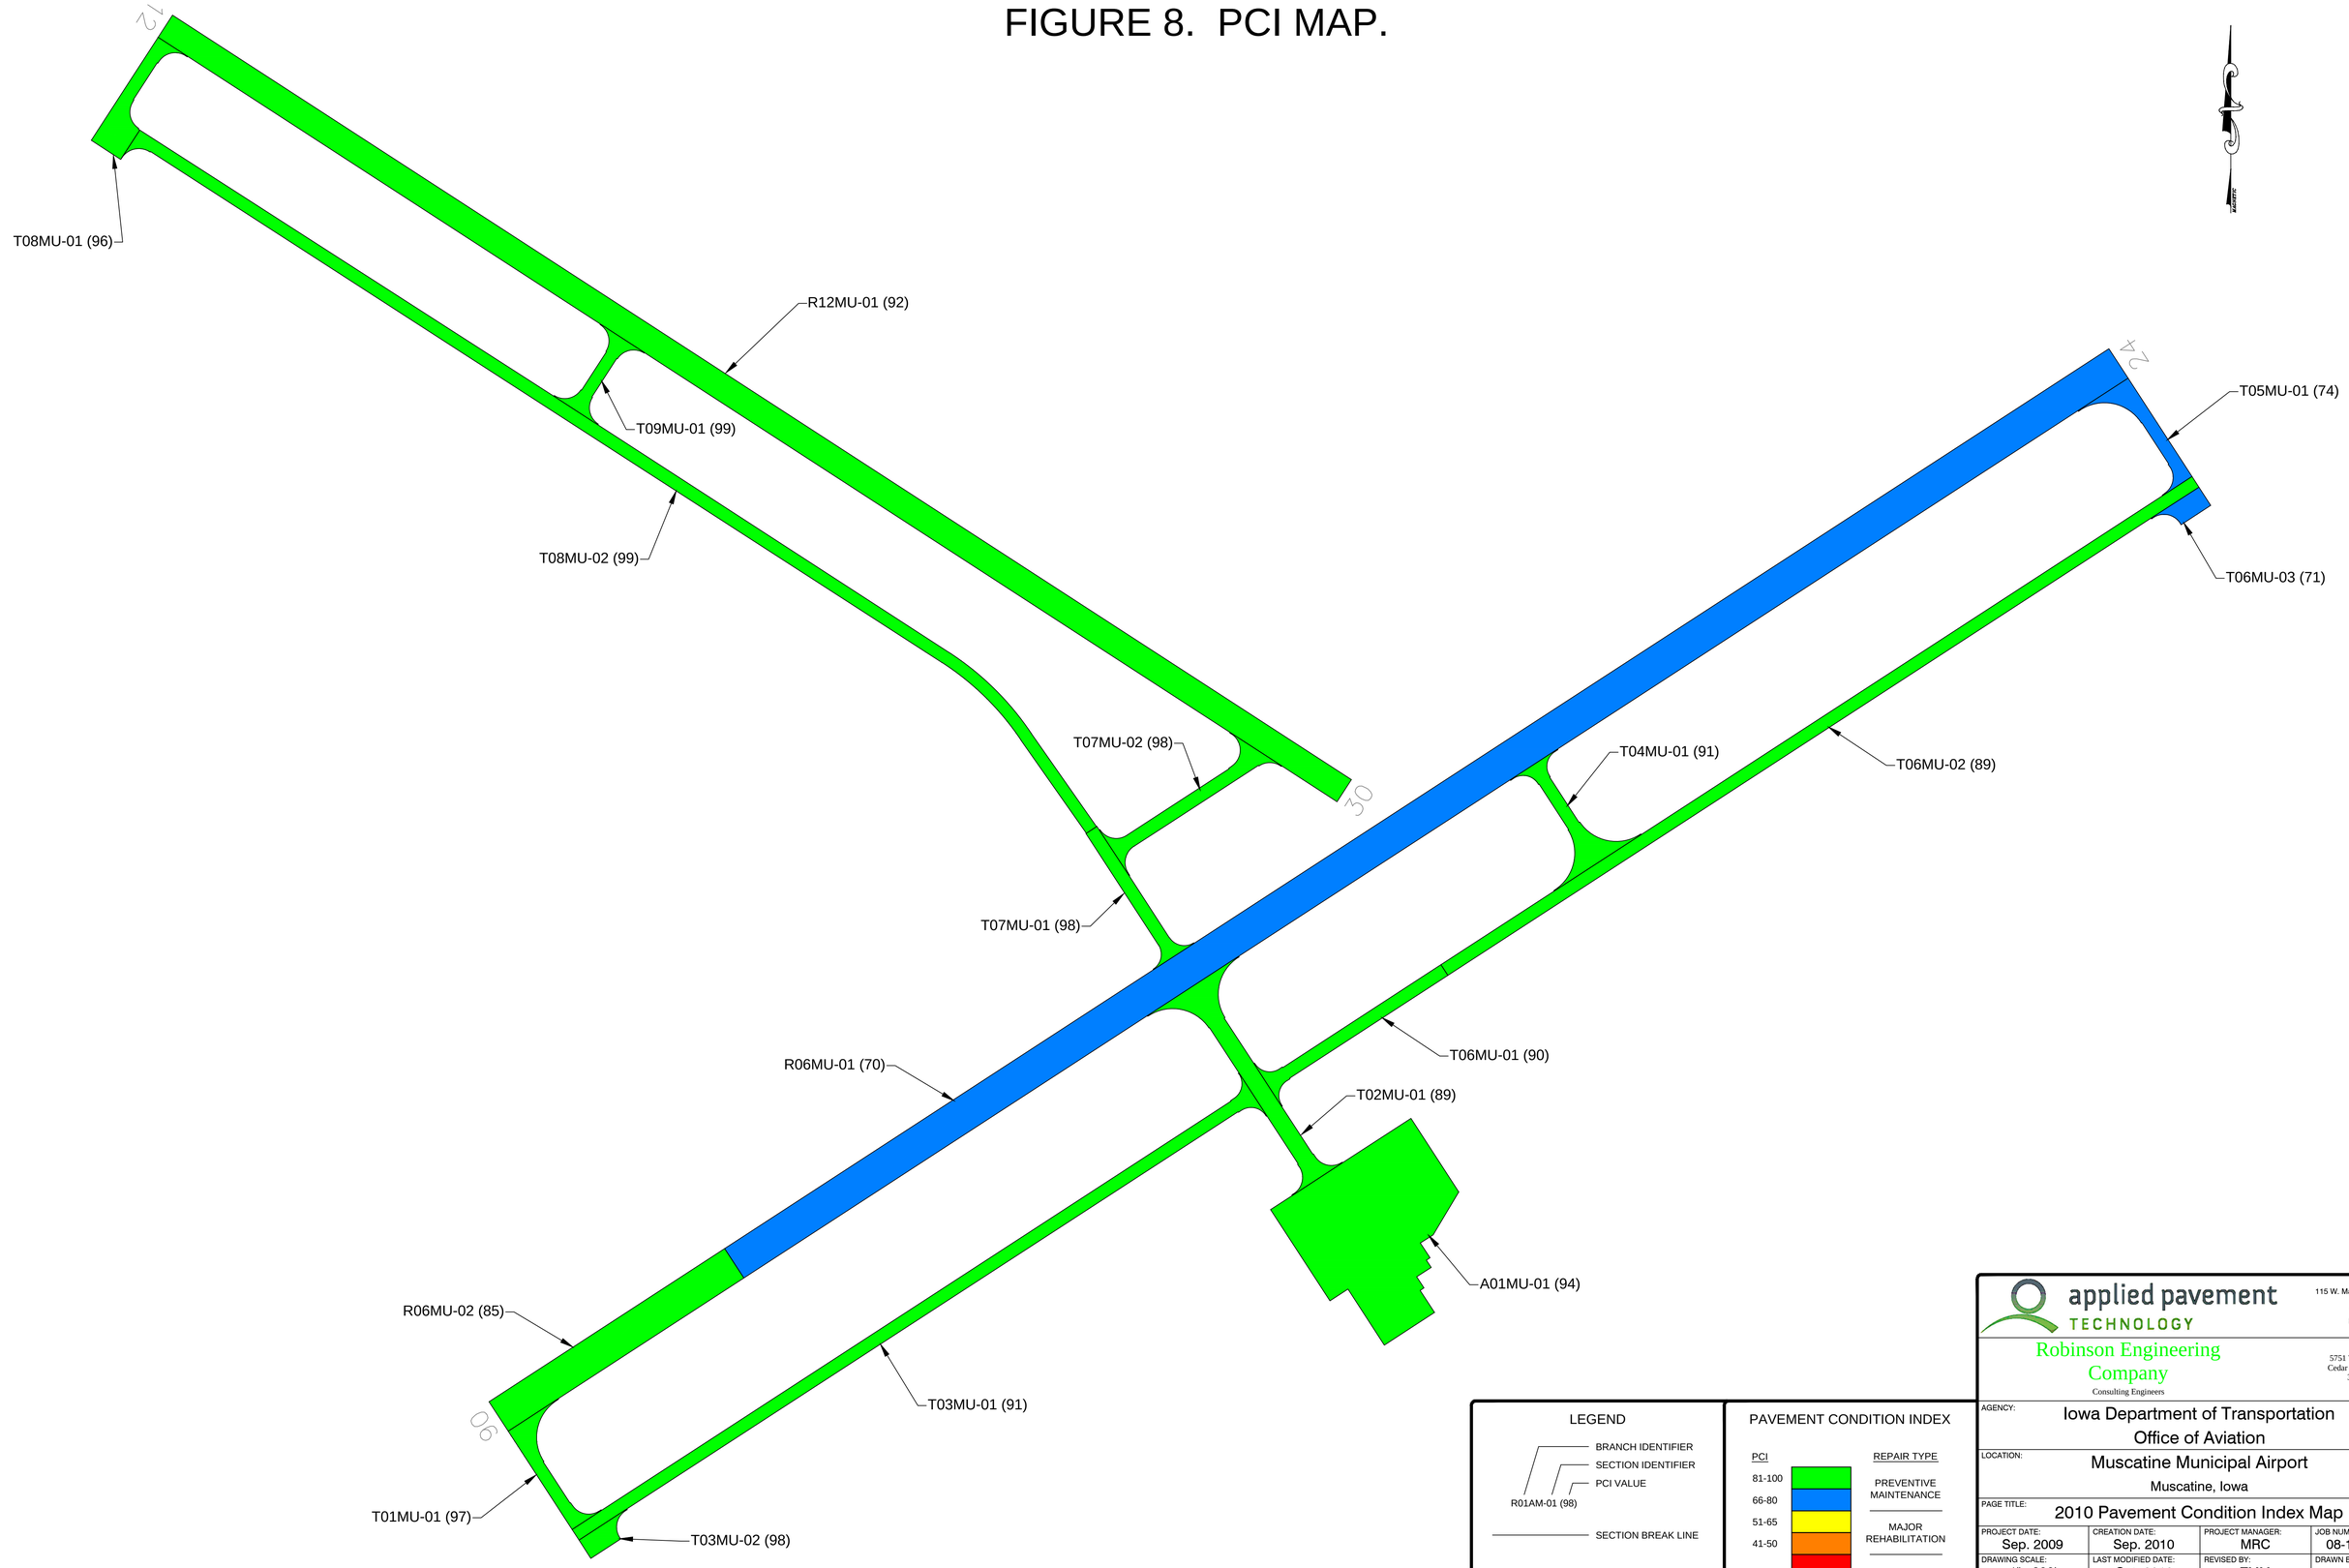
FIGURE 8. PCI MAP.

The pavements at Muscatine Municipal Airport were inspected on September 22, 2010. The 2010 area-weighted condition of Muscatine Municipal Airport is 85, with conditions ranging from 70 to 99 (on a scale of 0 [failed] to 100 [excellent]). During the previous pavement inspection in 2006, the area-weighted PCI of the airport was 86.

Figures 6 and 7 provide graphs summarizing the overall condition of the pavements at the Muscatine Municipal Airport. Figure 8 is a map that displays the condition of the pavements evaluated. Table 1 summarizes the results of the pavement evaluation. Appendix C presents photographs taken during the PCI inspection, and Appendix D contains detailed information on the distresses observed during the visual survey. Appendix E includes detailed work history
