MONTICELLO MUNICIPAL AIRPORT PAVEMENT MANAGEMENT REPORT

Prepared By:
Applied Pavement Technology, Inc.

December 2010

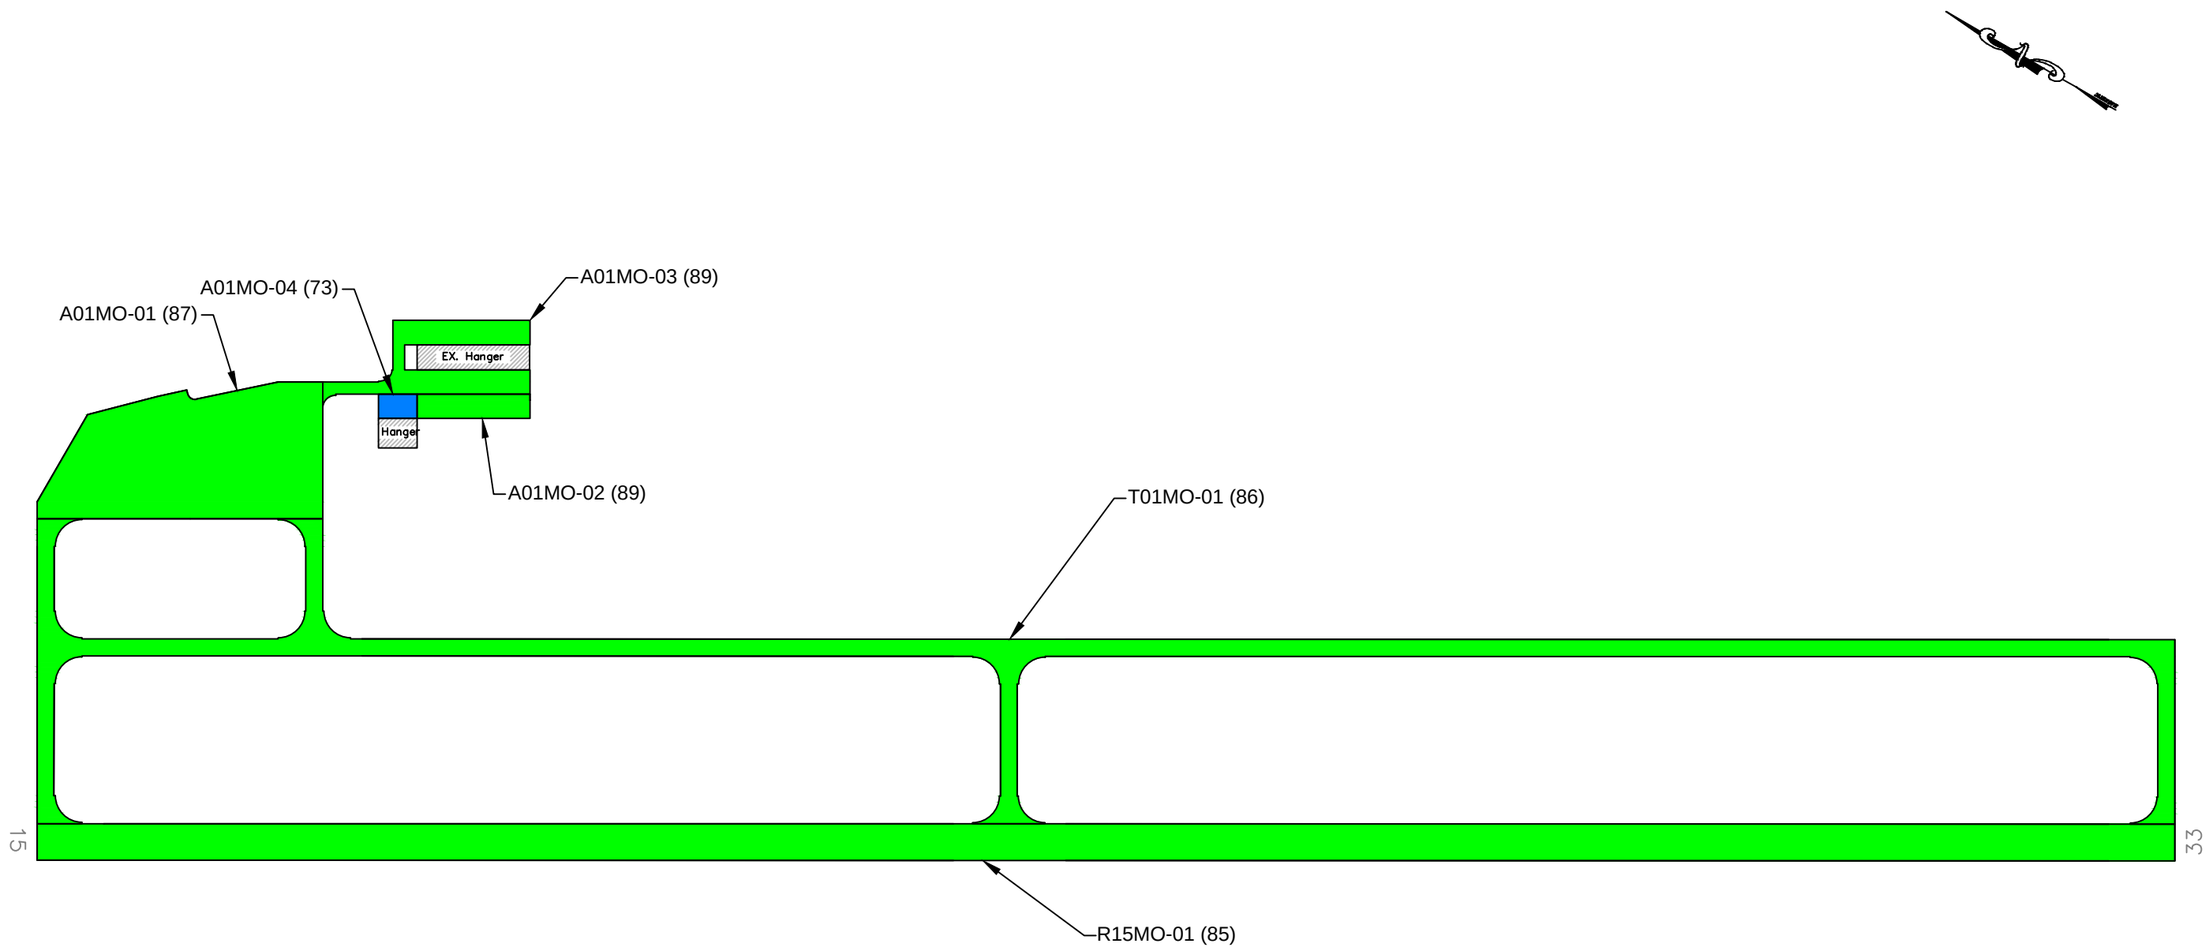
FIGURE 8. PCI MAP.

The pavements at Monticello Municipal Airport were inspected on September 21, 2010. The 2010 area-weighted condition of Monticello Municipal Airport is 86, with conditions ranging from 73 to 89 (on a scale of 0 [failed] to 100 [excellent]). During the previous pavement inspection in 2006, the area-weighted PCI of the airport was 87.

Runway 15-33 is defined by one section. Section 01 is in good condition with medium-severity joint seal damage recorded throughout. Moderate amounts of low-severity large patching were identified, as well as small quantities of low- and medium-severity corner spalling and low-severity joint spalling and small patching.

Taxiway 01 consists of the parallel taxiway system to Runway 15-33. Section 01 is in good condition with medium-severity joint seal damage and moderate quantities of low-severity linear cracking observed.

Four sections are defined in the apron area (Apron 01). Section 01, the majority of the apron area, is in good condition with medium-severity joint seal damage recorded throughout. In addition, small quantities of low-severity large patching, linear cracking, corner breaks, and faulting were observed. Section 02, the southwestern portion of the T-Hangar apron area, is in good condition with medium-severity joint seal damage and isolated quantities of low-severity linear cracking and shattered slabs identified. Section 03, the eastern portion of the T-Hangar area, is in good condition with medium-severity joint seal damage observed. Additionally, small quantities of medium-severity corner spalling and low-severity faulting were noted. Section 04, the northwestern portion of the T-Hangar apron area, is in satisfactory condition with medium-severity joint seal damage and low-severity linear cracking and shattered slabs recorded.
